**REPORT INTO A
FATAL INCIDENT AT
KILLYBEGS HARBOUR
CO. DONEGAL
14th MARCH 2019**

**REPORT NO. MCIB/288
(No.3 OF 2020)**

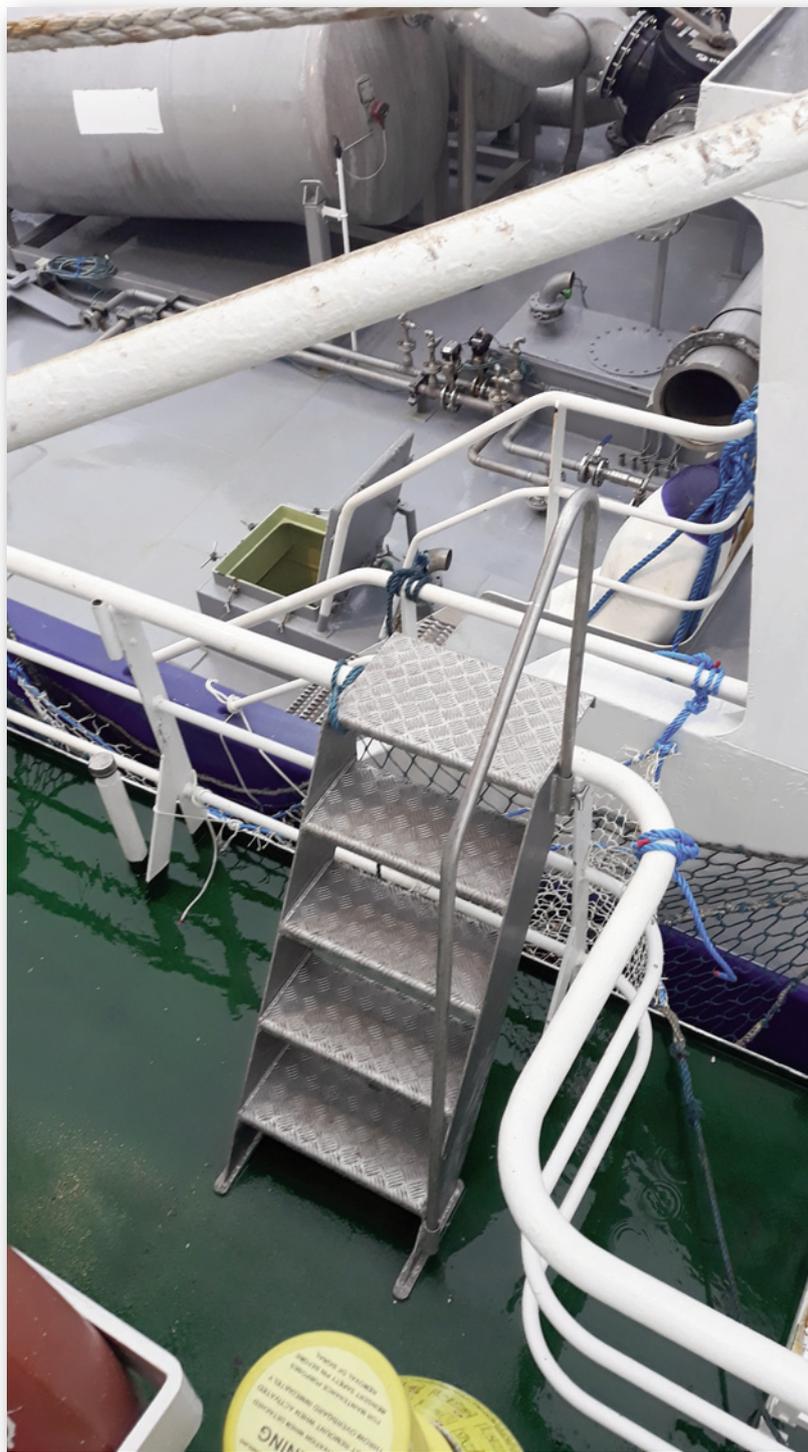
2.2.4 Photographs No. 1 & 2 show the boarding arrangements between the ‘*MV Grip Transporter*’ and ‘*MFV Menhaden*’. There were steps on both vessels and a net was rigged. It is noted that there was no gangway.

Photograph No.1 - Steps and net on 'MFV Menhaden'. View from 'MFV Menhaden'.

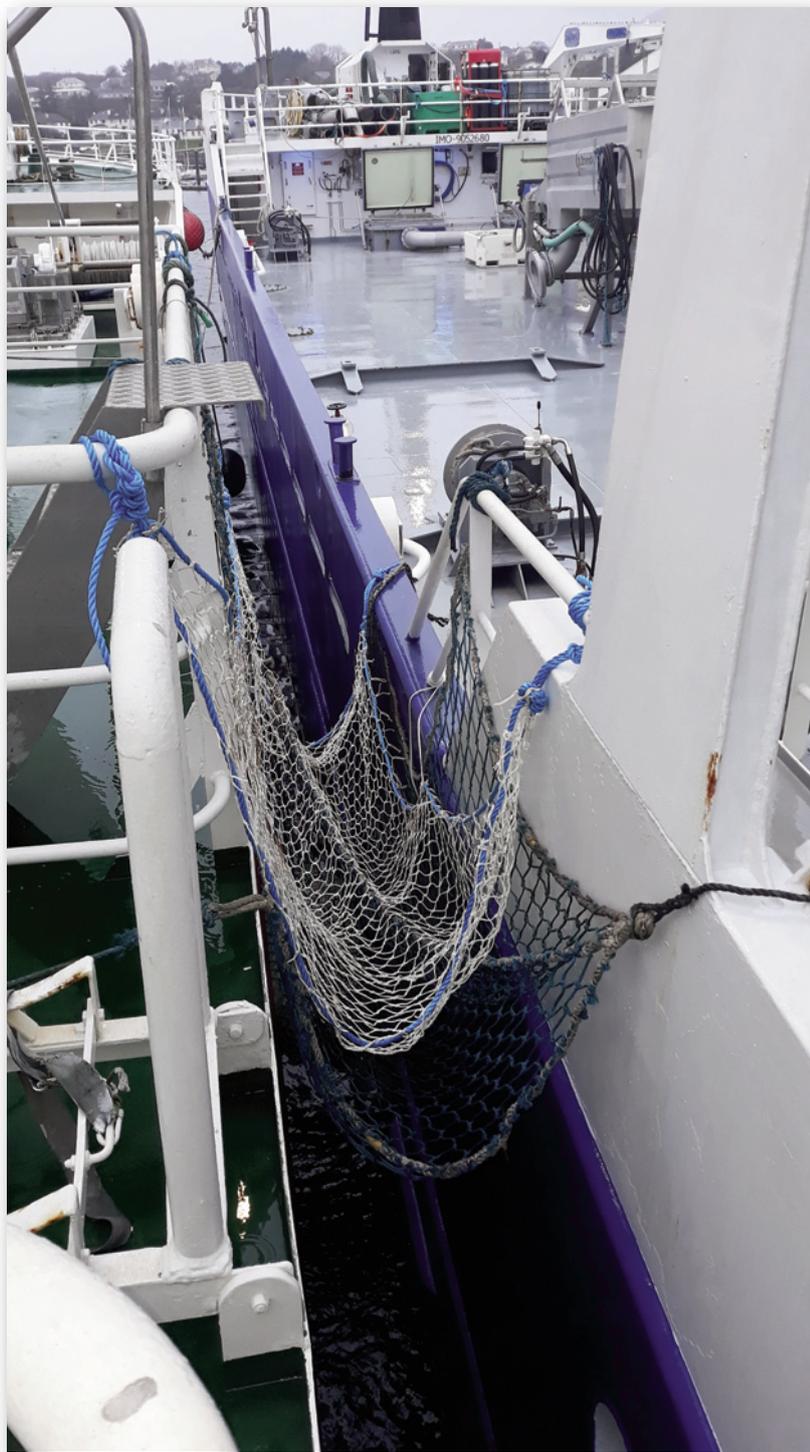
Photograph No.2 - Net from 'MFV Menhaden' to 'MV Grip Transporter'.

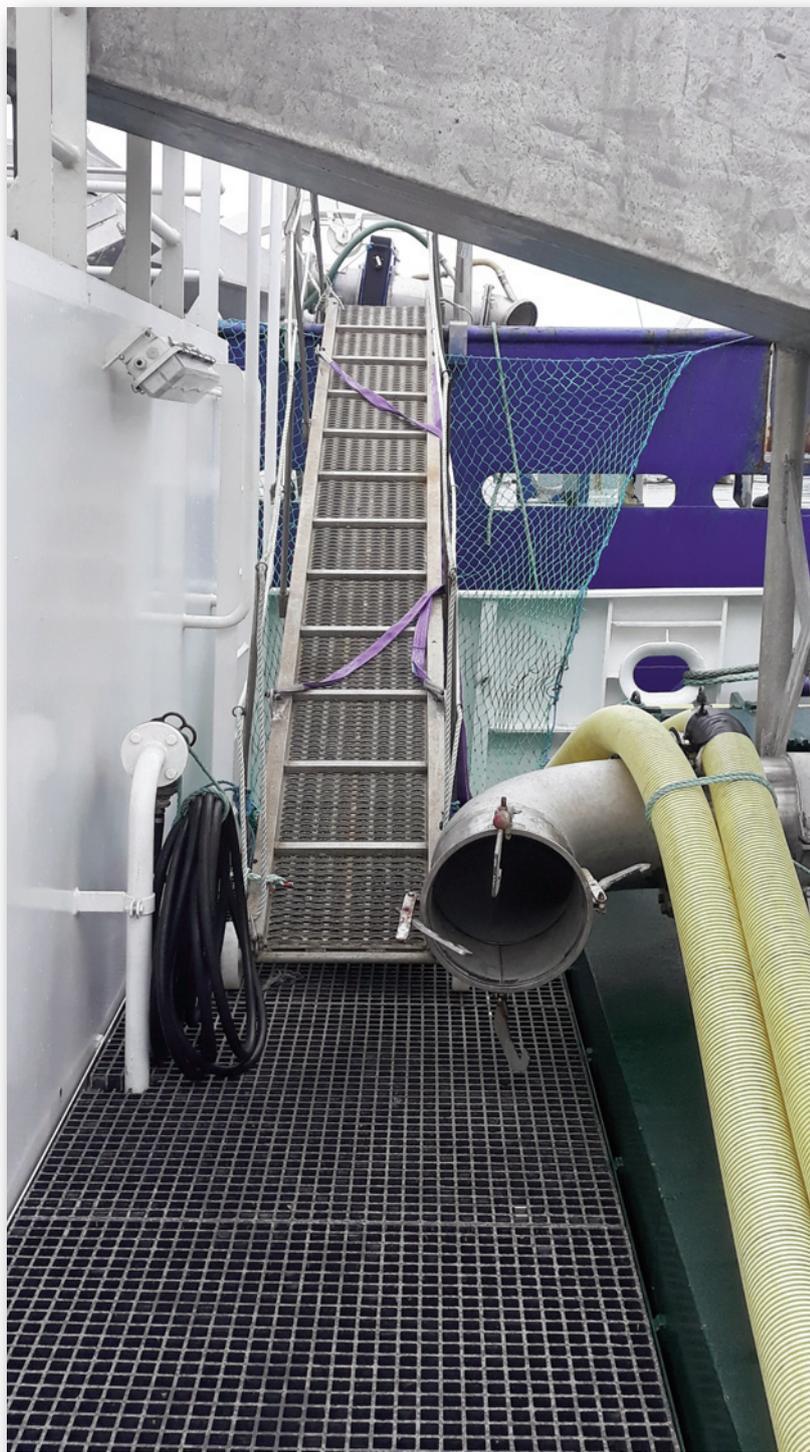
Photographs No. 3 & 4 shows the gangway rigged between the ‘*MV Grip Transporter*’ and the ‘*MFV Olgarry*’. There was a gangway, steps and a net.

Photograph No.3 - Steps between 'MFV Olgarry' and 'MV Grip Transporter'.

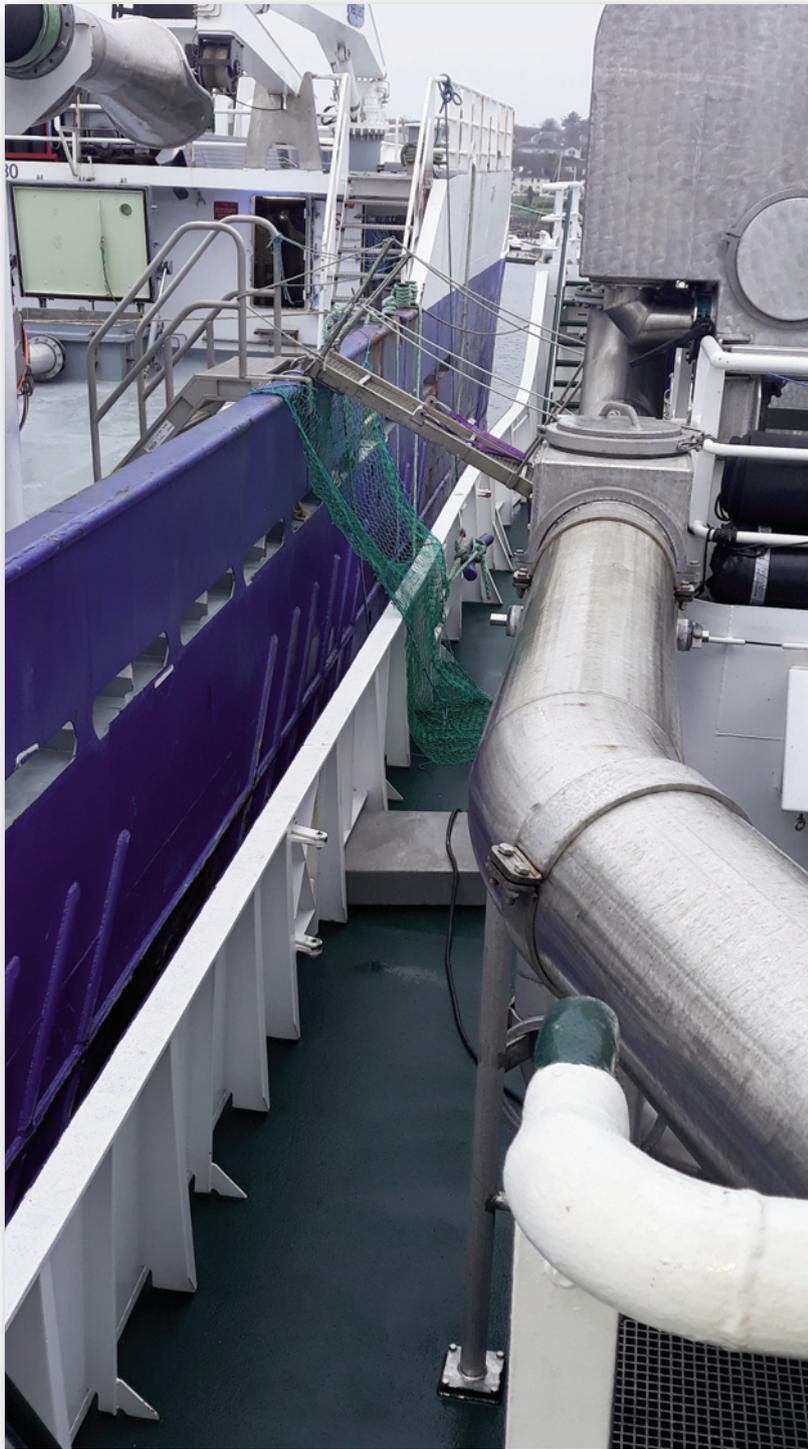
Photograph No.4 - Gangway and net rigged between 'MFV Olgarry' and 'MV Grip Transporter'.

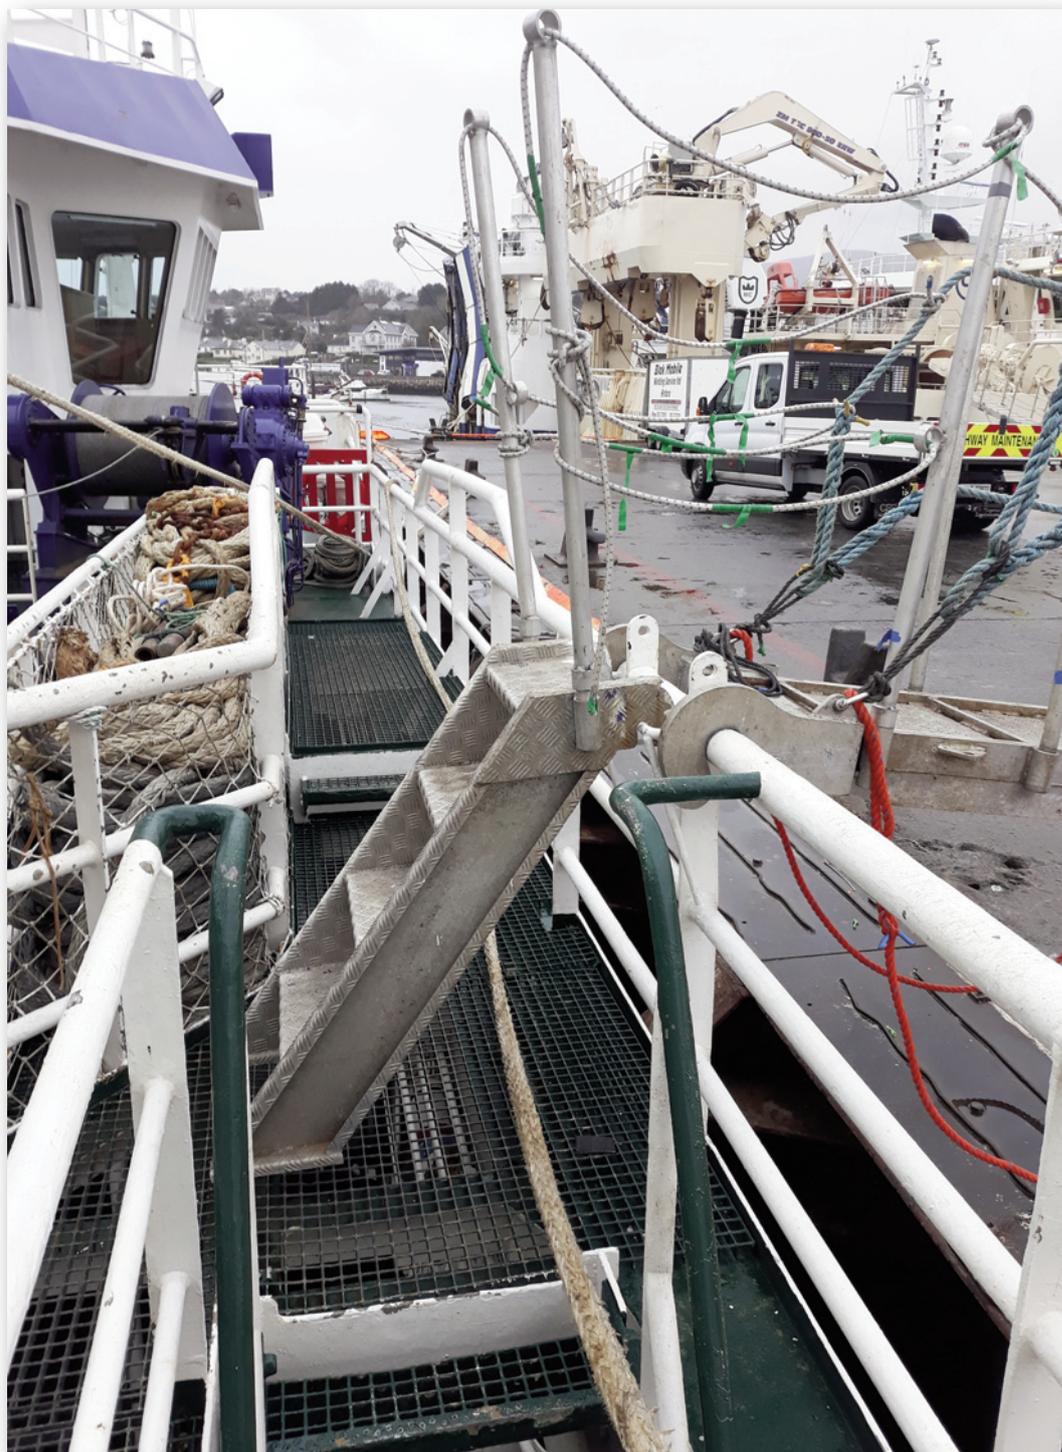
Photographs No. 5 & 6 show the gangway rigged between the ‘*MFV Olgarry*’ and the quay. Steps and a gangway were rigged. It is noted that there is no net visible.

Photograph No.5 - Gangway on 'MFV Olgarry' to shore.

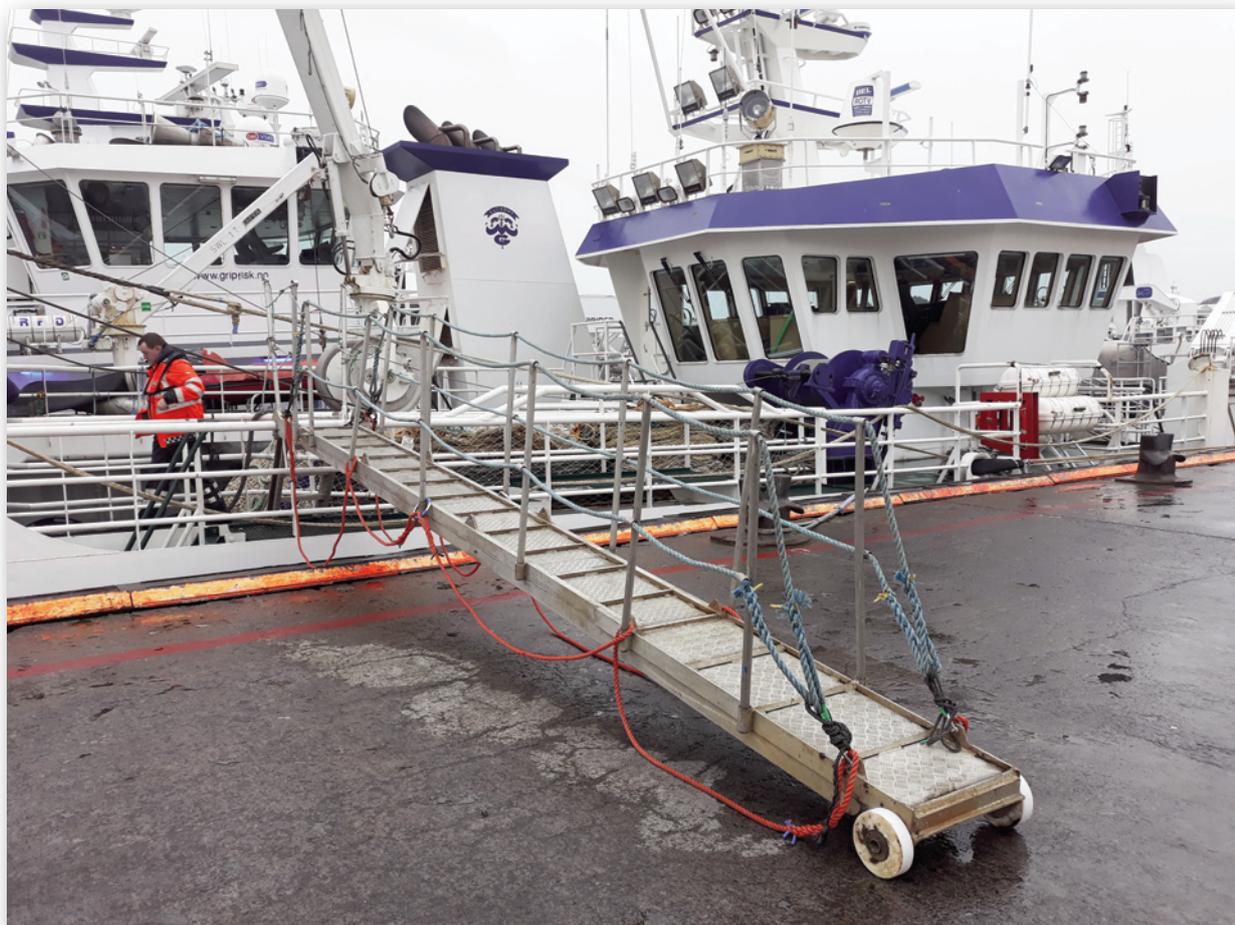
Photograph No.6 - Gangway from shore to 'MFV Olgarry'.
