**REPORT INTO THE  
COLLISION BETWEEN  
A TANKER 'VARKAN EGE'  
AND  
A SAILING VESSEL 'MEDI MODE'  
23rd AUGUST 2019**

**REPORT NO. MCIB/293  
(No.7 OF 2020)**

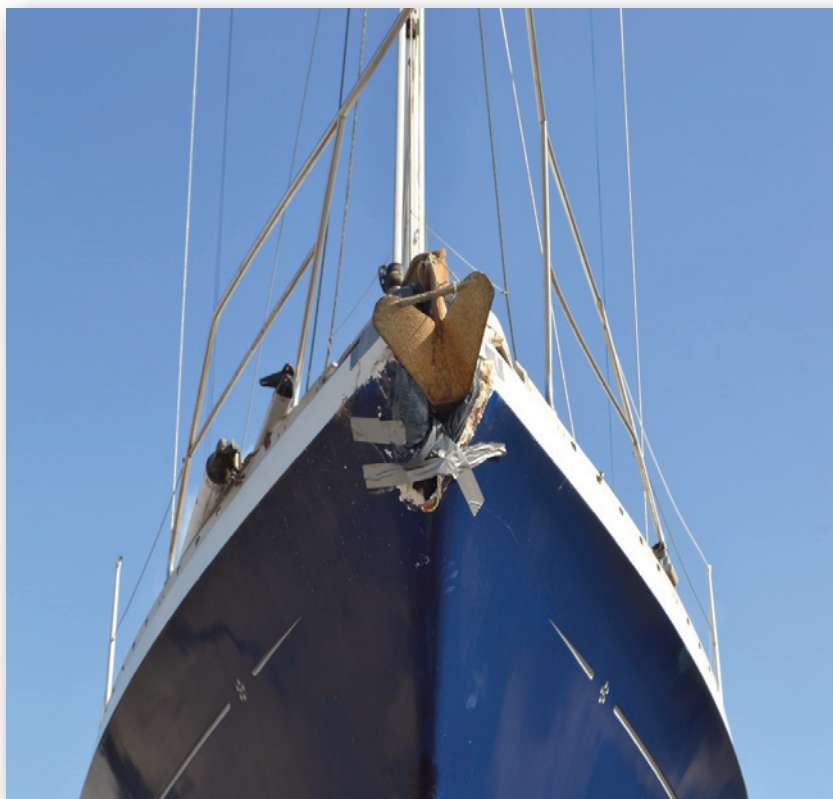
- the stem head fitting was torn away, the pulpit, toe rail and surrounding area was severely deformed;
- the mast was held upright by the baby stay forward;
- rudder control was restricted by damage and was unable to use the full range;
- there was damage to the aft bulkhead and door to the aft cabin; and
- the starboard sheet winch was driven down through the cockpit coaming.

Photograph No.3 - Damage to bow of 'Medi Mode'.

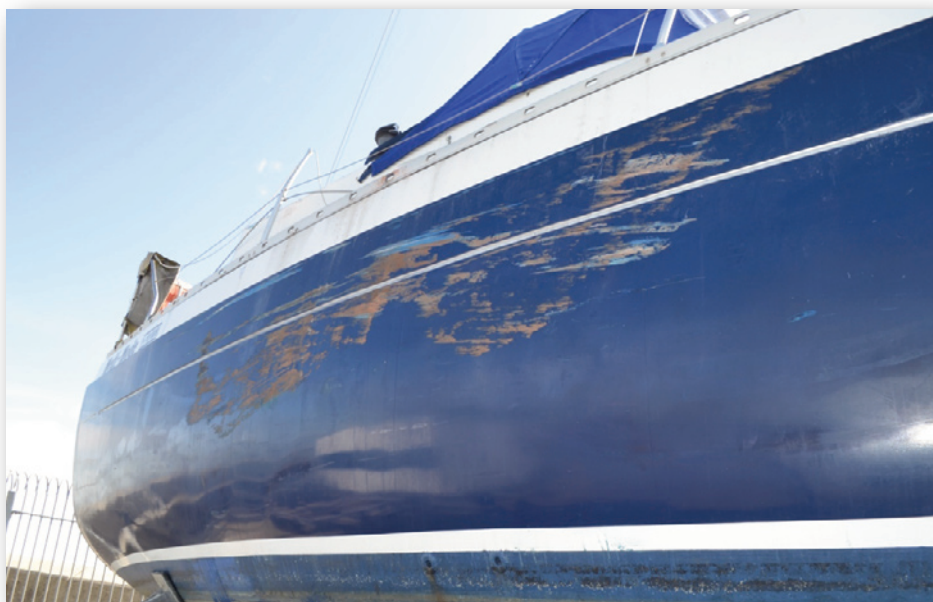
Photograph No.4 - Damage to hull, starboard side.

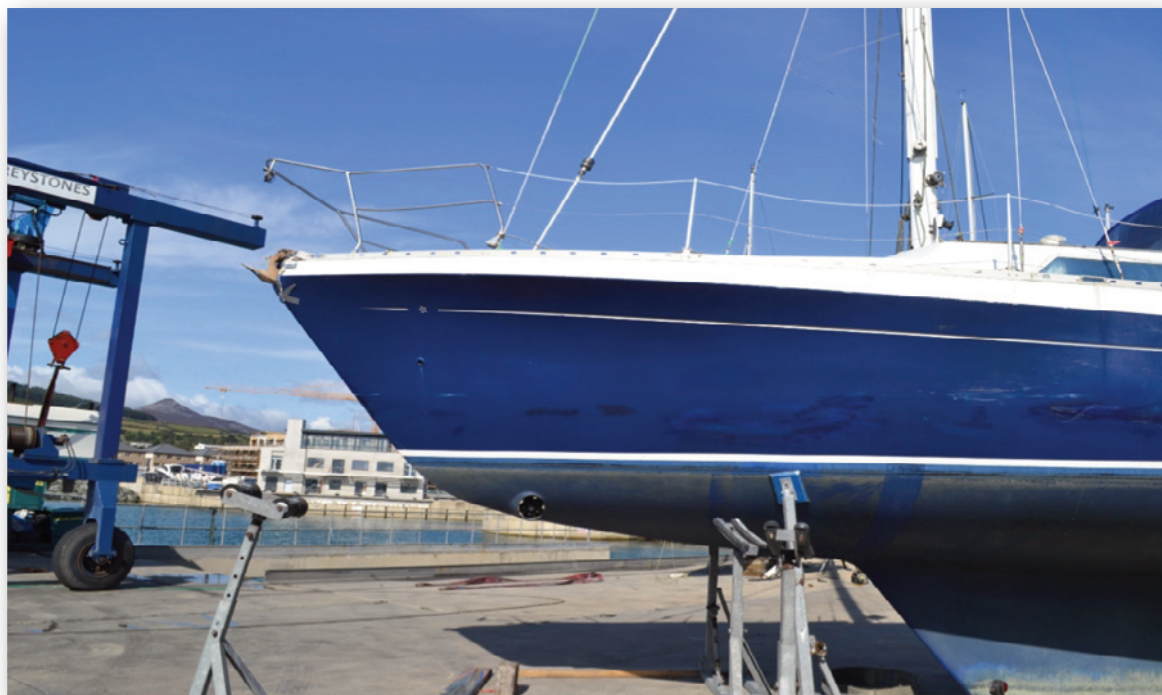
Photograph No.5 - Damage to port bow of 'Medi Mode'.

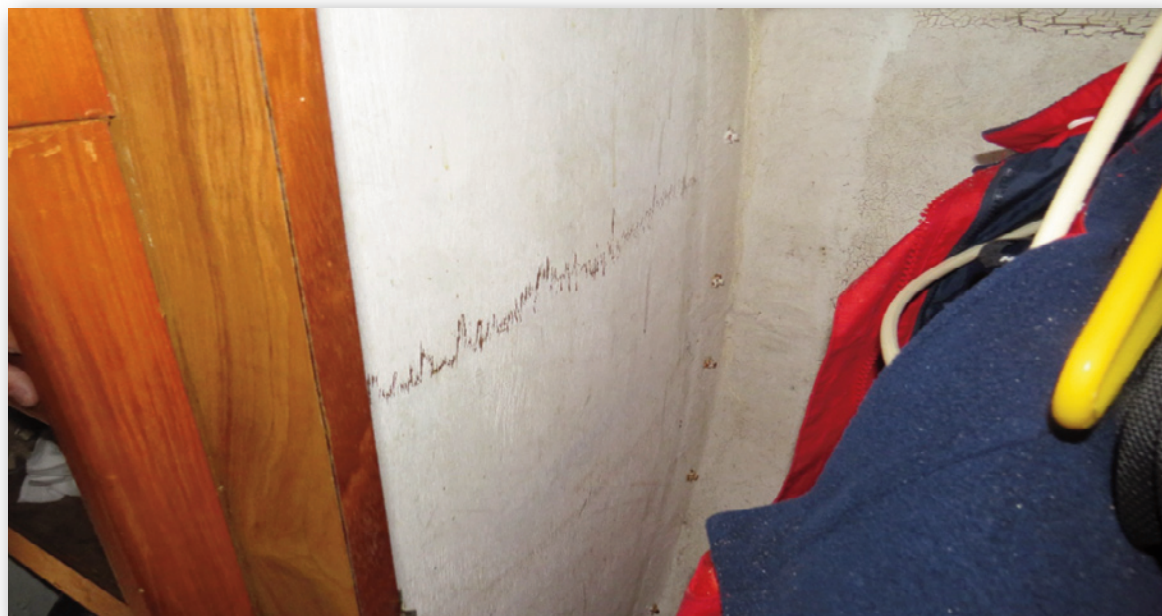
Photograph No.6 - Internal damage to bulhead.

Further damage to aft bulkhead & door to aft cabin.

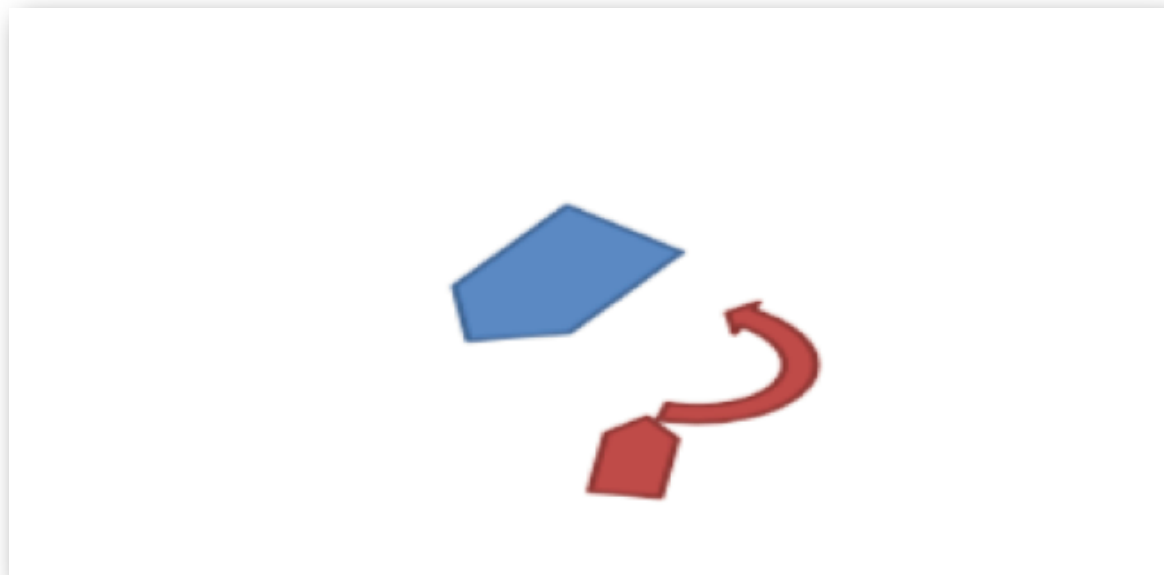
### Appendix 7.5 Demonstration of Incident as Described by 'Varkan Ege'

As 'Varkan Ege' was altered course to Starboard 'Medi Mode' altered to Port.
