**REPORT OF AN INVESTIGATION
INTO A MARINE CASUALTY
INVOLVING THE MERCHANT VESSEL
ARKLOW RAIDER
IN THE BRISTOL CHANNEL,
25 NOVEMBER 2022**

**REPORT NO. MCIB/324
(No.7 OF 2023)**

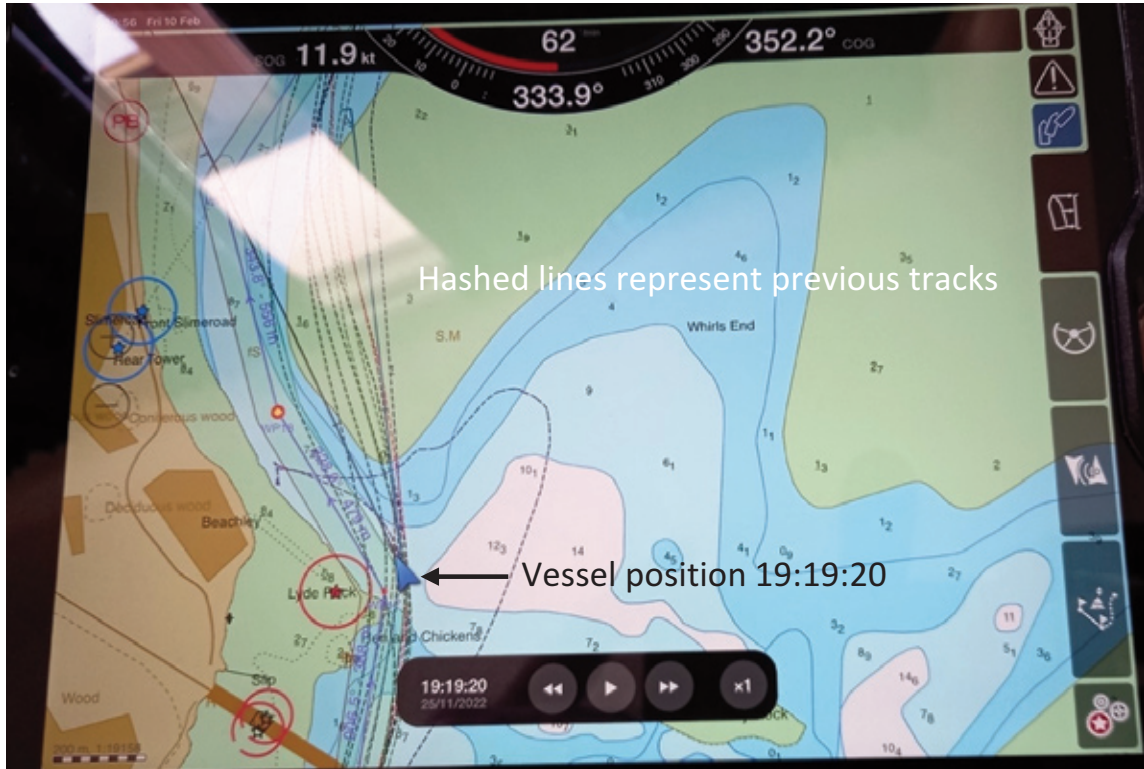
Screenshot of Portable Pilot Unit.

- 4.23 During interviews there was no evidence that either the Pilot or Master lost situational awareness at any point. The helm orders applied appear reasonable. The Master and Pilot have differing recollections on whether the pitch was increased from 85% to 100%, but ultimately given the speed with which the vessel turned to port, this engine command is unlikely to have made any difference to the eventual outcome. A review of previous tracks on the Pilot's PPU evidences that on 25 November 2022, the Pilot was following a very similar track to ones that he had used to successfully execute the turn around Lyde Rock on multiple previous occasions. See Appendix 7.9 - Extract from Admiralty Chart 1166: River Severn Avonmouth to Sharpness and Hook Cliff and following screenshot:

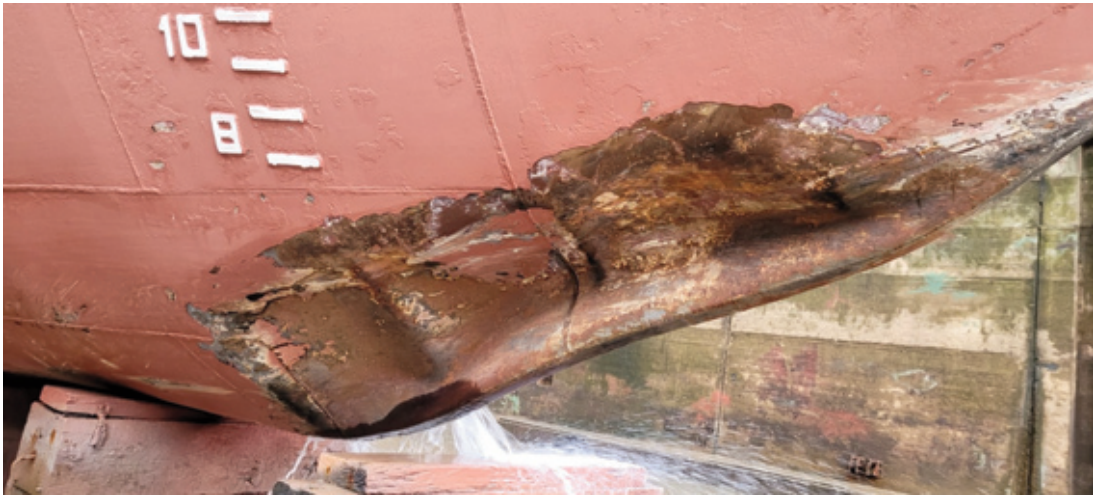
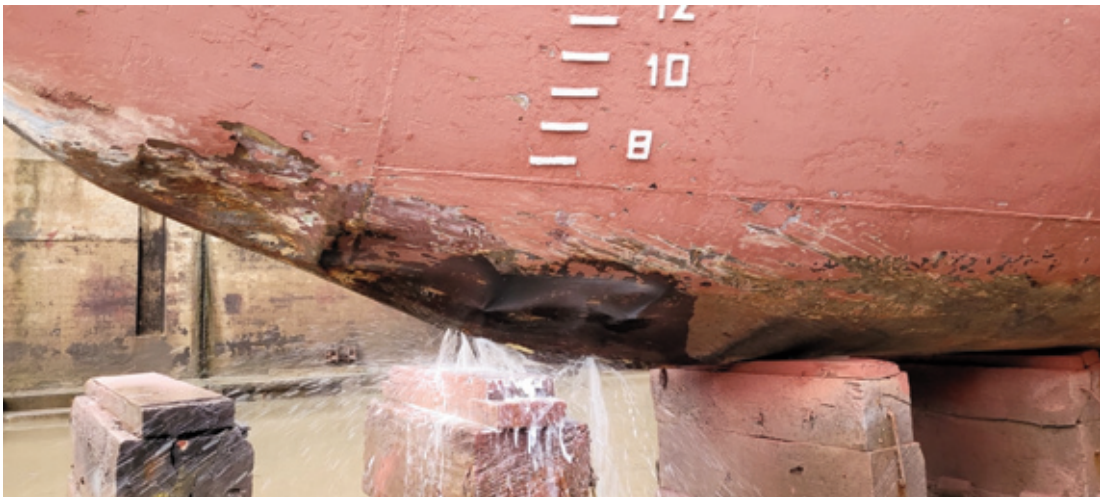
Appendix 7.12 Photographs of the Vessel Damage

- 3.20 After arrival in Sharpness it was identified that the bottom plating of the forepeak tank was breached and dry-dock would be required to effect repairs.

Forepeak bottom damage to Arklow Raider

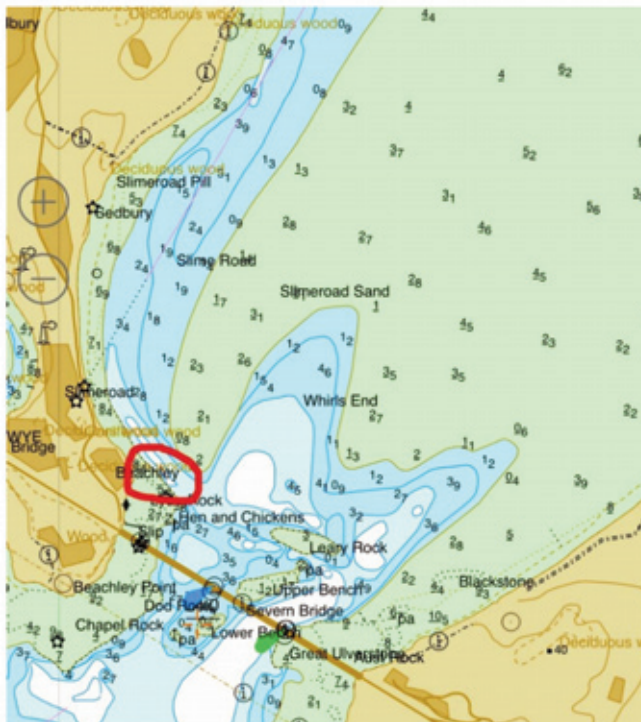
1921hrs The vessel made contact with the bank at a speed of 5.6kts, still going astern on the engine, and was then apparently fast by the bow. See Fig 1&2 below. Various relevant parties/ authorities were contacted by the Pilot and Master. Tidal window assessed for vessel removal. There was approximately 1.3m of further rise in tide predicted before high water.

Fig. 1: Chartlet indicating area of grounding

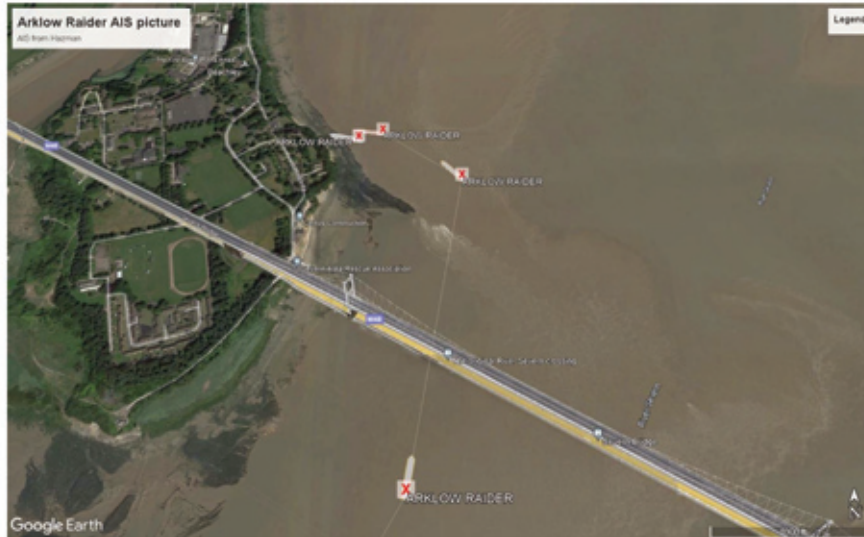
Fig.2: Satellite image of grounding site with AIS overlay of vessel

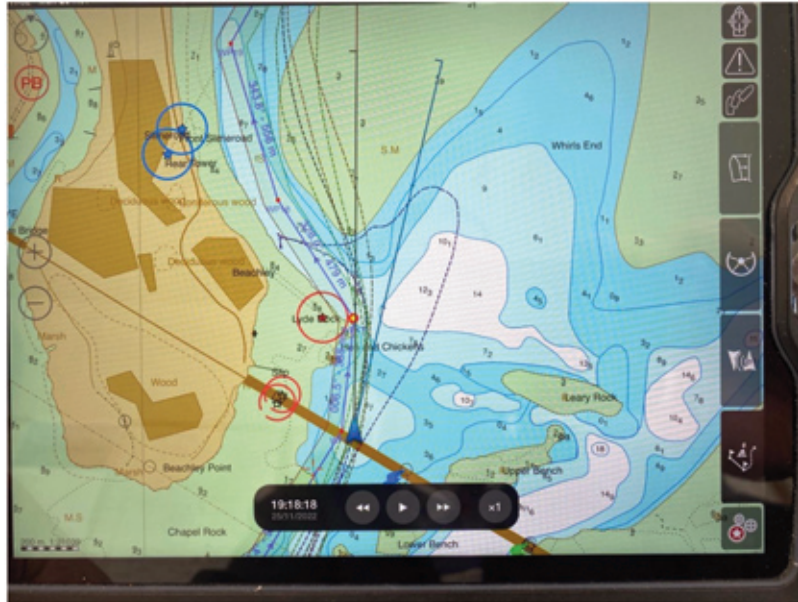
Fig.4: Screenshot of PPU showing inwards track to grounding, plus subsequent outwards track. Also tracks of prior vessels with same Pilot.

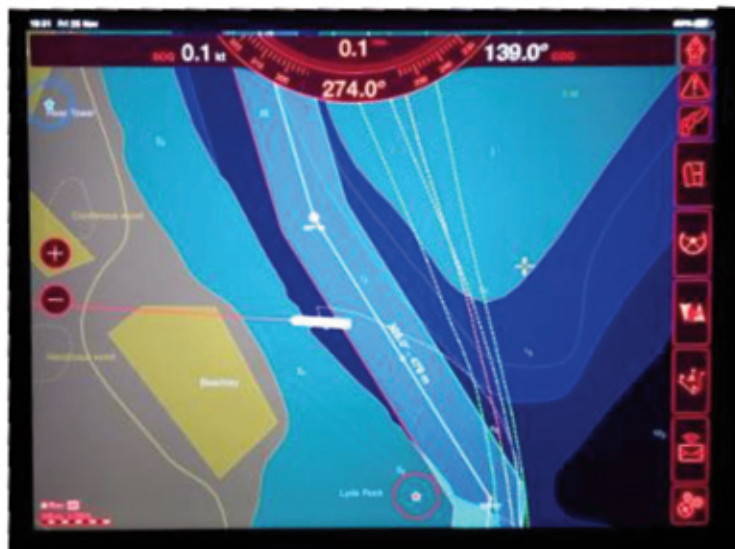
Fig.5: Screenshot of PPU with vessel in grounded position, plus Pilot's previous vessel tracks.

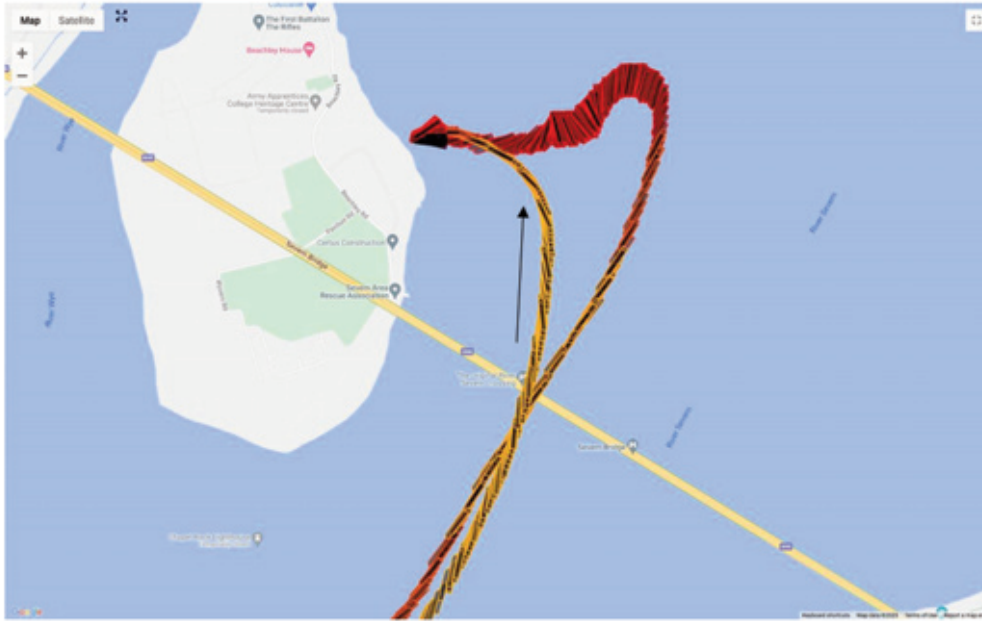
Fig.6: Screenshot of AIS positions/track showing approach to grounding (indicated by arrow) and subsequent refloating and outwards passage on date of incident.
