**REPORT OF AN INVESTIGATION INTO  
A MARINE CASUALTY  
INVOLVING THE VESSEL  
SIMMERDIM  
OFF ARDMORE PIER,  
CO. GALWAY  
8 NOVEMBER 2022**

**REPORT NO. MCIB/321  
(No.9 OF 2023)**

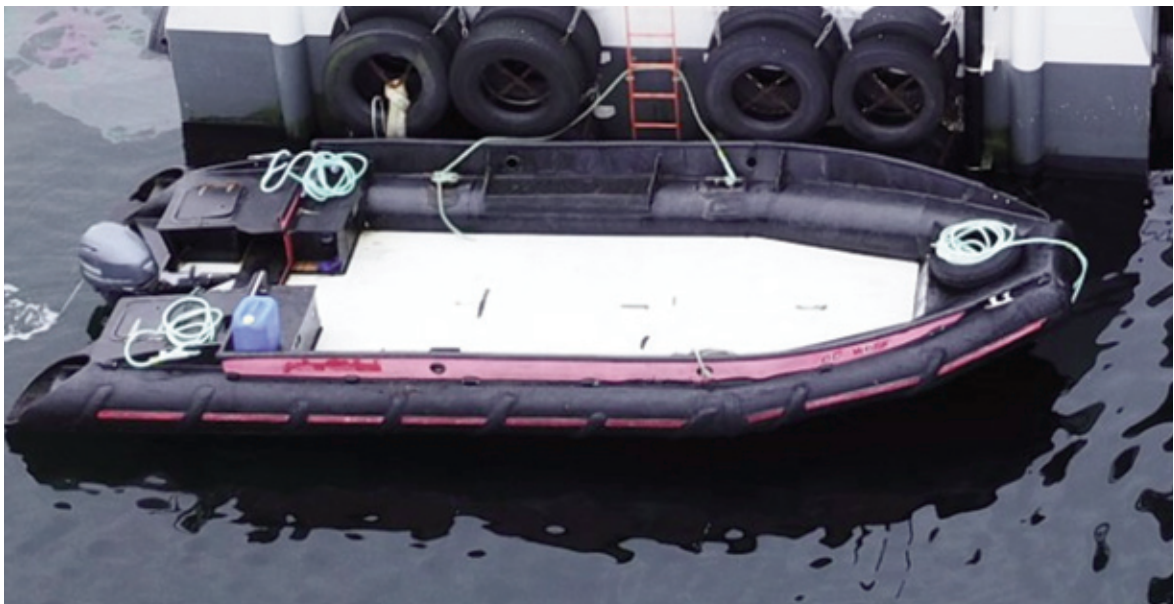
Polar Boat while Alongside the Stern of Feed Barge

- 2.1.13 As the Polar boat operated to transport personnel within the meaning of the Merchant Shipping (Passenger Boat) Regulations S.I. No. 273 of 2002, it should have held a Passenger Boat Licence. It did not have a Passenger Boat Licence.

- 4.5.2 The Polar boat used to transport personnel from Ardmore Pier to Simmerdim did not hold a Passenger Boat Licence as required under the Merchant Shipping (Passenger Boat) Regulations 2002 S.I. No. 273 of 2002. The Polar boat departed from Ardmore Pier at around 08.30 hrs with five personnel onboard. During the short transit to the salmon farm site there was an opportunity for the salmon farm employees, including the site manager to perform a safety briefing with the industrial personnel and to highlight the hazards and risks associated with the transfer across to Simmerdim and onto the Feed Barge. Such a safety briefing would prompt discussion around performing the task in a safe manner and highlight any concerns that personnel may have. However, there was no evidence to suggest such a briefing took place.

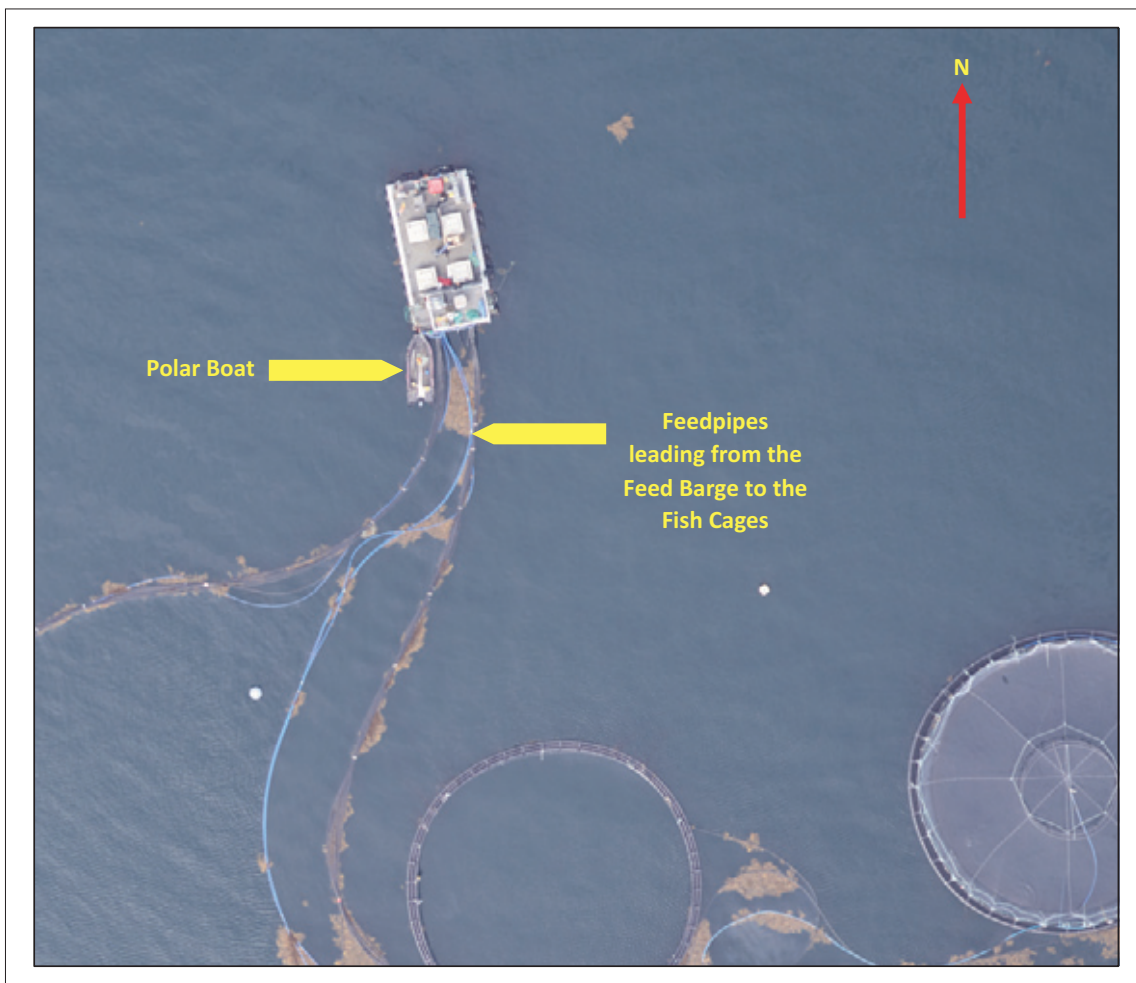
Appendix 7.2 Photograph - Fixed Orientation of the Feed Barge

- 4.7.1 The Skipper assessed the weather conditions before leaving Lettermullen and deemed the conditions acceptable for the works. There is no doubt that environmental conditions impacting the vessels and their interaction was a significant contributing factor to this incident. The Sea Site was greatly exposed from a southerly direction as there was no local landmass that offered protection from this direction. On the day of the incident the swell was reported

from a south-south westerly direction at about 2 m in height. The motion of the sea caused both vessels to pitch in the prevailing conditions, making the transfer from Simmerdim to the Feed Barge even more challenging.

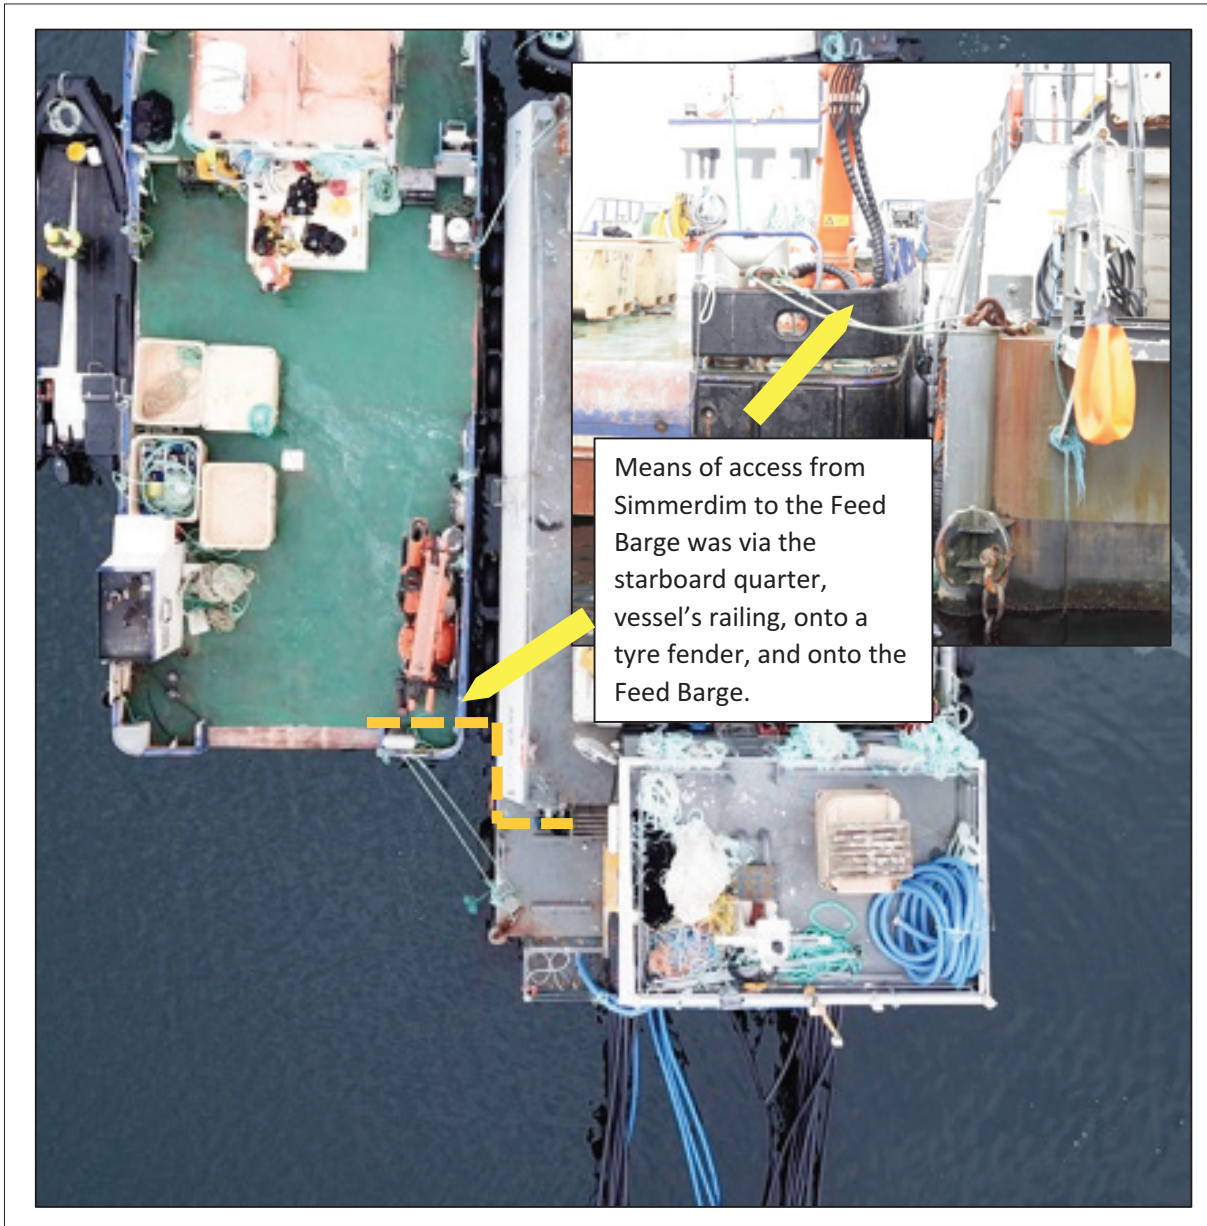
Appendix 7.10 Photograph Showing Means of Access

- 4.4.4 On the risk assessment document, which was created in 2021, there was an option to select “Crushing” as a potential hazard or risk, however this was not selected and therefore not formally assessed in the risk assessment or the procedure. Assessing potential crush injuries with a view of eliminating exposure to the hazard could have ignited consideration for reviewing the means of access to the Feed Barge and prompted the salmon farm operator to consider a gangway or ladder type of access from the vessel to the Feed Barge.

causes to the incident, human factors must be considered. As the Casualty made his way outboard of Simmerdim and waited for an opportunity to step across onto the Feed Barge's tyre fender, the vessels came quickly together and resulted in the incident. It was likely that the Casualty was focused on stepping onto the tyre fender and unaware of the likelihood of being crushed between the vessels as he stepped across onto the tyre fender.

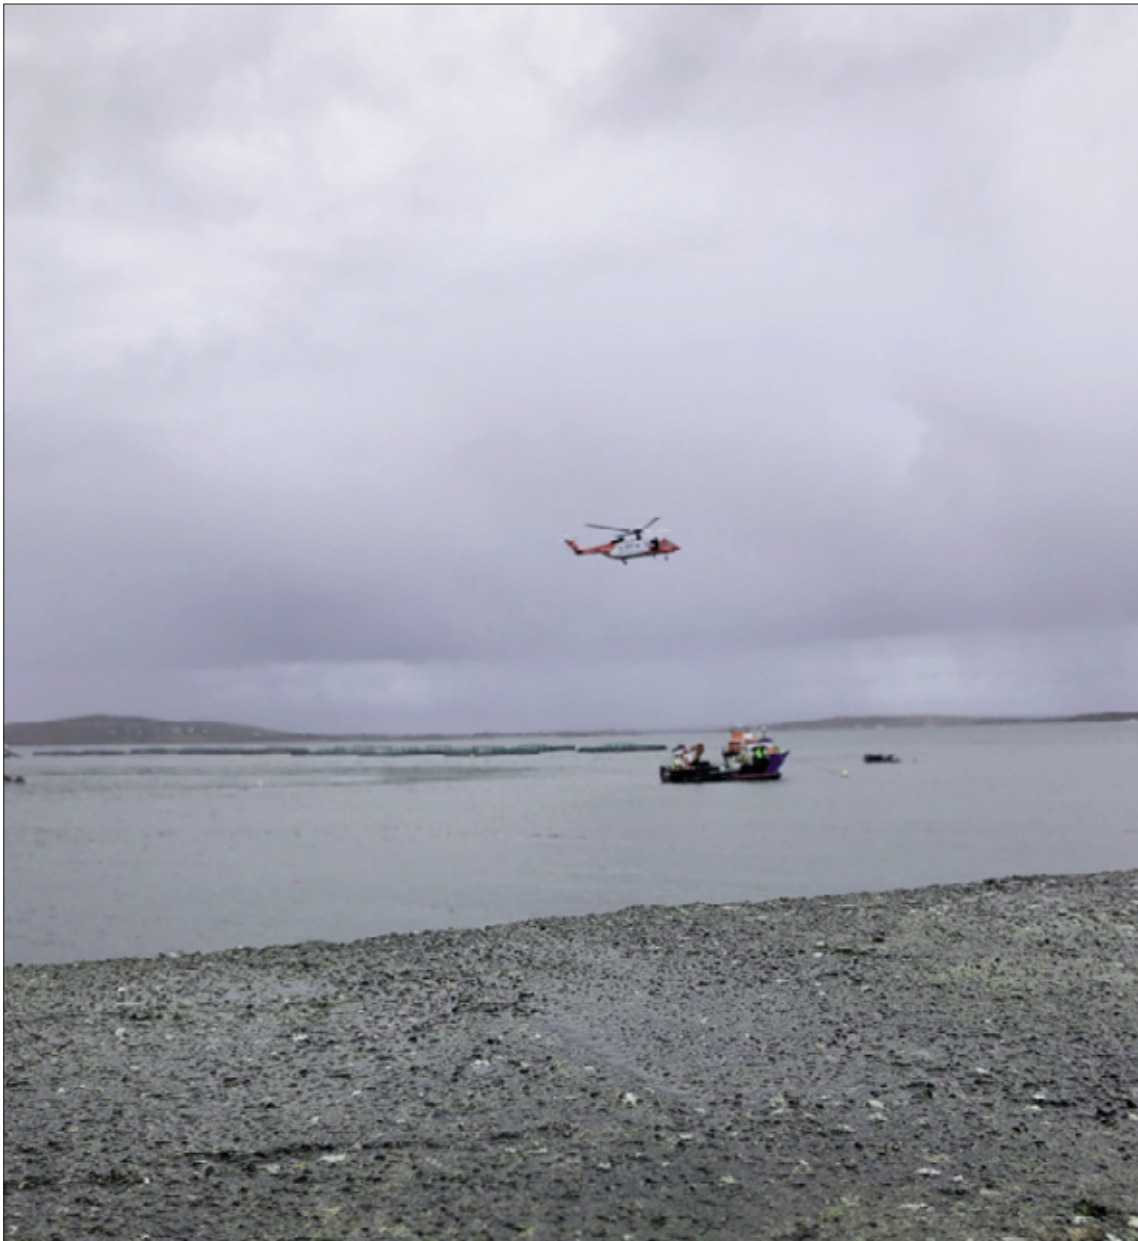
Appendix 7.13 Photograph - Medevac of the Casualty from the Vessel

- 3.7 Personnel onboard the Feed Barge exited the superstructure and observed the Casualty on the deck of Simmerdim and disembarked from the Feed Barge. First aid was commenced on the Casualty by the vessel and barge crew, including stabilising the injuries, keeping the Casualty warm and treating the Casualty for symptoms of shock. The Skipper of Simmerdim took the decision to depart the Sea Site and relocate to sheltered water to reduce the vessel's motion and make it more comfortable for the Casualty. As the vessel departed the Feed Barge, one of the team phoned the emergency services at around 08.54 hrs, reported the incident and requested assistance.
