Stabilisation of the Stanton Lees landslip using an embedded pile retaining wall

Published in the Journal of Geotechnical and Geological Engineering, 2007, Vol. 25, No. 6, 705–715.

Abstract. A landslide occurred near the village of Stanton Lees, Derbyshire, UK, in November 2000 following a prolonged period of heavy rainfall. The slip resulted in the gradual, progressive down-slope movement of a steep embankment that was supporting an existing gabion retaining wall and a minor road which was subsequently closed to vehicular traffic. This paper describes the site; the sequence of events leading up to the start of the landslide; an interpretation of the ground conditions and onsite monitoring data; and the engineering works carried out in order to stabilise the slip and return the road to serviceability. The landslide occurred due to the superficial deposits moving over the weathered bedrock after the groundwater levels had been elevated following a prolonged period of heavy rainfall. A stability analysis indicated that the embankment was at a state of limiting equilibrium and its factor of safety on slope instability was found to be particularly sensitive to fairly minor changes in

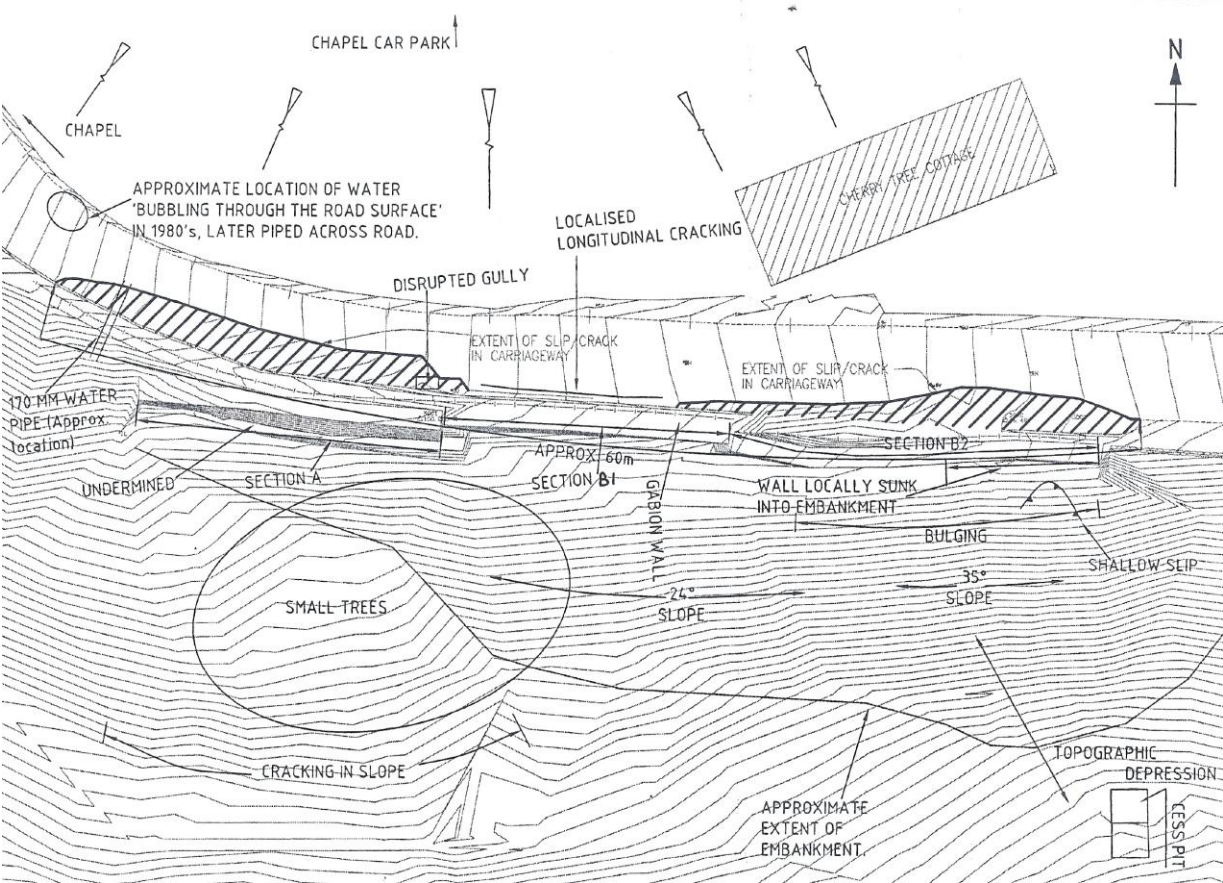
The embankment, which was constructed between 1955 and 1962, is located in front of the Cherry Tree cottage and, in plan, is about 90 m in length (Fig. 1). The site is located at an elevation of 180 to 190 mAOD on the eastern side of Stanton Peak. The natural hillside is characterised by pronounced undulations that extend from the foot of the gritstone crags located behind Stanton Lees village to Hillcarr Farm at an elevation of about 120 mAOD. Natural springs discharge off the hillside to the relatively level ground to the north of the landslide location before percolating underground as groundwater flow. Anecdotal evidence indicated that the embankment and the field below had carried surface flow after periods of heavy rainfall, with the flow originating from the western side of the landslide.

The embankment straddles a gentle topographic depression that is roughly centred on a cesspit at the toe of the slope and trends in a north-westerly direction directly in front of the Cherry Tree cottage (Fig.1). To the west of this depression, a benched spur follows the curve of the roadway up into the valley below the chapel building (Fig. 1). The embankment slope

Figure 1. Main features of the landslip.

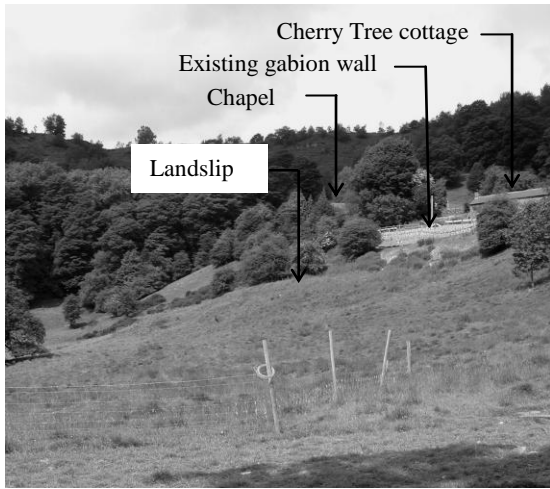
was at its steepest (35 to 40 degrees) directly in front of the cottage, with the slope angle reducing to about 25 degrees on either side (Fig. 2). The slope had a cover of grass, with sparse vegetation where it was at its steepest. Several trees and bushes, which were located at the toe of the slope on its western side, had bent trunks indicating the effects of previous ground movements. The embankment had shown signs of bulging and cracking over some of its length, with a small slip scar to a shallow slip evident at the eastern side of the main landslip, where the slope had been at its steepest.

The landslip occurred on the down-slope side of the single-carriage road which is located between the chapel building and Cherry Tree cottage (Fig. 2). The road, which falls in elevation by about 4 m between the chapel and the cottage, had a longstanding problem of instability. The slip was reactivated in November 2000 and again in February 2002, which caused an outward destabilising movement of up to 1.0 m of the existing gabion wall, Fig. 3(a) and (b). The southern part of the roadway had settled locally by up to 1.5 m along an affected length of about 60 m as a result. A tree located near the embankment crest to the west of the cottage had toppled over and the fill material that had been tipped into the sunken road, as a temporary repair, had settled noticeably.

Figure 2. Site topography viewed towards the upslope direction.

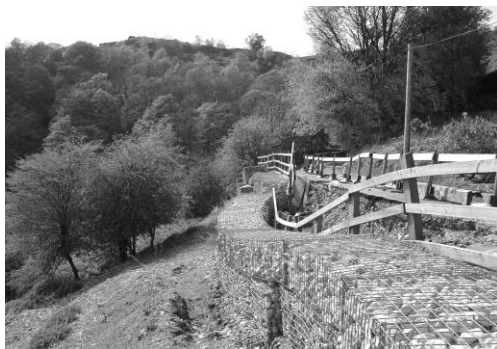
The embankment slip occurred when the groundwater levels had risen following a prolonged period of heavy rainfall. The downward movement of the embankment slope undermined the foundations of the existing gabion wall which resulted in its outward and downward movement, and ultimately the partial collapse of the roadway. The shallow rotational slips day lighted directly beneath the wall foundations. An additional load was placed on the head of the slip following the forward movement of the wall and its backfill. It is likely that the tilting of the wall also exaggerated the eccentricity of the loading on the foundations, which contributed to the local bearing capacity failures that occurred.

(a) Outward movement of existing gabion wall.

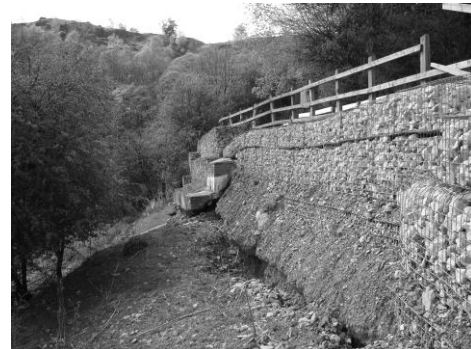
(b) Settlement of gabion wall foundations.

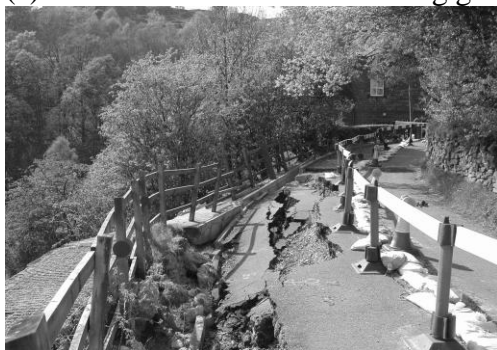
(c) Collapse of southern part of road.

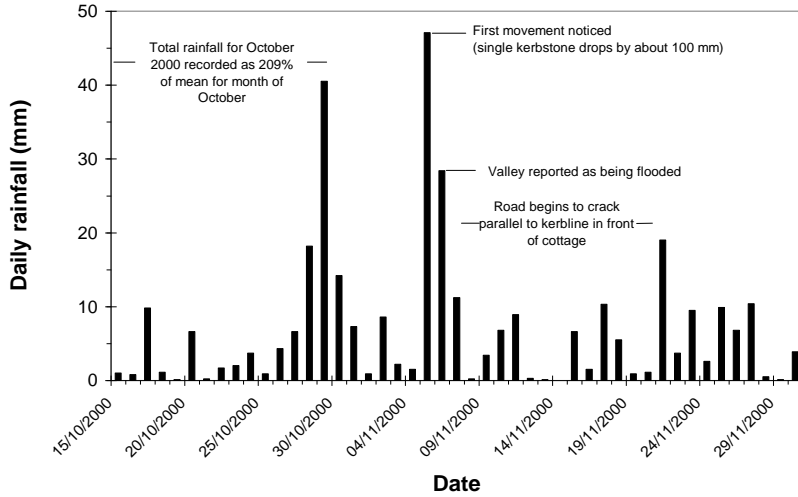
The rainfall data recorded at the Middleton weather station for the period from mid October 2000 (before the November 2000 landslip) to May 2002 are shown in Fig. 4. The Middleton weather station (National Grid Reference SK25 275557) is located at an elevation of 321 mAOD (140 m above that of the Stanton Lees slip) and about 7 km to the south of the landslip site. As the weather station was remote from the slip, it is likely that the rainfall intensity values for the two sites would differ slightly over short periods. However, the overall rainfall trend for the sites would be expected to be broadly similar. The daily rainfall data recorded around the reactivation period of the slip in November 2000 are shown in Fig. 4a. The monthly rainfall data for the period leading up to the February 2002 slip are shown in Fig. 4b.

Heavy rainfall preceded the 5th of November event. October 2000 had produced 209% of the mean monthly rainfall, determined from recordings for that month over the preceding 30 years. On the 5th of November 2000, the recorded rainfall was 47 mm at the Middleton weather station, and another 28 mm of rainfall was recorded the next day. Autumn 2000 had also been the wettest season on record since local records began in 1870. Moreover, the recorded rainfall for the month of October 2000 was the second wettest since 1870 (the wettest being in 1998), while November 2000 had been the wettest on record since 1951.

(a) Daily rainfall data leading up to the November 2000 slip.

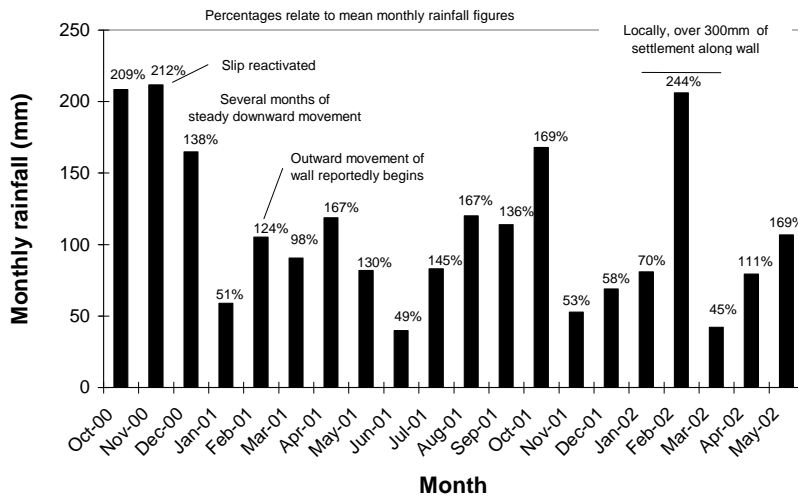
(b) Monthly rainfall data for the period covering the November 2000 and February 2002 slips.

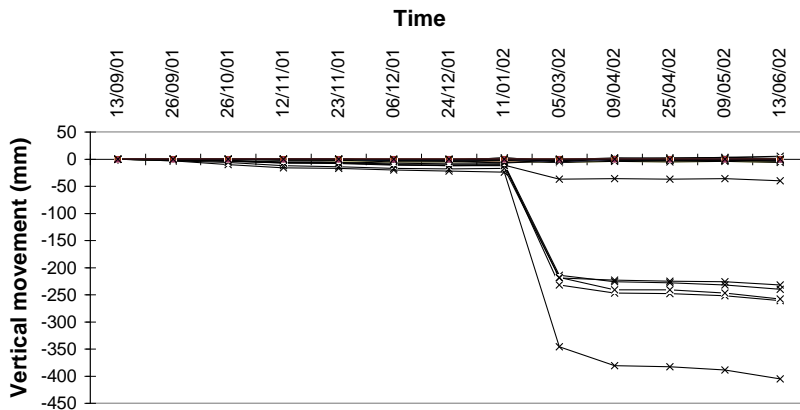
Figure 5 shows the recorded movements in front of the Cherry Tree cottage. The most substantial movements corresponded to the survey points on the gabion wall and the area of sunken roadway at the western part of the slip. Half of the movement occurred between the 11th of January and the 5th of March 2002, which coincided with the high rainfall that had been recorded at the Middleton weather station (200 mm rainfall recorded for the month of February alone). The survey points that were located on the northern part of the roadway showed no significant signs of vertical or horizontal movements, with all of the recorded movements well within the survey measurement accuracy of ± 5 mm.

Figure 5. Vertical movements of survey points along roadway.

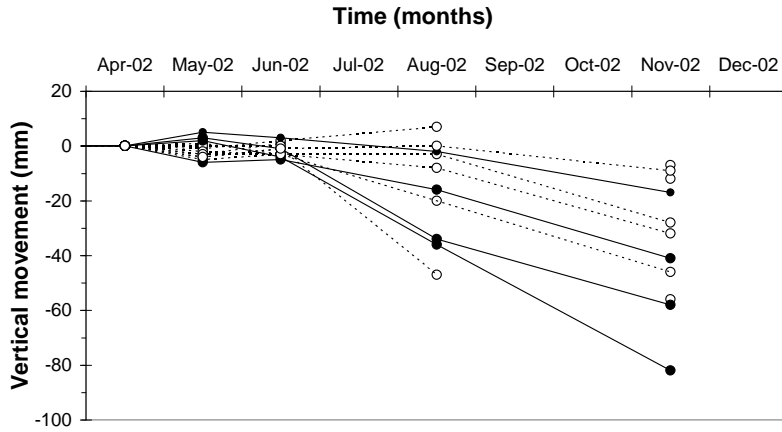
Several of the pegs that were located on the embankment had moved down-slope by up to 80 mm indicating an underlying trend related to the developing landslide (Fig. 6). The greatest down-slope movements were recorded along the embankment crest.

Figure 6. Vertical movement of survey pegs on the embankment slope. Note that the solid lines and symbols denote pegs located along embankment crest.

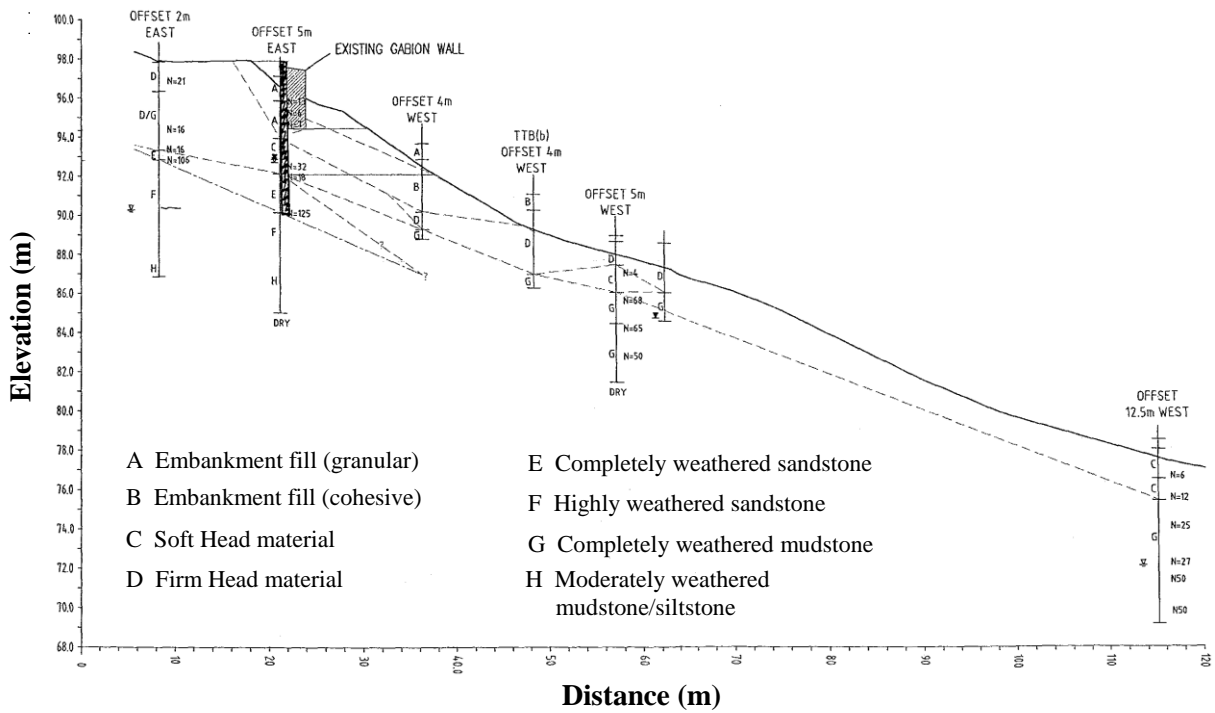
The ground investigation indicated that the most adverse ground conditions as regards slope instability were through the embankment slope located directly in front of the Cherry Tree cottage (Fig. 7). This section of embankment had the steepest slope; the largest recorded wall deformation and the greatest thickness of superficial deposits overlying bedrock. The gradual but progressive slope movements indicated that the embankment itself was at limiting equilibrium.

Figure 7. Geological cross-section of the site. Note that the elevation levels relate to a temporary datum and local grid set up near the chapel building.

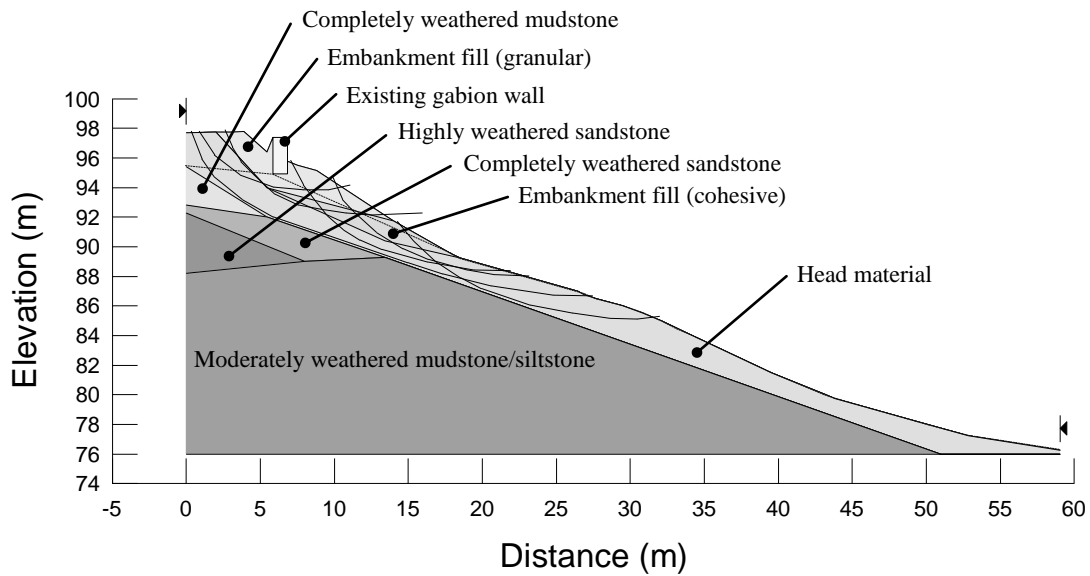
A stability back-analysis of the embankment slope was carried out using the *Slope/W* software developed by Geo-Slope International Limited. In the ground model (Fig. 8), the back scarps day-lighted in the roadway and the shallow rotational slips (recorded onsite in the embankment fill material) day-lighted in front of the gabion wall. A factor of safety (FOS) value of unity, consistent with the gradual progressive slope movements, was obtained using the Morgenstern-Price method (which provided the most rigorous analysis) and the input parameter values listed in Table 2.

A sensitivity study, which considered the affect of minor inaccuracies likely in the measured surface and geological profiles, was carried out to ensure that the values of the effective stress shear strength parameters were realistic. The reduction in the FOS value that accompanied a 1.0 m increase in the highest recorded groundwater level (as might have occurred at the time of the November 2000 slip) indicated that the overall stability of the embankment was particularly sensitive to fairly minor changes in the groundwater levels. The stratum of Head material further down-slope of the embankment toe was stable (FOS \cong 1.3) under the worst groundwater conditions recorded (adopting peak values of the shear strength parameters in the analysis since no slips had been recorded in the natural hillside).

It was not necessary to invoke the residual values of the shear strength parameters (measured using the Bromhead ring-shear apparatus) for the completely weathered mudstone and Head material since the stability analysis indicated that the embankment slope was at the limiting equilibrium condition for the peak parameters values. A reduced angle of shearing resistance (ϕ') value of 26° for the Head material (failed condition) gave a FOS value of unity for the shallow translational slips day lighting in the roadway and directly below the gabion wall foundation. However, lower ϕ' values could not have occurred for the Head material over an extensive area of the slip surface since such a condition would have resulted in a catastrophic failure having occurred.

Figure 8. Slope/W analysis. Note that the elevation levels relate to a temporary datum and local grid set up near the chapel building.

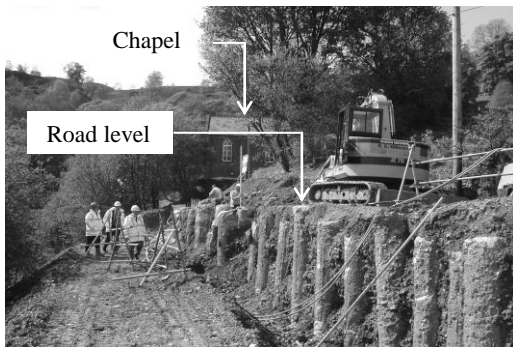
(a) Outermost row of piles in place.

The design solution adopted necessitated two rows of cantilevered bored piles (86 in total and each 600 mm in diameter) installed along the road verge (Fig. 9). The location of the piles were staggered in plan arrangement, with a centre spacing of between 2.0 and 2.7 times the pile diameter between adjacent piles. This configuration had the added benefit of allowing the easy passage of groundwater, as compared to a contiguous wall solution.

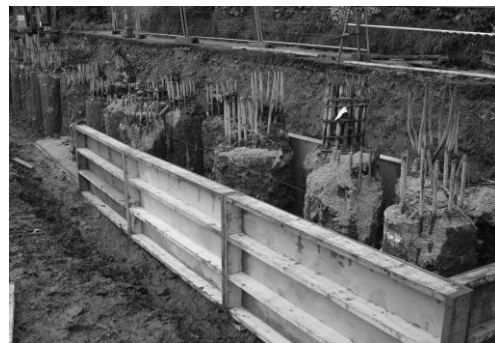
(b) Placement of formwork for capping beam.

The pile embedment depths were increased above the values calculated by the *WALLAP* analysis in order to allow for the adverse combination of sub-vertical and sub-horizontal fracturing in the bedrock, with the final overall pile lengths ranging between 8.0 and 13.5 m. A reinforced-concrete capping beam was also poured (Fig. 9b) in order to connect the pile heads; enhance the wall integrity and even out the lateral displacements of the pile rows. A mortared, gritstone parapet wall was constructed above the capping beam. Samples of the Head and embankment fill materials were tested to determine their aggressiveness to concrete. pH values of 7.2 to 7.3 and a soluble sulphate content of 0.19 to 0.26%SO₄ were measured for a 2:1 water/soil extract. A soluble sulphate value of 0.26%SO₄ (i.e. 2.6 g/l SO₄) requires a design sulphate class DS-3 in accordance with BRE (2001). An ACEC class AC-3 concrete was specified for the characteristic pH value of 7.2 and the groundwater conditions encountered onsite. Grade 35N concrete was used in the construction of the bored piles.

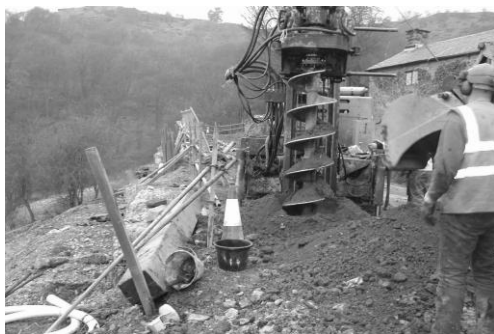
(c) Lightweight augur rig.

The engineering works were carried out by Piling Solutions, UK. The 600-mm diameter cavities for the piles were drilled using a compact, 25-tonne Bauer rig (Fig. 9c). The unsuitable subgrade material that was located beneath the affected roadway was excavated and replaced with granular fill (thereby providing free sub-surface drainage behind the retaining wall) and the road pavement was reconstructed over its full depth. Further details on the construction works have been reported by Forrest (2003).

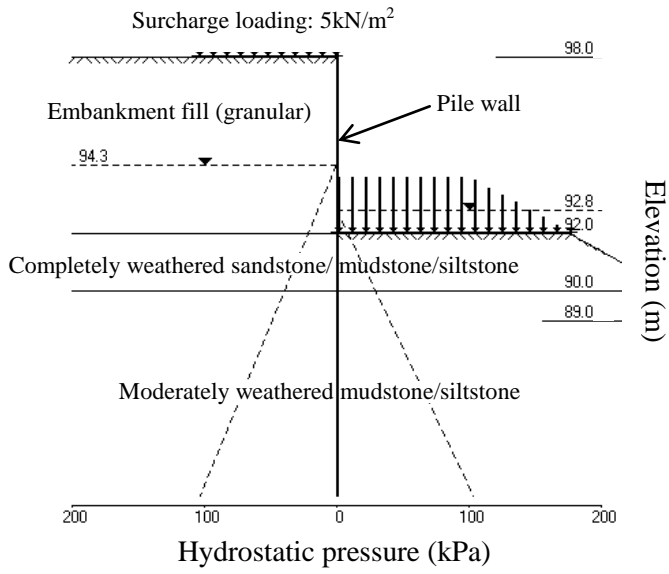
The worst possible case of slippage occurred directly in front of the Cherry Tree cottage, and based on the ground investigation data, the thickness of the Head material that was overlying the weathered sandstone/mudstone/siltstone was conservatively assumed to be 6.0 m. The progressive down-slope movement of the relatively steeply sloping ground would ultimately cause a loss in passive support to the new wall over the 6.0 m depth of Head material. Hence, no passive resistance was assumed to act over this depth in the analysis. The wall design shown in Fig. 10 assumed that the failed groundmass on the passive side would only provide a surcharge (in the form of a trapezoidal stress distribution) to the underlying weathered rock. A live surcharge loading of 5 kN/m² (as specified by Derbyshire County Council Consulting Engineers) was also applied across the roadway in the analysis. The Young's modulus and moment of inertia values of the cantilevered pile wall were 2.0 x 10⁷ kN/m² and 0.011 m⁴/m-run, respectively.

Figure 10. Design model for WALLAP analysis.

The staggered pile wall was analysed for stability using the *GEOSOLVE WALLAP* programme (version 5.01) on the basis of a one-metre strip (plane strain) and the Burland-Potts method. The new wall was assumed contiguous for the purposes of the analysis since the pile centre spacing was less than three times the pile diameter. Portal frame action between the two rows of piles was not considered in the analysis since they were so closely spaced. The pile toes were founded in the underlying mudstone and siltstone bedrocks.
