Repair and Conservation of the Four Courts Dome, Dublin.

M. Aly¹ and S. Pavía²

ABSTRACT: The Four Courts was built between 1786 and 1802. Fire events, the 1922 civil war, pollution and exposure have damaged the building's fabric. A conservation project by the Office of Public Works focussed on the dome, an outstanding structure built with limestone, fire-clay brick and granite. This paper presents the results of the material's investigation prior to the restoration.

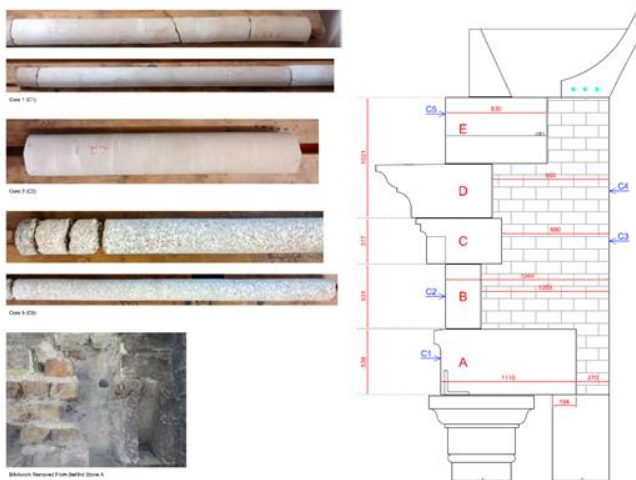
Figure 1. Location of the materials studied in the dome. Cores 1 and 2 (C1-C2) Portland stone; C5 Leinster granite; C3-C4 bricks. Figure by McFarland and Associates Ltd. 2016.

On the contrary, the strength of the granite is much lower than expected (102.00-139.00 vs 35.8 MPa - quarry and building respectively). This could be partly attributed to strength loss due to permanent loading however, the granite core tested came from the top of the parapet (figure 1) which is probably outside the load path and does not seem to carry or have carried any significant loads.

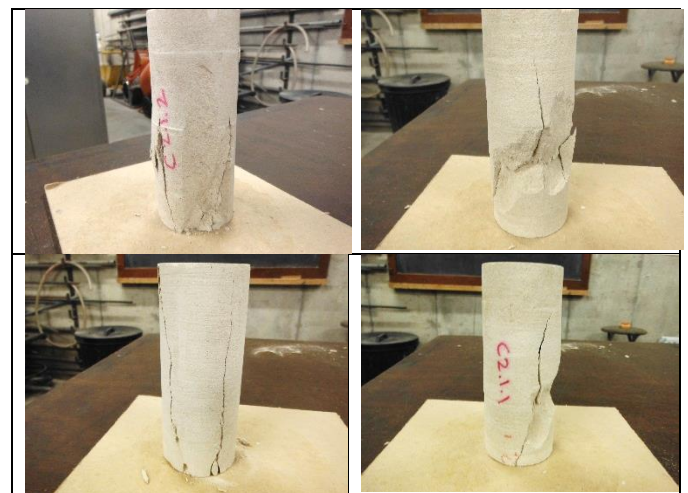
The failure modes observed in the Portland stone under uniaxial compression were predominantly axial splitting and shearing along single planes- figure 2. The results were various types of brittle fracture. Longitudinal splitting by the uniaxial load was apparent in most specimens often in combination with conic fractures probably induced by boundary effects. Figure 2 illustrates some of the most representative failure modes.

Figure 2. Brittle failure modes in Portland stone with predominant longitudinal splitting.

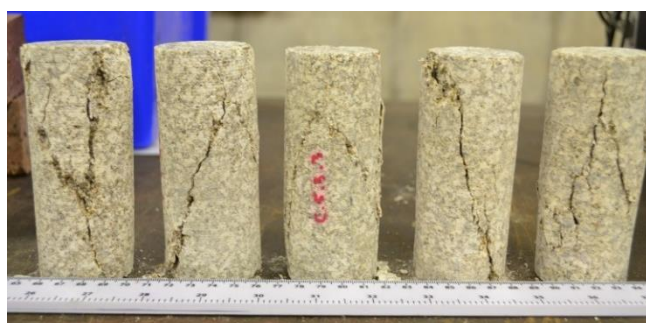
The arithmetic mean of the compressive strength of the 5 boreholes of granite tested is 35.8 MPa- table 3. This is lower than expected when compared with fresh Leinster granite (102.00 -139.00 MPa [15]) however, still a high strength when compared to the average strength of masonry building units. Figure 3 illustrates the characteristic failure modes of the granite. Only specimen one (right) and 5 (left) showed significant bucking before failure. All other specimens failed in shear fracture indicating a brittle behaviour.

Figure 3. Failure modes of Leinster granite cores.

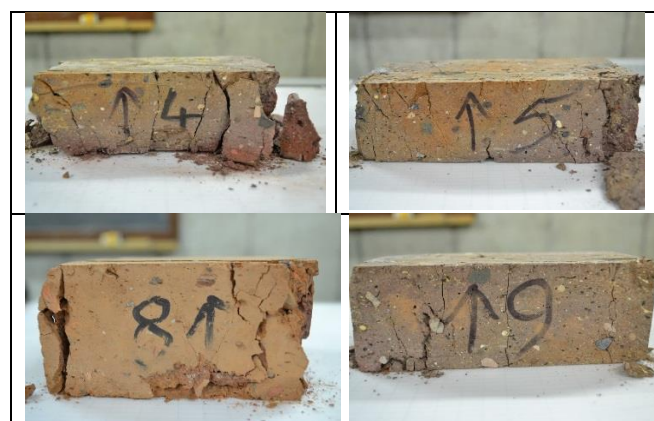
As expected for historic solid, pressed bricks the strength varies. The strength of brick number 8 is not representative as its features suggest that it was underfired. The arithmetic mean of the brick strength is 31.55 MPa (excluding brick 8), superior to common values for historic solid ware (13-22 MPa [15]) and comparable or superior to contemporary machine-pressed, single frogged ware (>20MPa, EN 771-1[16]). Figure 4 illustrates the characteristic failure modes of the bricks showing crushing, split tensile failure and pore collapse. Their ultimate stress and failure were characterised by a progressive collapse rather than a sudden shattering evidencing a plastic behaviour. An initial collapse of the specimens occurred by shear and cracking but the final collapse was only reached at a later stage by increasing the applied load.

Figure 4. Failure modes of the bricks in the dome.

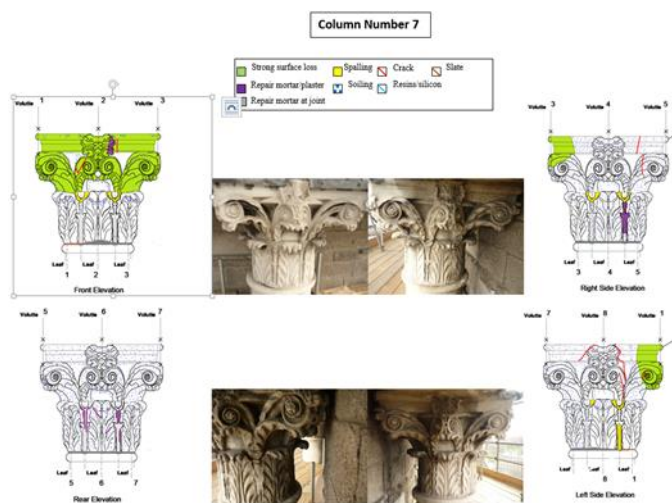
Fracturing induced by expansion of iron fixings embedded in the fabric was identified together with several generations of mortar repairs and resins. Several Portland soffit stones were face bedded which has resulted in the opening of cracks along the bedding. Varying weathering forms and intensity were evidenced in the material including: spalling, soiling, surface loss and cracks. Black crusts were found especially in sheltered

areas. The results of the condition assessment were mapped, a representative example is included in figure 5.

Figure 5. A representative example of the mapped condition assessment- column capital No 7- on drawings assembled by the Dept. of Surveying of the DIT.

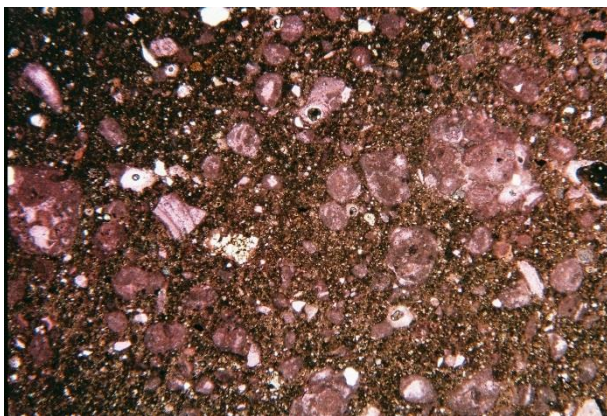
Most repairs are cement or polymer-based composites which are currently failing. Polyester or epoxy resins with aggregate of crushed Portland Stone and/or siliceous sand were noted. These are generally incompatible with stone substrates as they exhibit different behaviour in ambient conditions. Some have resulted in advanced deterioration. Most of the Portland cement repairs consist of crushed Portland stone and a PC binder (figure 6). In contrast with the polymers, some of these are in good condition and do not evidence salts or strong damage however, they are progressively detaching from the Portland stone probably due to differential thermal and hygric expansion at the interface.

Figure 6. Petrographic photograph of a cement repair made with crushed Portland stone and a PC binder in good condition. 2X natural light. Field of view c. 7 mm.
