A COMPARATIVE STUDY OF THE EFFECT OF HYDROGEN PEROXIDE VERSUS NORMAL SALINE ON THE STRENGTH OF THE BONE-CEMENT INTERFACE

S.R. Guerin^{a,b}, R. MacNiochail^{a,b}, P. O'Reilly^a, J. O'Byrne^b and D.J. Kelly^{a,*}

^a Trinity Centre for Bioengineering, Dept. of Mechanical Engineering, Trinity College, Dublin, Ireland.

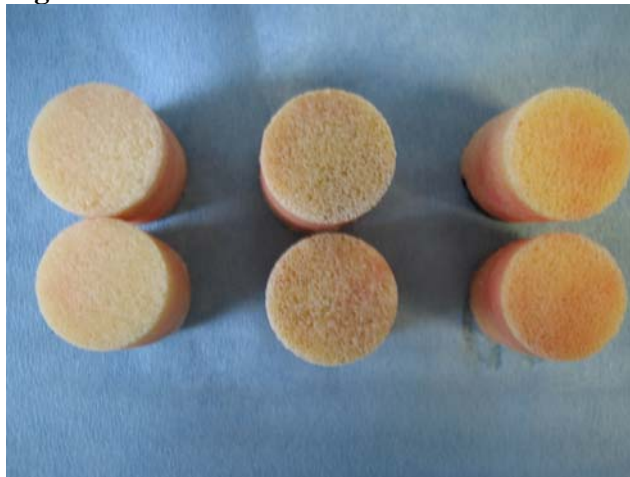
Figure 1 (a) Three pairs of finished bone samples. (b) Teflon mould: The mould material and plunger ends are made of Teflon. Each of the six plungers weighs 1 kg. There is a protruding rod on top to facilitate the addition of a further 2 kg. (c) Lathe used to create reduced diameter bone-cement interface (d) Sample tested to failure in torsion: Failure has occurred at the bone-cement interface. (e) Typical bone surface after tensile failure at interface.

Adult proximal bovine femurs were obtained from a local abattoir (KeyPac, Co. Meath, Ireland). A portion of the greater trochanter was then sawn off with a hack-saw, and two 23mm diameter bone samples were cored out of each bovine greater trochanter using a standard coring bit. (One of each matched pair was assigned to the hydrogen peroxide group and the other to the saline group.) The cores were then attached to a diamond saw (Struers Accutom-50), from which uniform cylindrical samples of cancellous bone were obtained (see Fig. 1a). This saw cut through the bone very gently at a rate of 1mm every five seconds, under constant irrigation to minimise damage to the architecture of the cancellous bone.

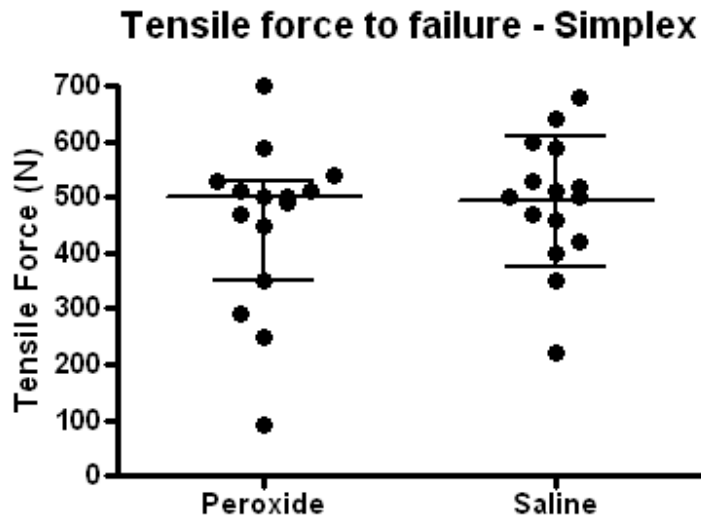
Figure 4. Tensile force (N) to failure for the fifteen pairs manufactured with Antibiotic Simplex bone cement. Lines represent median and interquartile range.

The mean tensile load to failure for the peroxide group was $451.3 \text{ N} \pm 150.2$ N, compared with $492.7 \text{ N} \pm 116.6$ N for the saline group. The tensile load to failure for each of the fifteen paired samples is represented graphically as a scatter plot (see Fig. 4). A paired student's t-test was performed of the fifteen pairs, and this demonstrated the means not to be significantly different ($p = 0.23$). The mean difference between the pairs was -41.33 N (95% CI: -111.2 N to 28.53 N). The pairing was deemed to be significantly effective, with a correlation coefficient of 0.57 and a one-tailed p value of 0.012.

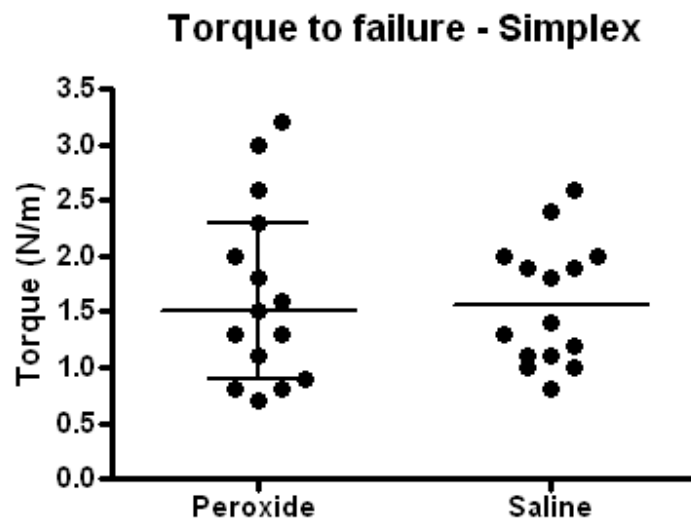
Figure 5. Torque (Nm) to failure for the fifteen pairs manufactured with Antibiotic Simplex bone cement. Lines represent median and interquartile range.

The torque to failure for the fifteen pairs is summarised graphically as a scatter plot (see Fig. 5). The mean torque to failure for the peroxide group was $1.66 \text{ Nm} \pm 0.80$ N versus 1.57 Nm

± 0.55 N for the saline group. A paired student's t-test was performed of the fifteen pairs, and this demonstrated the means not to be significantly different ($p = 0.71$). The mean difference between the pairs was 0.0933 Nm (95% CI: -0.4306 Nm to 0.6173 Nm). The pairing was not deemed significantly effective. An unpaired t-test on the same data reported a p value of 0.72.
