# Geotechnical stability of peat dams and embankments

Grainne P. McInerney, Brendan C. O'Kelly and Paul M. Johnston  
Department of Civil, Structural, and Environmental Engineering, Trinity College Dublin, Ireland

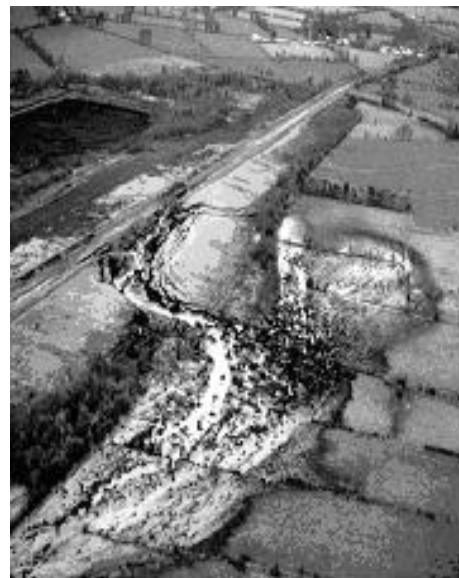
Figure 2 - Canal embankment failure at Edenderry (Pigott et al. 1992).

The peat embankment failure occurred along the Grand Canal near Edenderry in 1989. The embankment, about 115-m in width at the base and 10 m in height, had been constructed on the bog surface by compacting partially dried peat material that had been placed in 0.5-m lifts. A channel 13–16 m in width was later excavated in the top of the embankment to form the line of the canal. The embankment failure (Figure 2) involved the lateral movement of up to 60 m of an intact block of peat material about 225-m by 105-m in plan area (Pigott et al. 1992).

The slip plane was inclined at  $2.5^\circ$  to the horizontal and extended into the bog beneath the embankment. An estimated  $200,000 \text{ m}^3$  of displaced peat material and  $135,000 \text{ m}^3$  of flood water caused

extensive damage to about 6 ha of the neighbouring land and temporary flooding to another 18 ha.

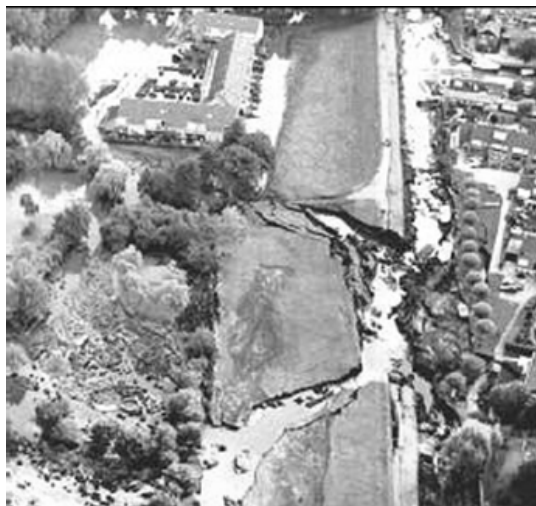
Figure 3 - Wilnis peat dyke failure (van Baars 2005).

The peat dyke failure (Figure 3) at Wilnis, located about 30 km southeast of Amsterdam, occurred in August 2003 following a particularly dry summer. An intact block of peat material about 60-m in length was displaced laterally by about 10 m. Although repair works were started without delay, more than 600 neighbouring houses were flooded.

van Baars (2005) carried out a detailed study of the Wilnis failure taking into account the effects of drying out of the peat material near the crest of the dyke during the dry summer that preceded the failure and the effect of an increase in the active hydrostatic pressures arising following an intense rainfall event.

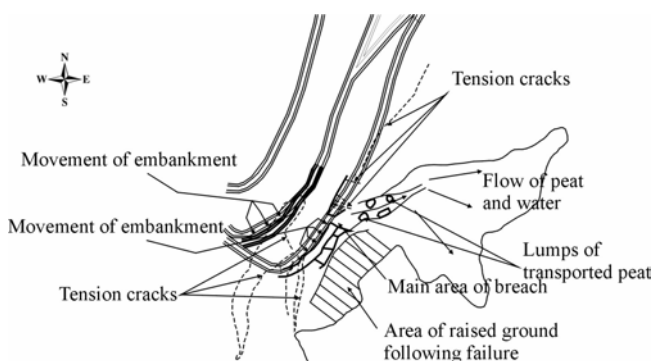
Figure 4 - Extent of local slip failure at Raheenmore bog.

The system of peat dams at Raheenmore bog, County Offaly, had been constructed as a conservation measure to encourage the natural regeneration of sections near the cutaway bog perimeter. A local slip failure along one of the dams occurred in December 1998 with the crest of the dam being displaced laterally by up to 1.5 m (Figure 4). An area of about 0.36 ha was affected by the resulting discharge of water and peat debris (Bennett, 1998).
