THE THERMO-HYGROMETRIC ENVIRONMENT IN CATHEDRALS IN IRELAND

**Department of Civil, Structural and Environmental Engineering
Trinity College Dublin**

**A thesis submitted for the degree of Doctor of Philosophy to the University of Dublin,
Trinity College.**

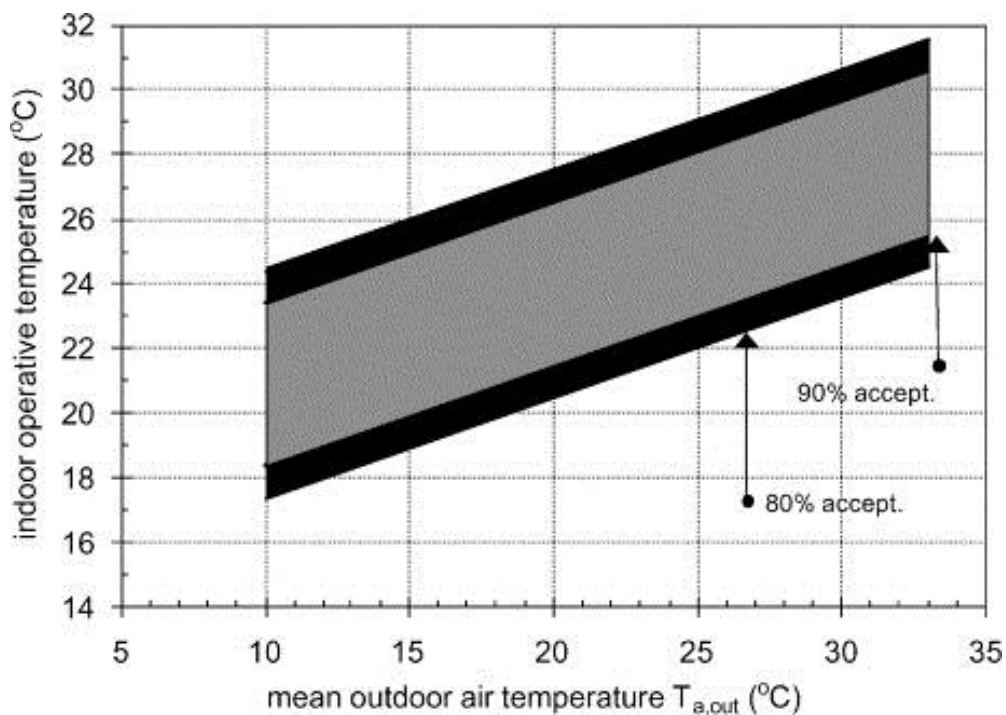
Figure 2.1 - ASHRAE comfort graph illustrating recommended indoor comfort temperatures for external temperature conditions (ASHRAE, 2004)(Byrne, 2014)

Figure 2.1 shows the American Society of Heating, Refrigeration and Air Conditioning Engineers (ASHRAE) graph showing the area of thermal comfort depending on indoor and outdoor temperatures. This is a recommendation and not a regulation in America, and the graph may not be entirely appropriate in other climates.

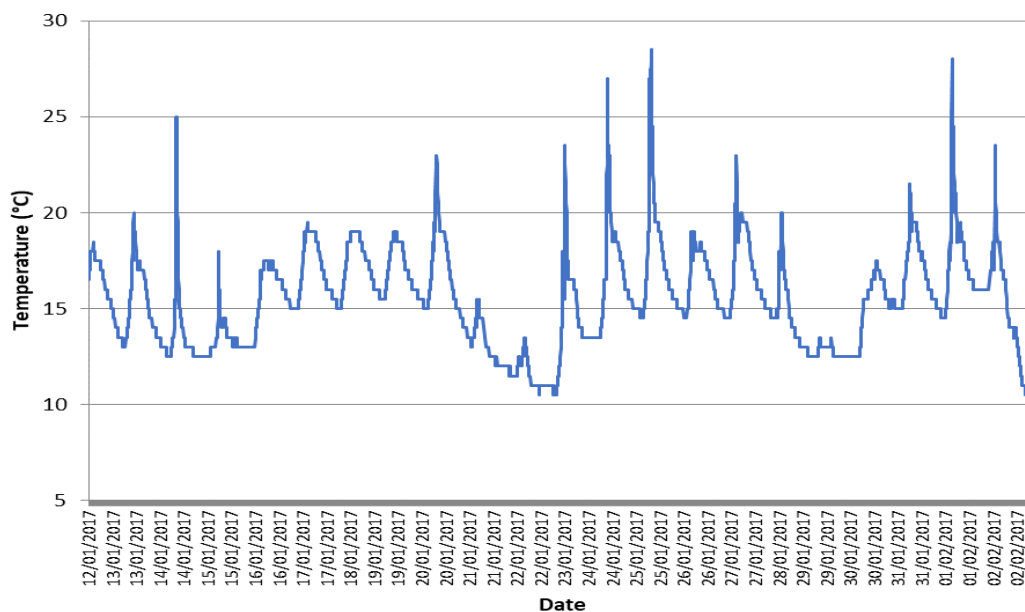
Figure 3.7 - Sunlight test on a data logger in Trinity College

The data loggers also had to be protected from direct sunlight entering the buildings through the windows and in fact two loggers may have been exposed to this light and heat source since their readings were higher than they were expected to be. A test was done by placing a logger on a window in an office in Trinity College to monitor the effects of direct sunlight on the USB logger and, as the graph in Figure 3.7 shows, the peaks are clearly shown when the sunlight hits the logger, for instance on the 13, 14, 20, 23, 24, 27 of January and on 1 February 2017.

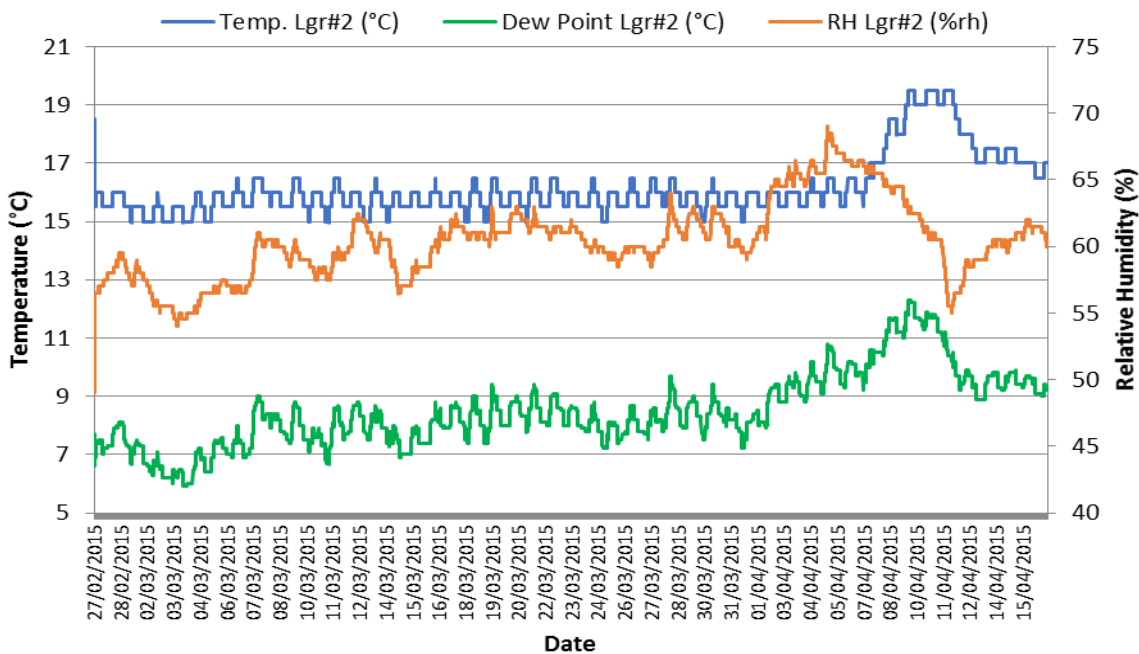
Figure 3.8 - Sample graph for logger 2 in St. Patrick's Cathedral, Dublin

An example of a graph produced by the data loggers is given in Figure 3.8. It displays temperature, dew point and relative humidity for one logger in, in this case, St. Patrick's cathedral in Dublin. Each of these readings from these individual loggers in each of the 25 cathedrals are displayed in the Appendices numbers 1 to 25.

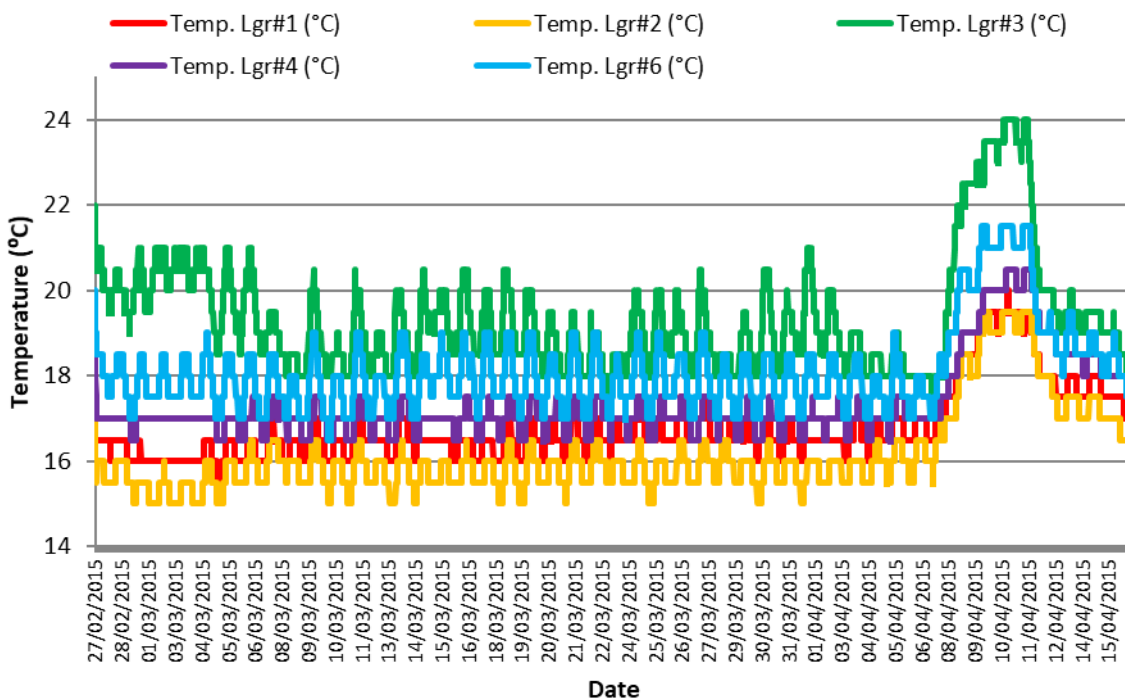
Figure 3.9 - Sample consolidated logger graph for T in St. Patrick's Cathedral, Dublin

It was possible to amalgamate all of the loggers for one cathedral onto one graph which produced typically a graph such as in Figure 3.9. Individual graphs were produced for each logger, which can be found in Appendix 2.

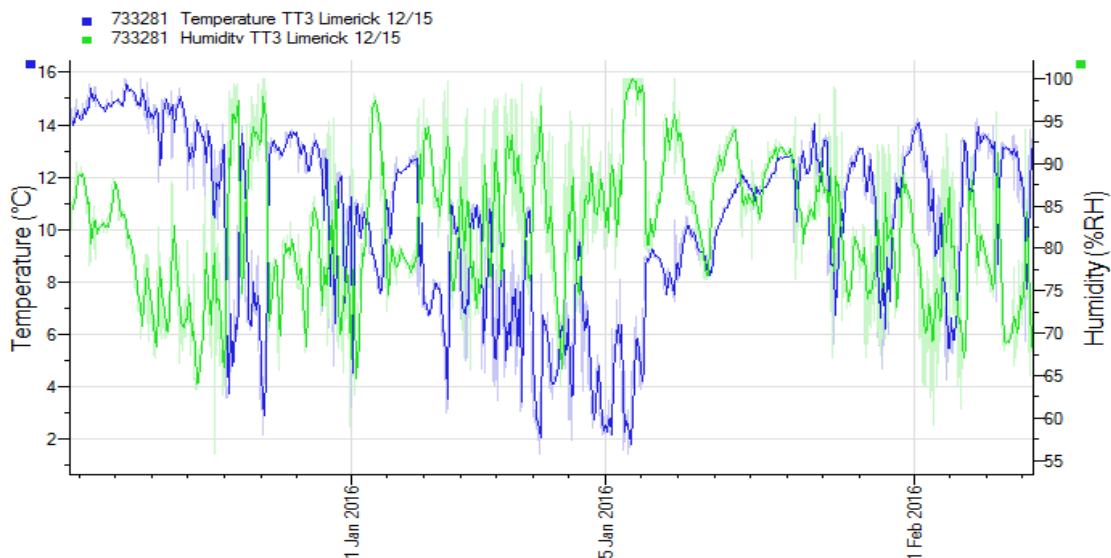
Figure 3.11 - TinyTag readings of external temperature and relative humidity from St. Mary's cathedral, Limerick

Finally the TinyTag which can also download the data directly onto a spreadsheet produces typically a graph such as in (Figure 3.11) which is an example from St. Mary's cathedral, Limerick.

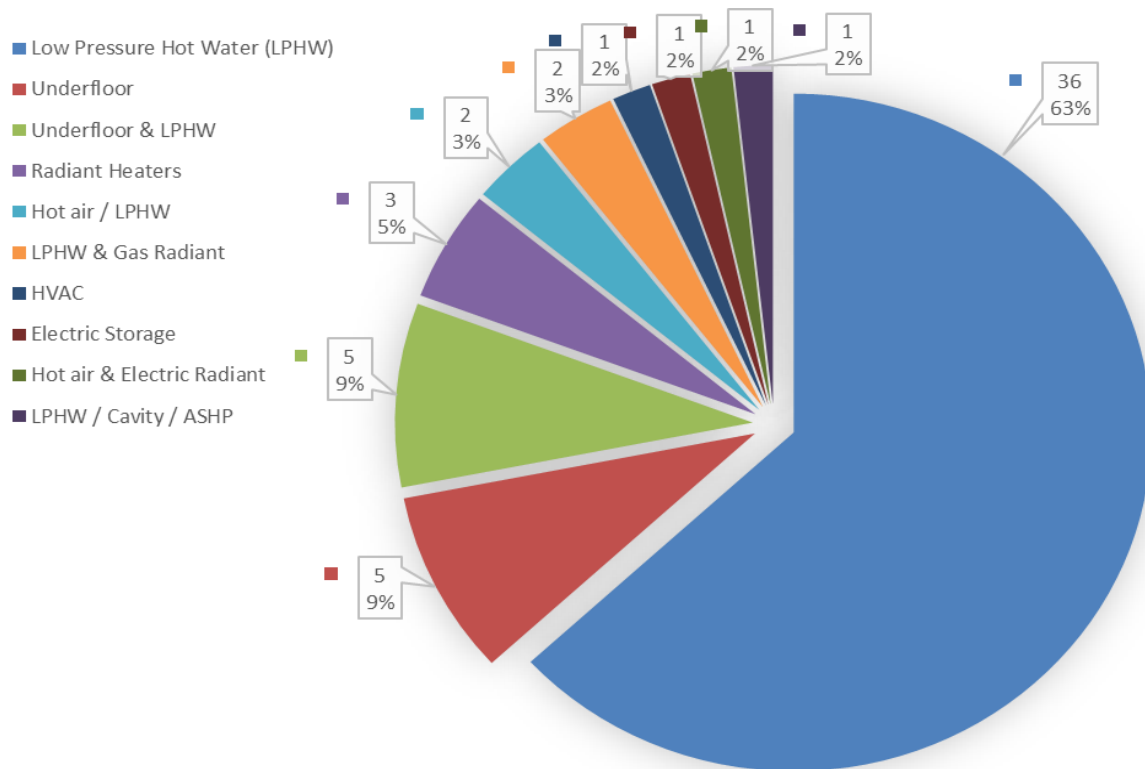
Figure 4.24 - Breakdown of heating types in cathedrals in Ireland

Details of the cathedrals together with the types of heating installed in each building can be seen in Appendix 27 and a breakdown of the heating installations is shown in Figure 4.24.

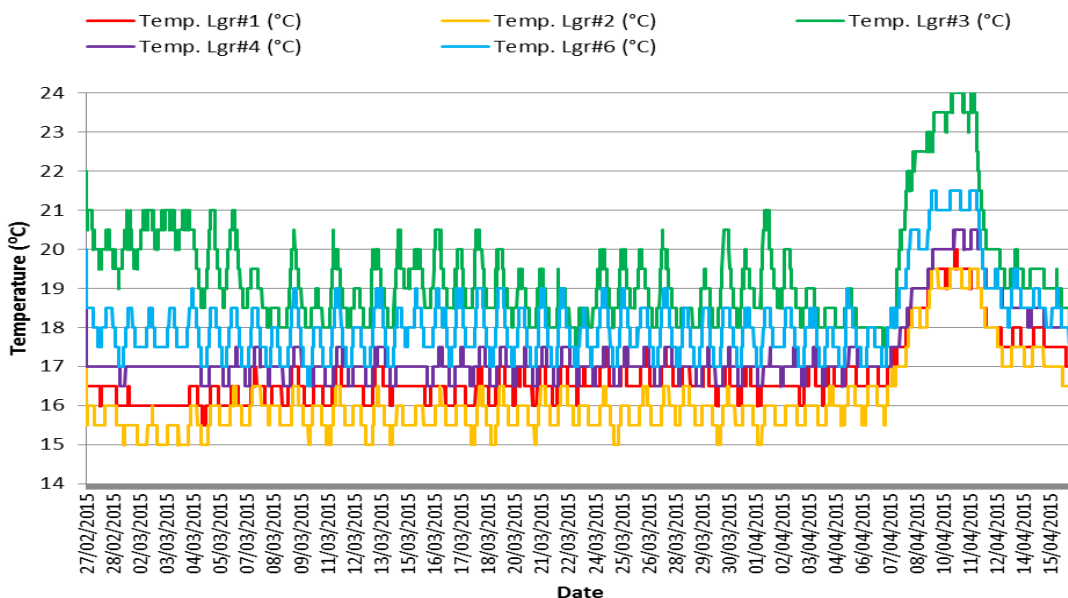
Figure 5.4 Showing the readings for T from all loggers for St. Patrick's cathedral, Dublin

Figure 5.4 shows the consolidated T readings in St. Patrick's cathedral during the monitored period. The graph shows that the daily rises and falls are small but sharp which would be expected from the relatively modern and powerful boilers which are installed. The internal ambient T is high at around 18°C, where it should be noted that the readings took place in March, which means that the boilers only need to raise the T by approximately 1°C each day as the heating is kept on constantly for long periods during the day and the thermal mass keeps the ambient high even during the night during the heating season.

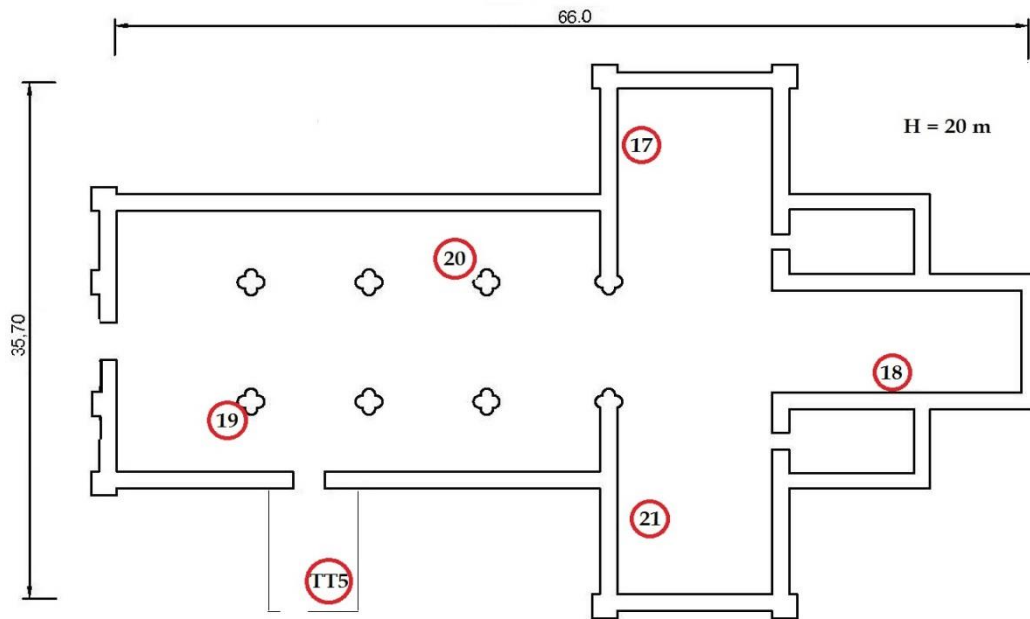
Figure 5.6 - Floor plan St. Canice's (winter)

The location of the loggers in St. Canice's (winter) is shown in Figure 5.6 and Appendix 2.B.

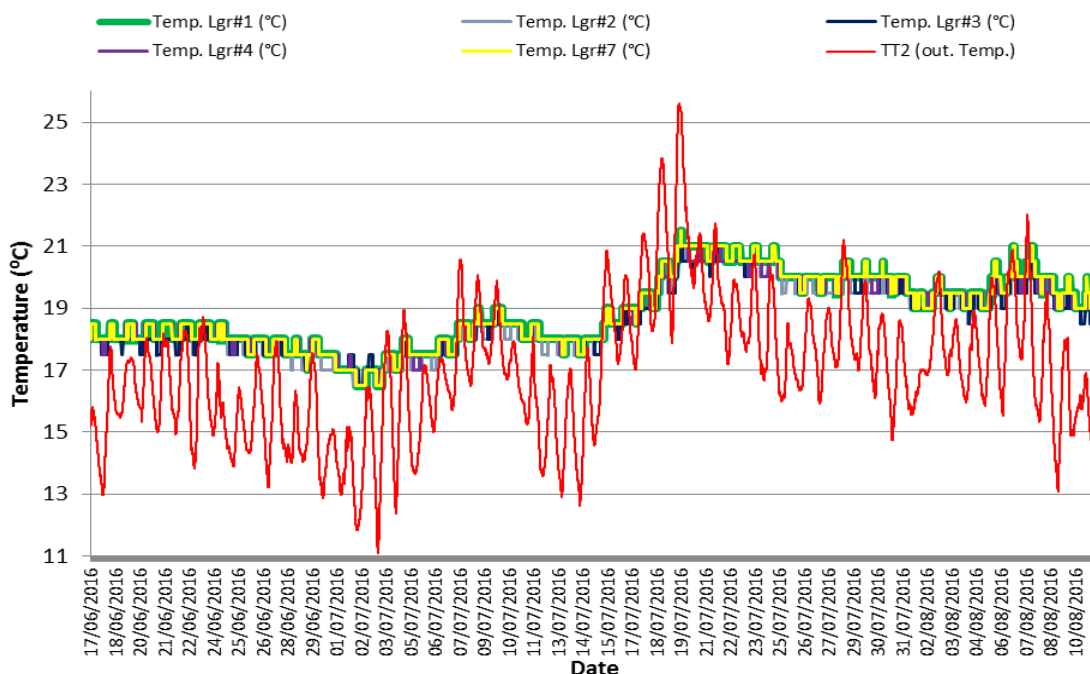
Figure 5.10 Logger readings for St. Canice's cathedral during summer 2016

St. Canice's was also monitored during the summer months and the logger readings for T are shown in Figure 5.10 and in Appendix 2B. The various loggers show highly uniform readings throughout the building (with daily fluctuations usually lower than 0.5°C) where the loggers were placed in the same place in the summer as they had been in the winter. This clearly shows that a general rise in the outside T was followed by a smaller, slower but commensurate rise in the inside, despite the wide daily range outside. As in the winter, this cathedral, because the heating is turned off during the night, is in a situation where the inside T movements mirror the outside with a lag, and much smaller daily variations. This is quite unlike St. Patrick's where, because they can afford to keep the heating on continuously during the winter, they can, in effect, isolate the interior of the building from much of the T movement in the outside environment. Had St. Patrick's been monitored during the summer months it is very likely that the inside T, just as it did in St. Canice's, would have mirrored the outside T as there was no internal heating to regulate the internal environment.

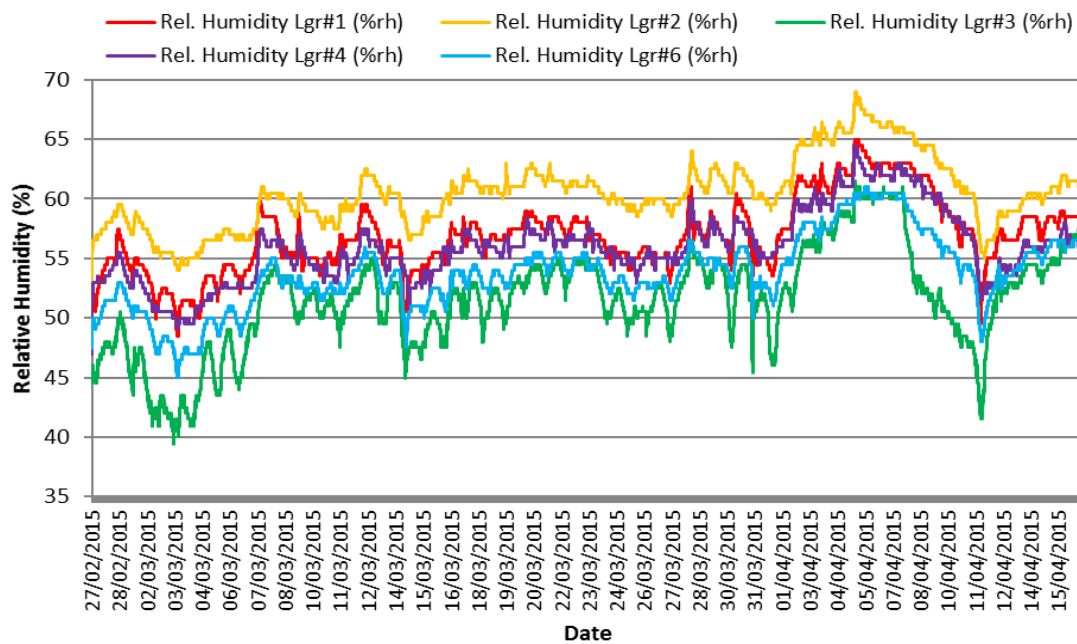
Figure 5.11 Logger readings for RH in St. Patrick's Cathedral, Dublin

Whilst T readings were being taken every five minutes in both cathedrals, so also were RH readings. St. Patrick's RH readings for the winter are shown in Figure 5.11 and in Appendix 1.

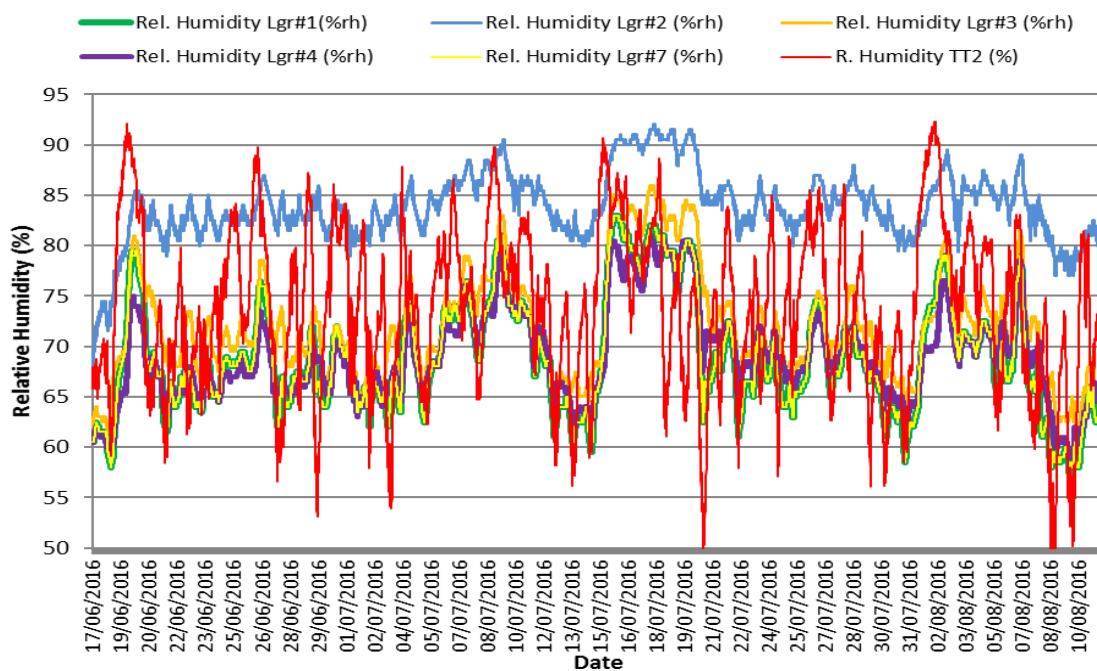
Figure 5.13 RH readings for St. Canice's Cathedral, summer

The RH figures for the summer for this cathedral are shown in Figure 5.13 and a clear connection between the outside and inside RH readings can be seen in the absence of any artificial heating. As with the T readings in this cathedral, the inside RH mirrors the outside RH readings but with much smaller, but noticeable, daily fluctuations, indicating infiltration/exfiltration of moisture over time through the fabric of the building. These very high RH summer readings are well outside the acceptable levels for both conservation and preservation and will be damaging to both the building and its contents.

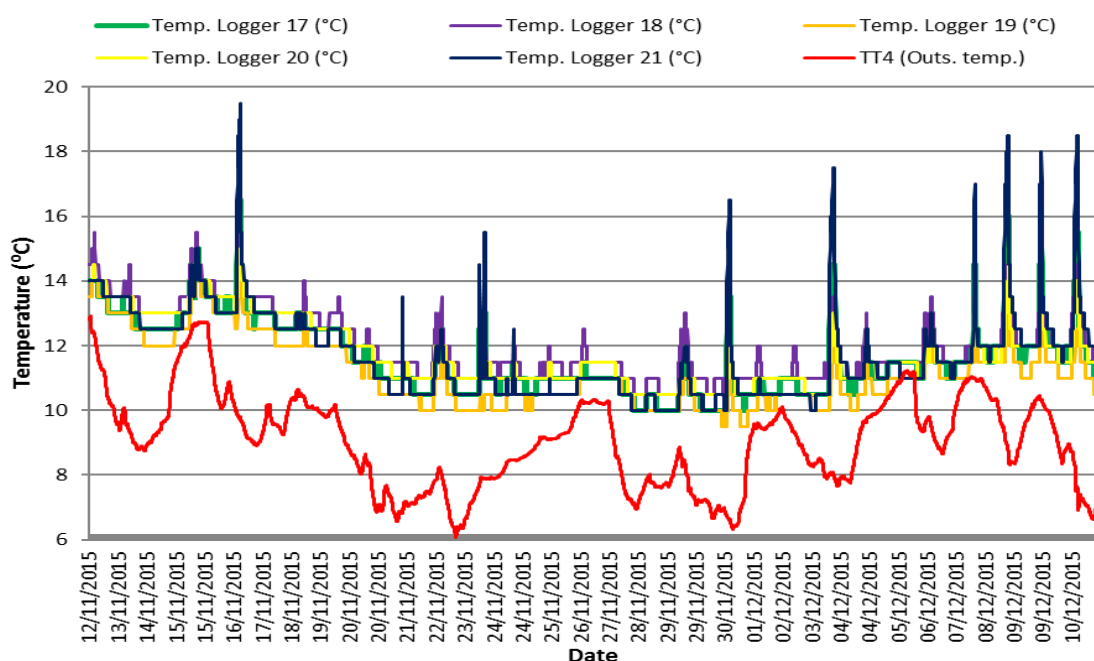
Figure 5.19 Loggers' and TinyTag T readings for St. Anne's cathedral, Belfast

This cathedral was monitored from 12 November 2015 until 11 December 2015 and the T readings from the data loggers and the TinyTag can be found in Figure 5.19.

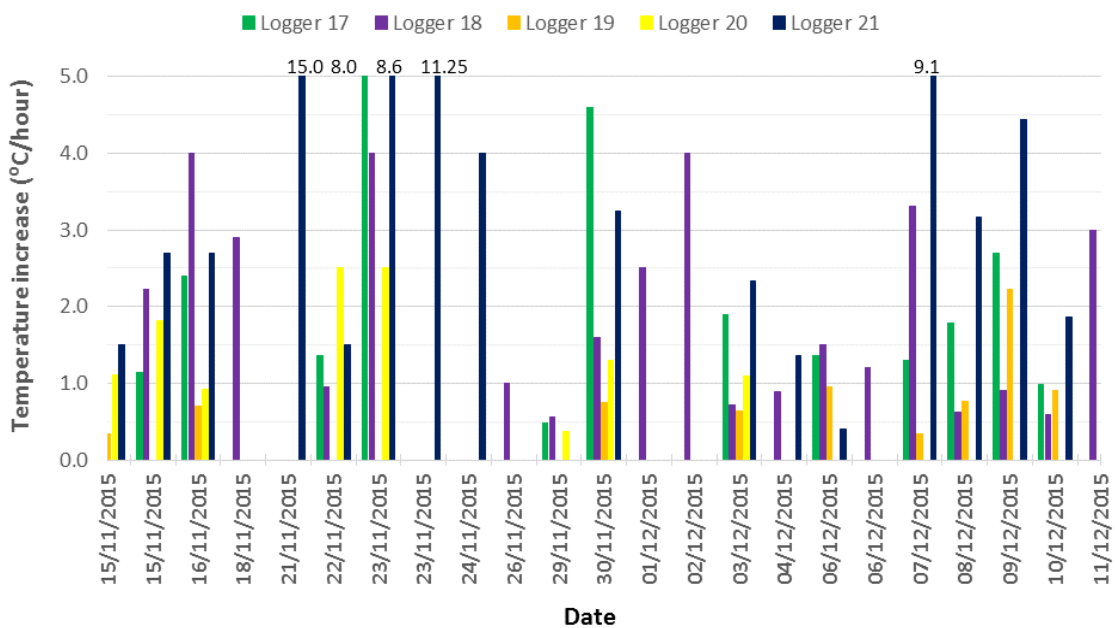
Figure 5.22 Rate of temperature increase per hour in St. Anne's cathedral, Belfast

The rate per hour increase for T for St. Anne's is shown in Figure 5.22. Unlike the previous cathedrals depicted, the rates differ widely amongst the loggers, depending on how far the loggers are situated from a radiant heater. The average is greater than 1°C/hr with many peaks above 4°C/hr, showing instantaneous heat close to the radiant heaters.

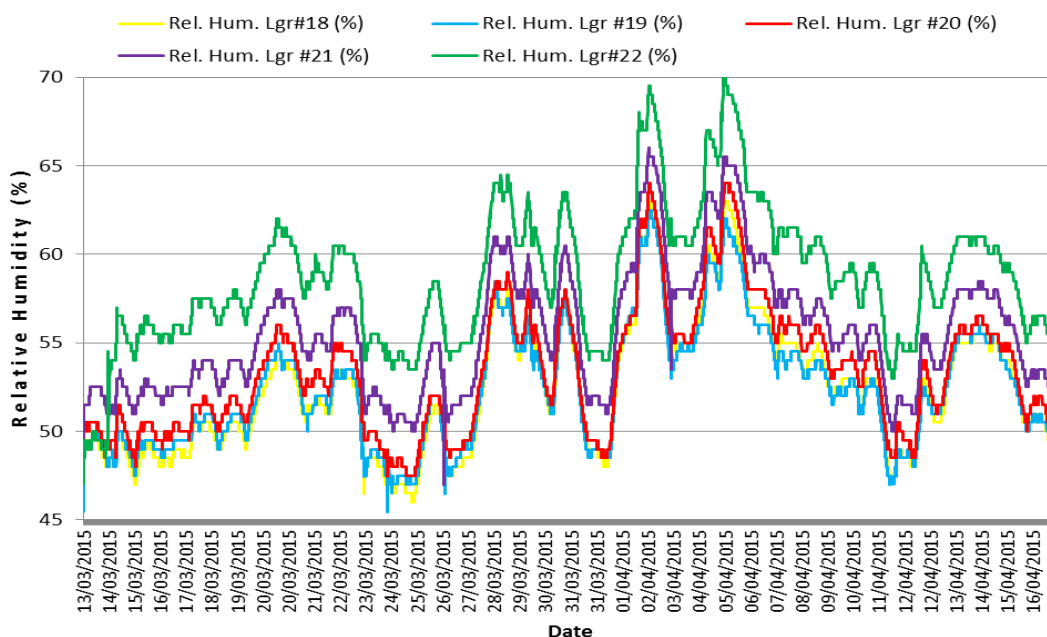
Figure 5.23 Loggers' readings on relative humidity in Cathedral of Our Lady Assumed into Heaven, Galway

On average, the RH values are lower and more stable due to the higher and more stable T. The lower RH readings at the end of the recording period corresponded with the Easter period and reflected the higher T readings in the same period. Logger 22 recorded higher RH readings than the other loggers but also lower T readings as it was situated in a side chapel which was infrequently used.

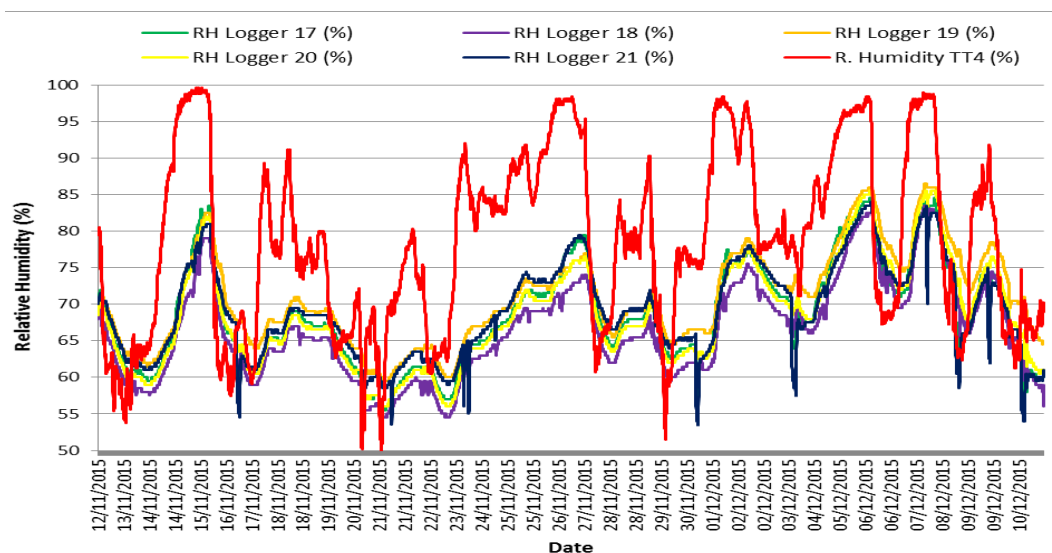
Figure 5.24 Relative Humidity levels (%) inside and outside in St. Anne's cathedral

The rises and falls are generally much sharper than in Galway with a difference of over 25% in four days. These large swings could be damaging to any hygroscopic materials in the buildings such as flags, books and wooden furniture as well as to the pipe organ.

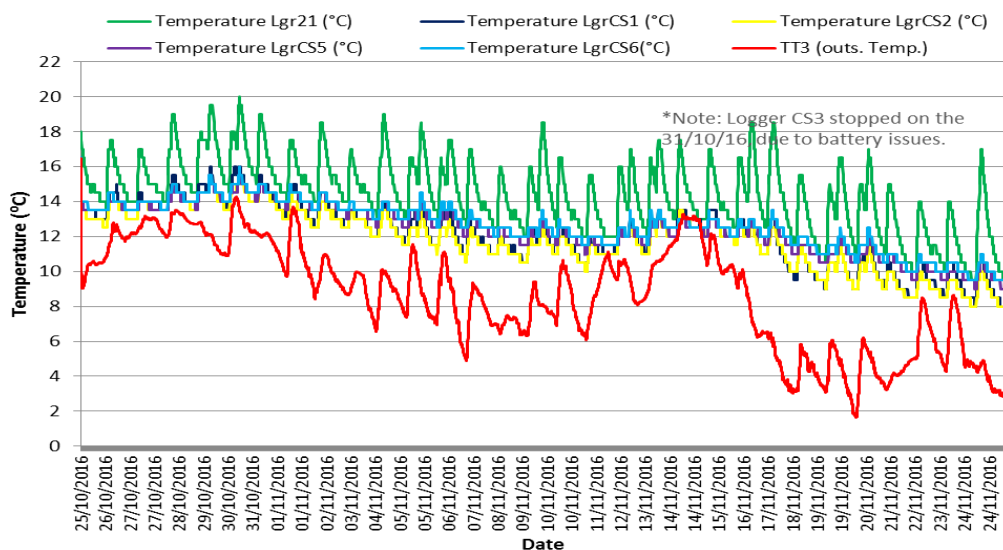
Figure 5.27 T readings in St. Patrick's cathedral, Armagh (RC)

The readings from the loggers, amalgamated with the external T readings (TinyTag) during the winter monitoring period are illustrated in Figure 5.27. Regrettably, the battery in Logger CS3 failed hence, the figures for this logger were not included.

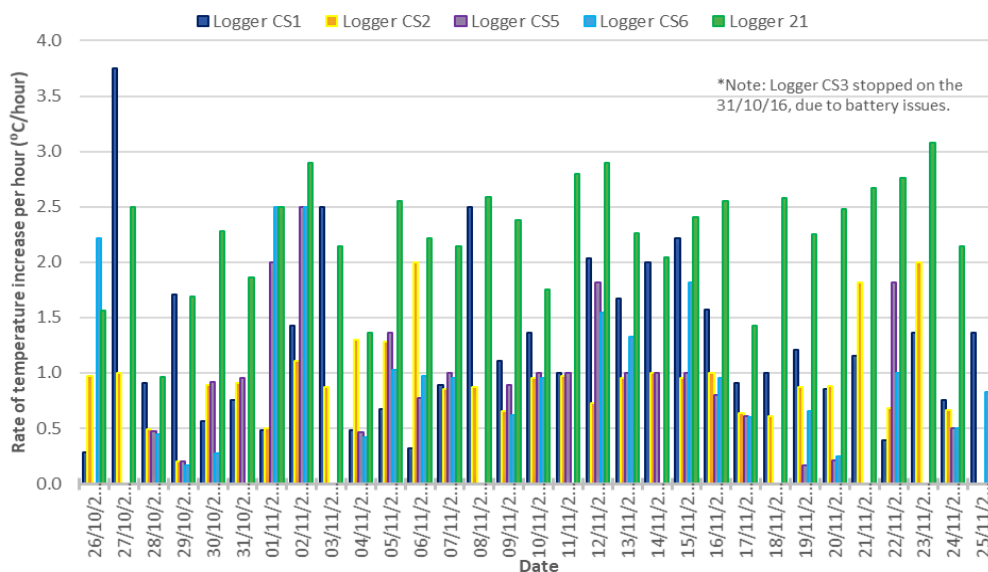
Figure 5.28 Rate of temperature increase per hour in St. Patrick's Cathedral, Armagh (RC)

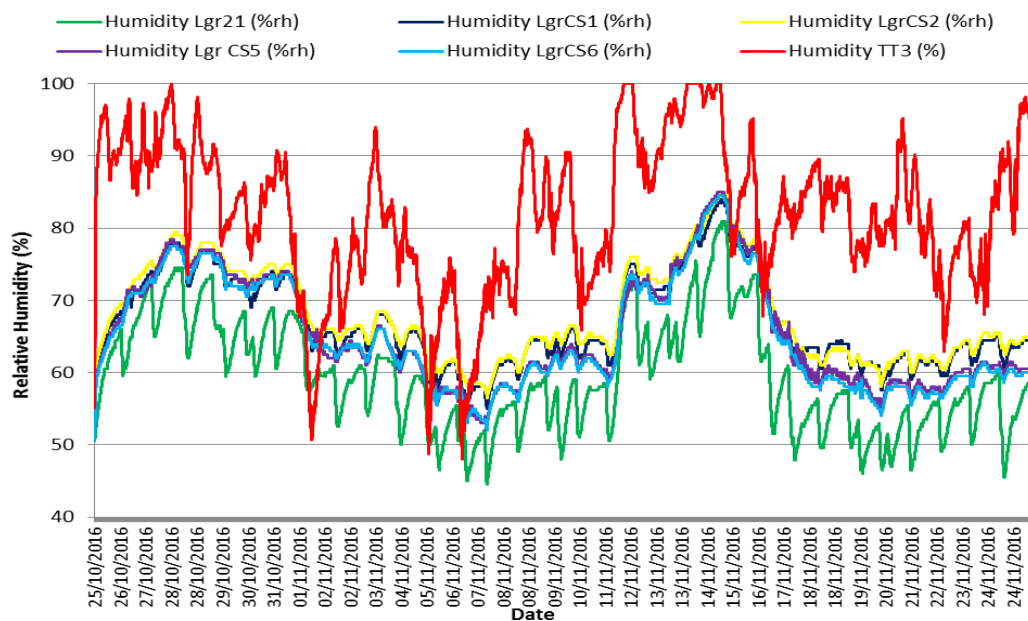
Figure 5.30 Inside and outside reading on Relative Humidity (RH%) in St. Patrick’s Cathedral, Armagh (RC)

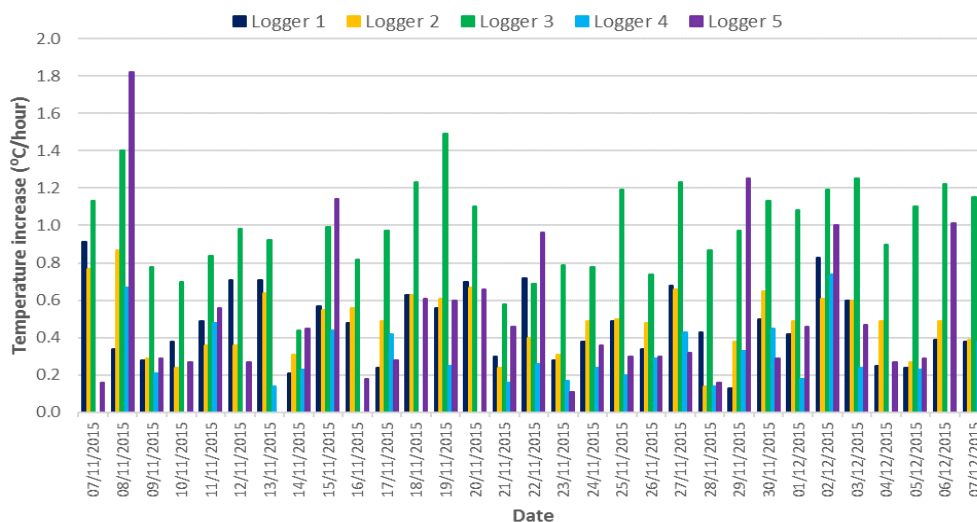
Figure 5.35 - Rate of temperature increase per hour in St. Mary's Pro Cathedral, Dublin

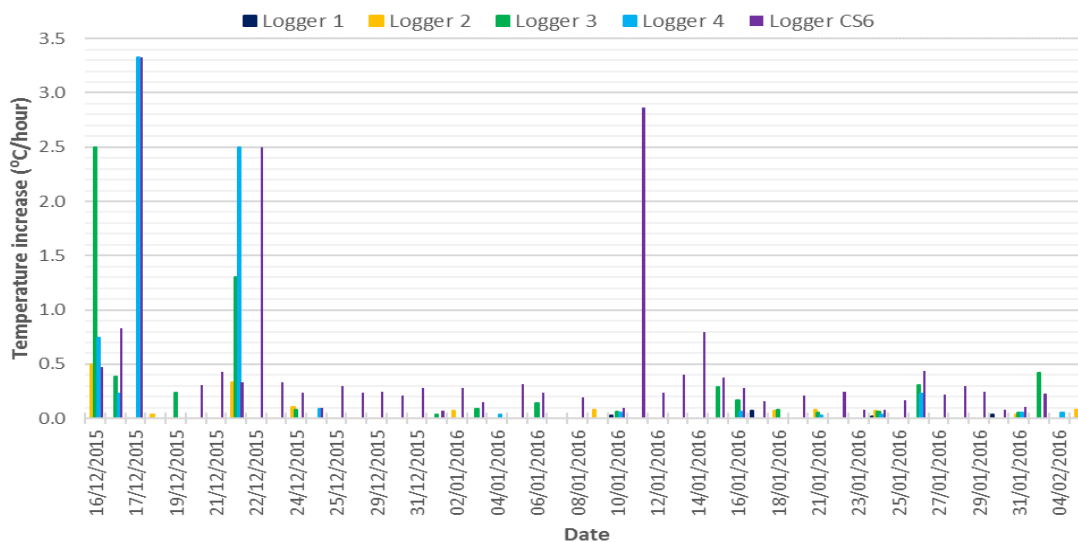
Figure 5.40 - Rate of temperature increase per hour in St. Mary's Cathedral, Limerick

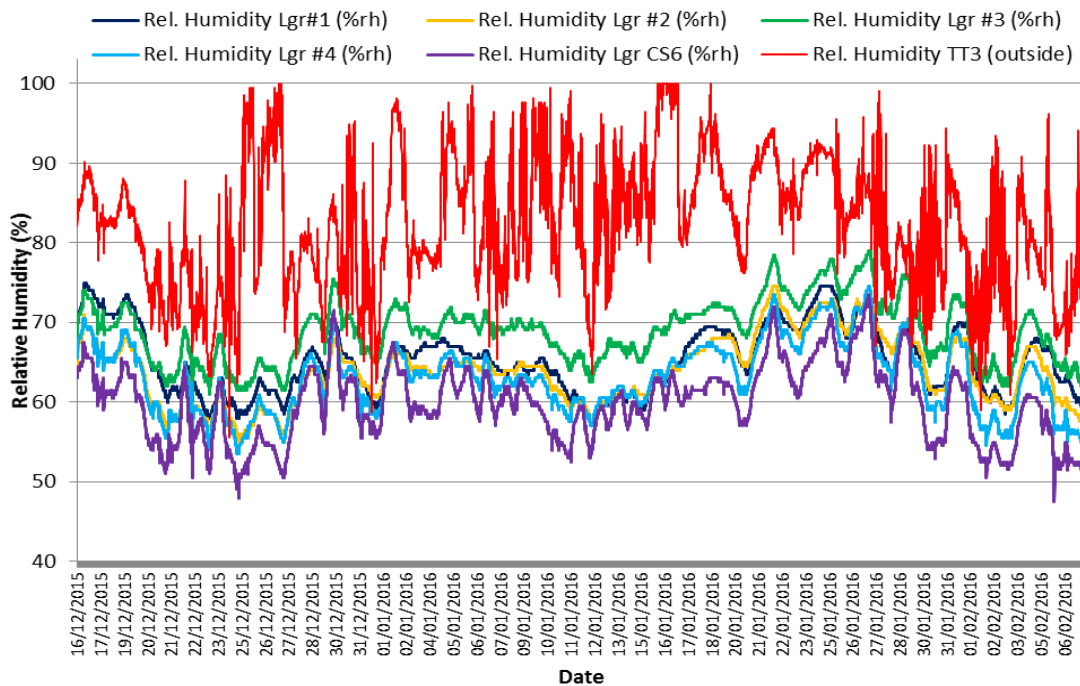
Figure 5.41 - Relative Humidity readings in St. Mary's Cathedral, Limerick

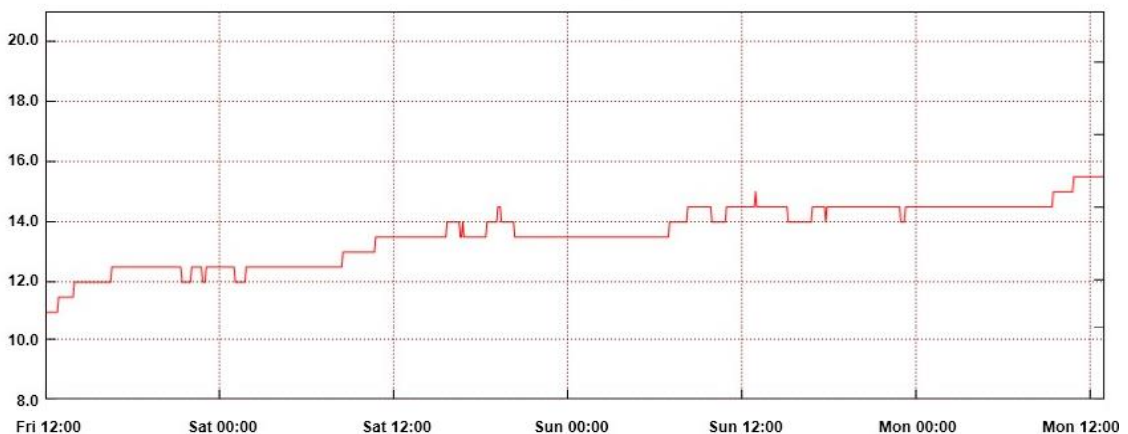
Figure 5.44 - Killarney cathedral logger CS2 from January Friday 15th to Monday the 18th

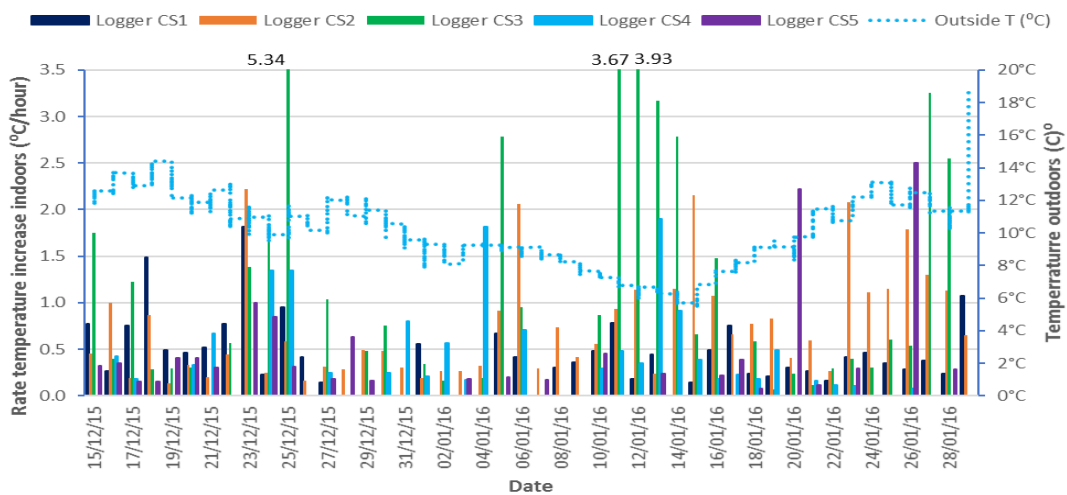
Figure 5.45 - Rate of temperature increase per hour in Killarney Cathedral

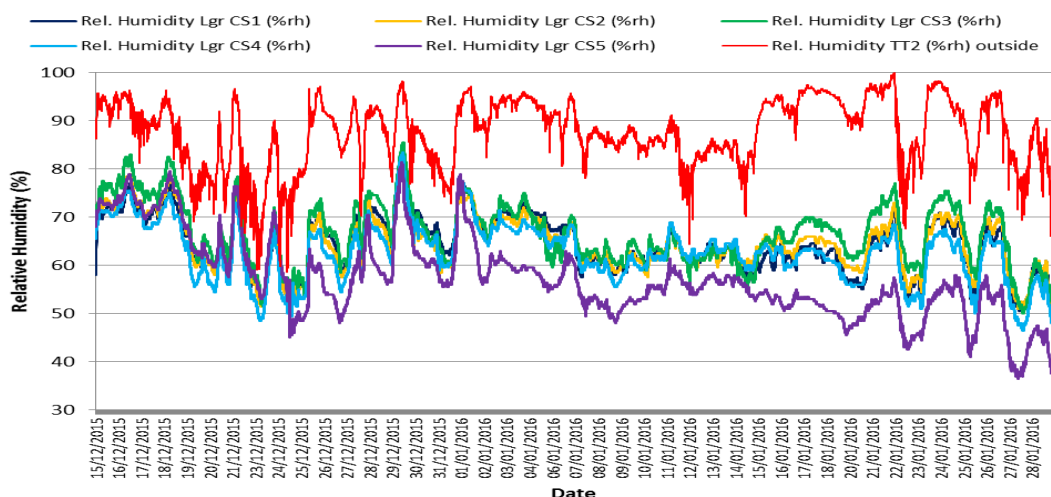
Figure 5.46 - Relative Humidity readings in Killarney Cathedral

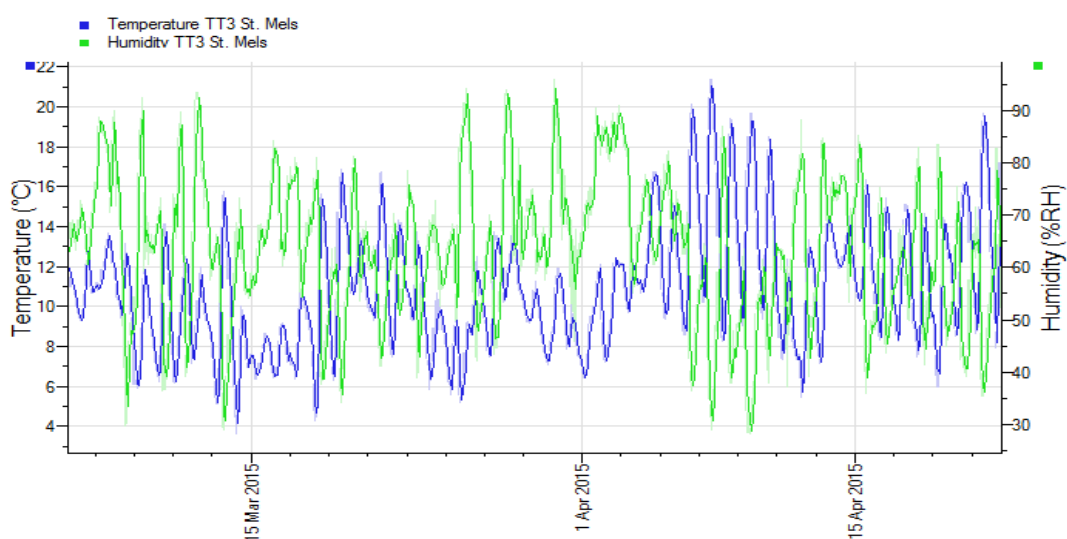
Figure 5.51 - TinyTag readings for temperature and relative humidity outside St. Mel's Cathedral, Longford

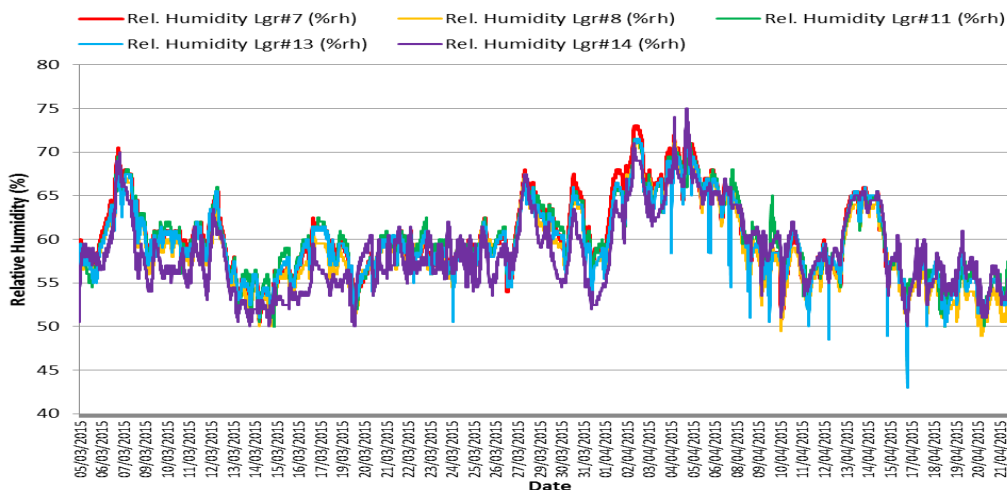
Figure 5.53 - Relative Humidity readings indoors of St. Mel's Cathedral, Longford

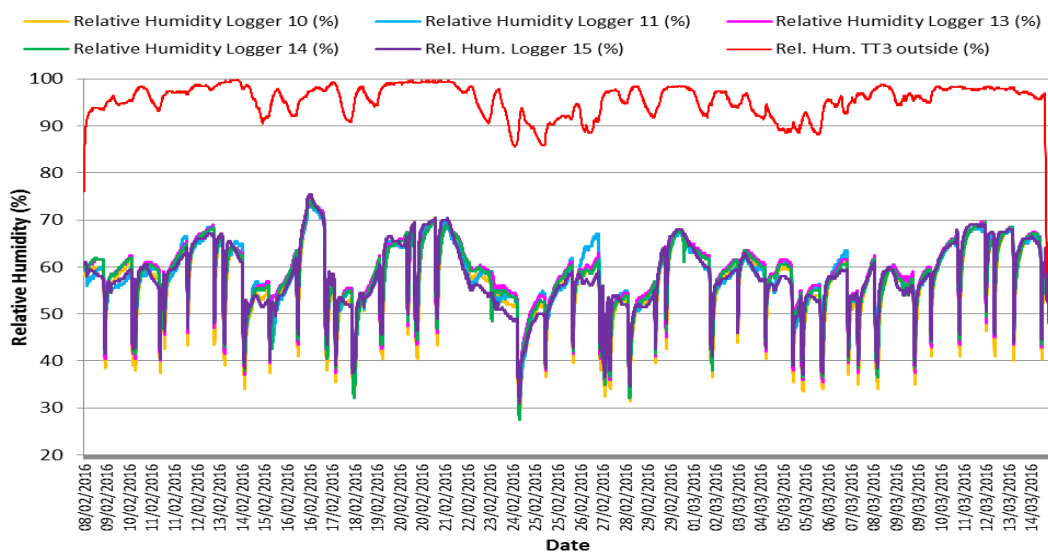
Figure 5.59 - RH readings inside and outside St. Mary's Cathedral, Cork

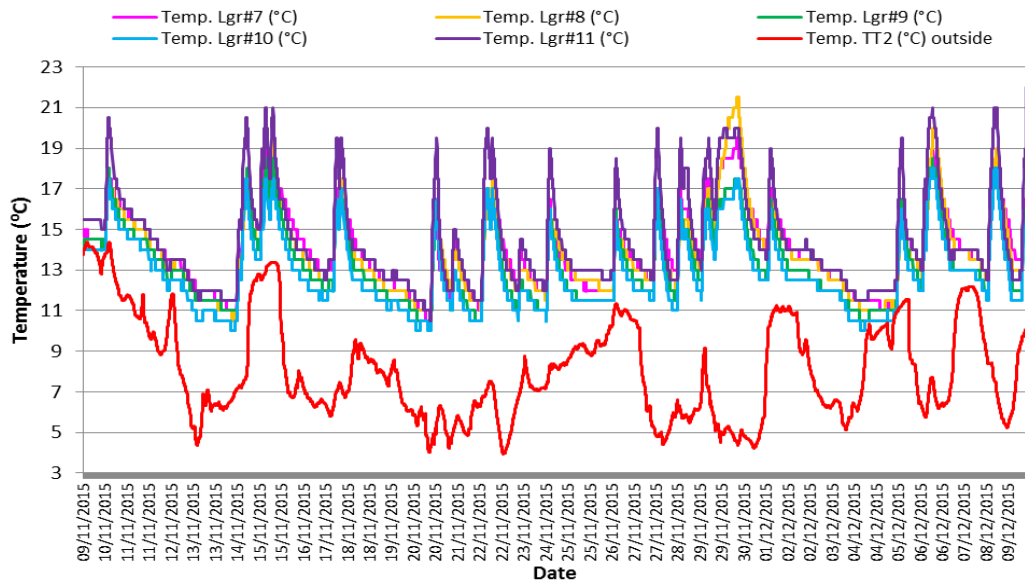
Figure 5.62 - Consolidated T readings (inside and outside) for St. Columba's Cathedral, Derry

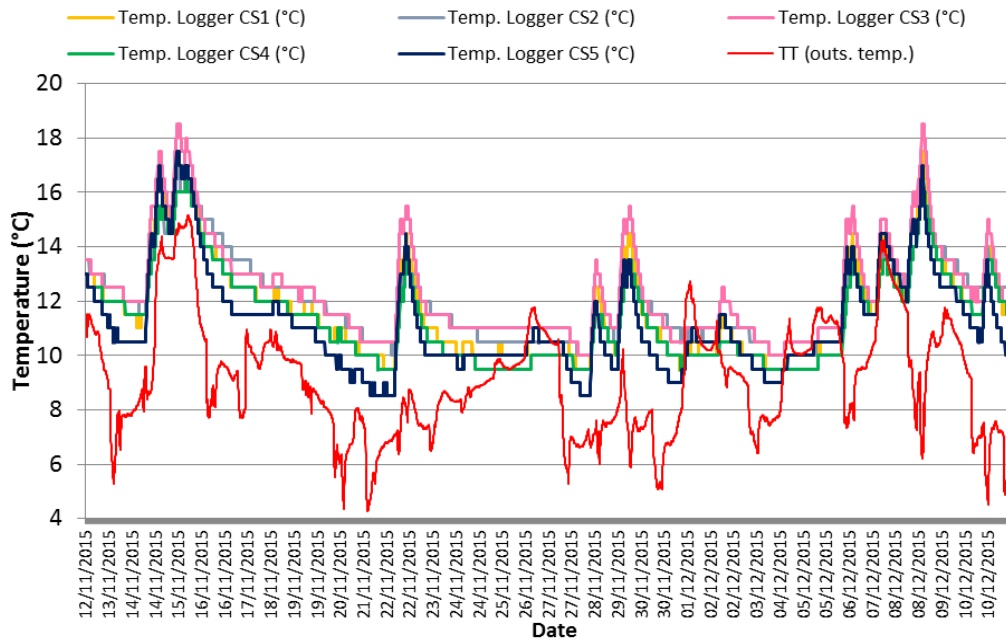
Figure 5.63 - Consolidated T readings for St. Patrick's Cathedral (CI) in Armagh

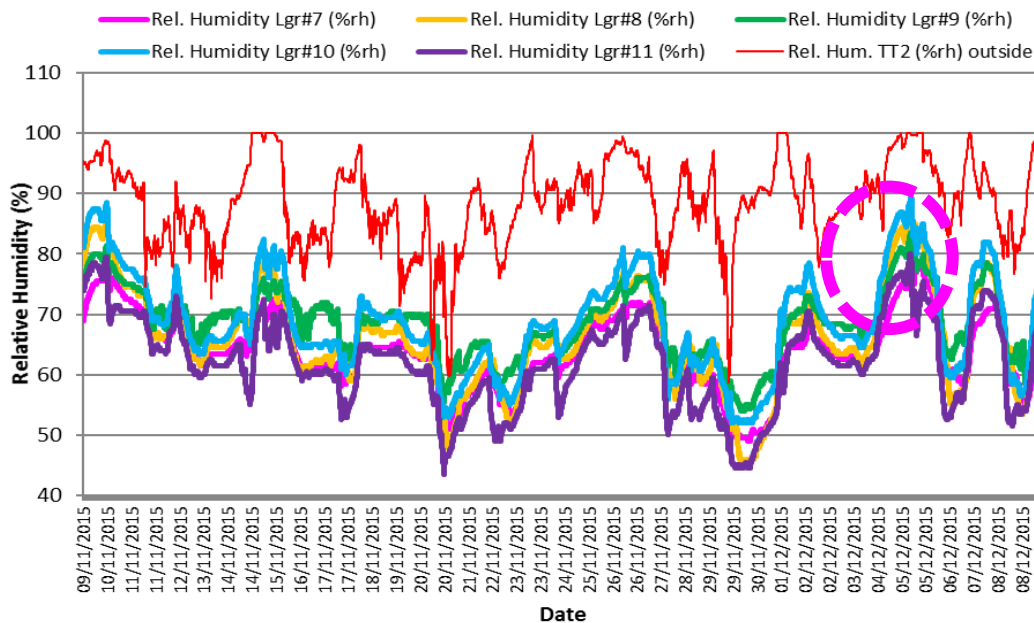
Figure 5.64 The effect of a large number of people entering the cathedral for a service on 5 December in St. Columb's cathedral, Derry (CI), when the weather was very wet.

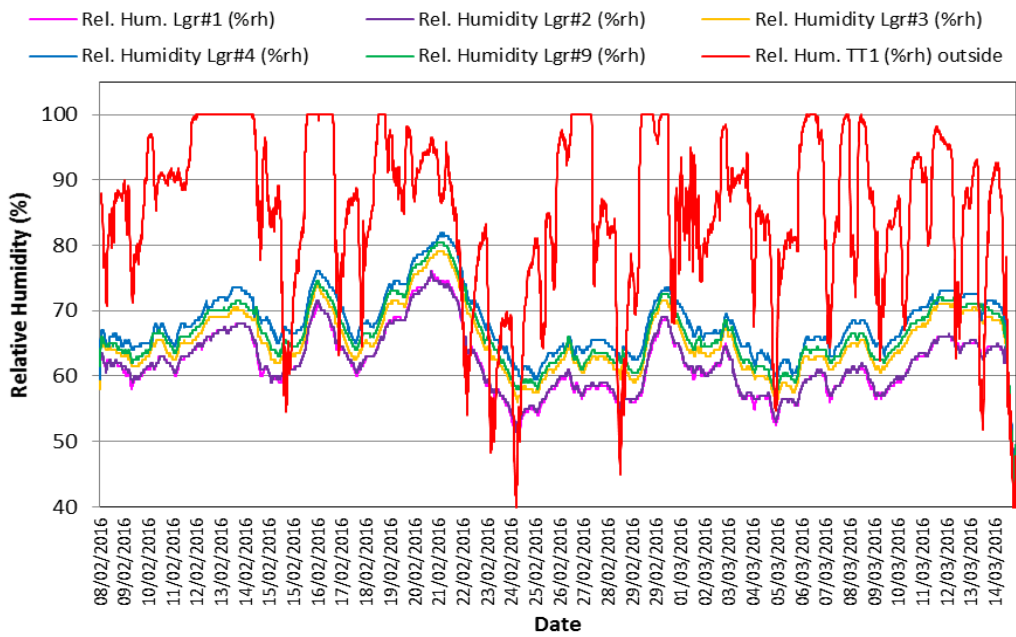
Figure 5.73 - Consolidated RH readings (inside and outside) for St. Fin Barre's Cathedral, Cork

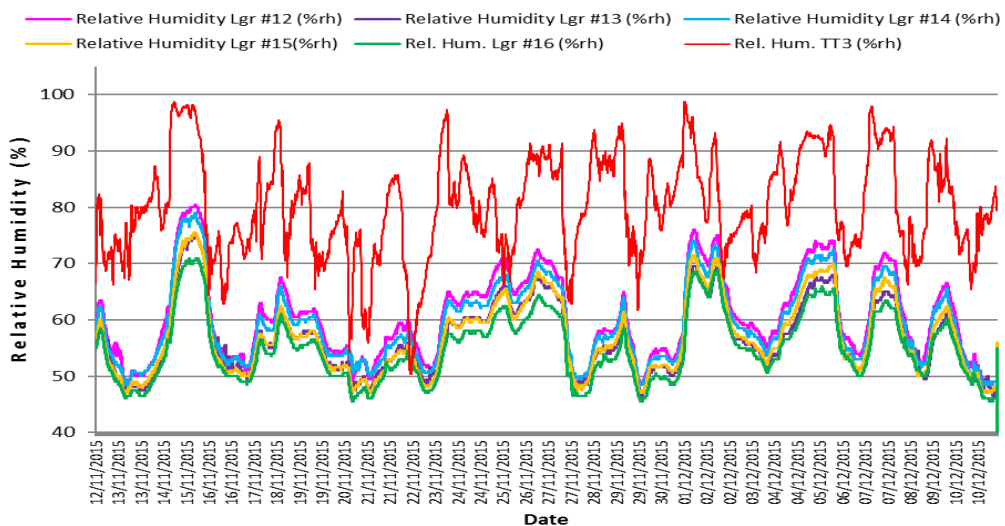
Figure 5.74 - Consolidated RH readings for St. Peter's Cathedral, Belfast
