THE THERMO-HYGROMETRIC ENVIRONMENT IN CATHEDRALS IN IRELAND

**Department of Civil, Structural and Environmental Engineering
Trinity College Dublin**

**A thesis submitted for the degree of Doctor of Philosophy to the University of Dublin,
Trinity College.**

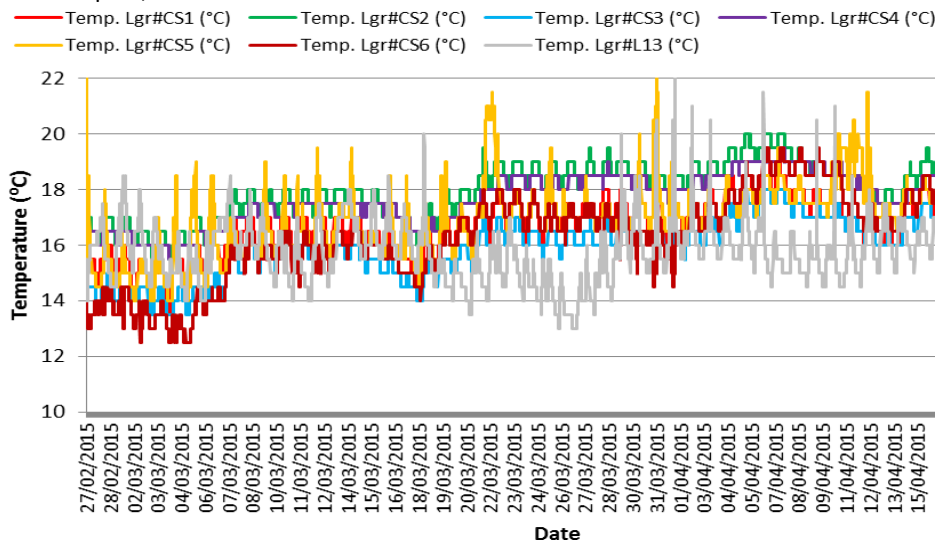
Figure 5.78 - Consolidated internal T readings in Christ Church cathedral, Dublin in winter

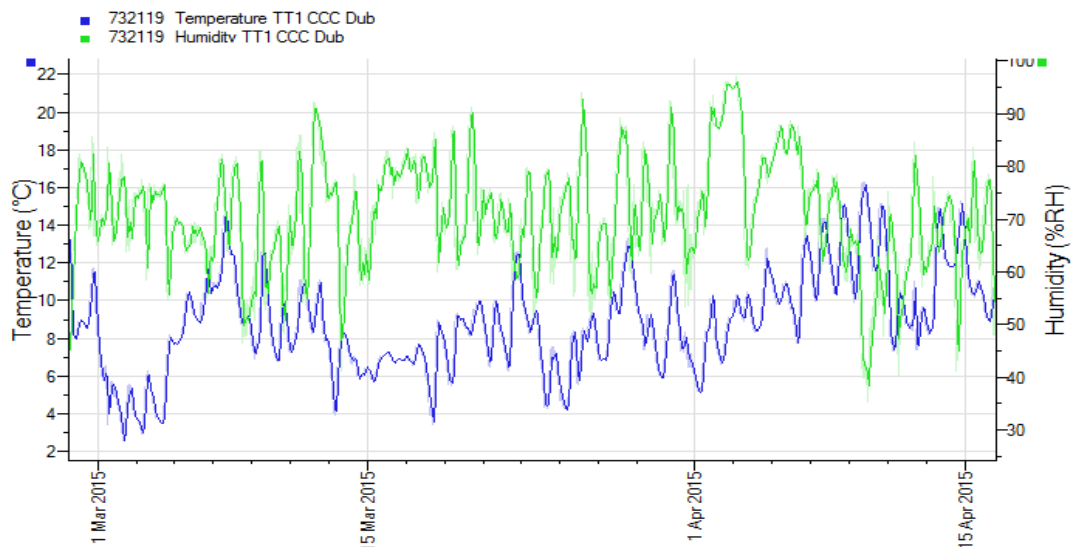
Figure 5.79 - TinyTag readings for Christ Church cathedral Dublin in the winter

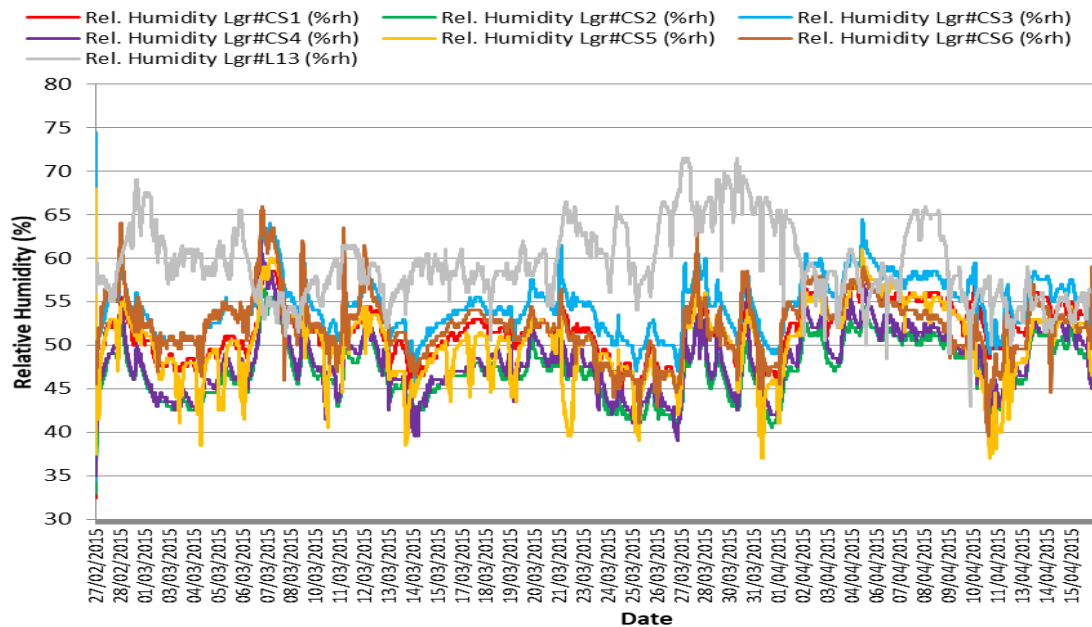
Figure 5.80 - RH readings for Christ Church cathedral, Dublin during Winter 2015

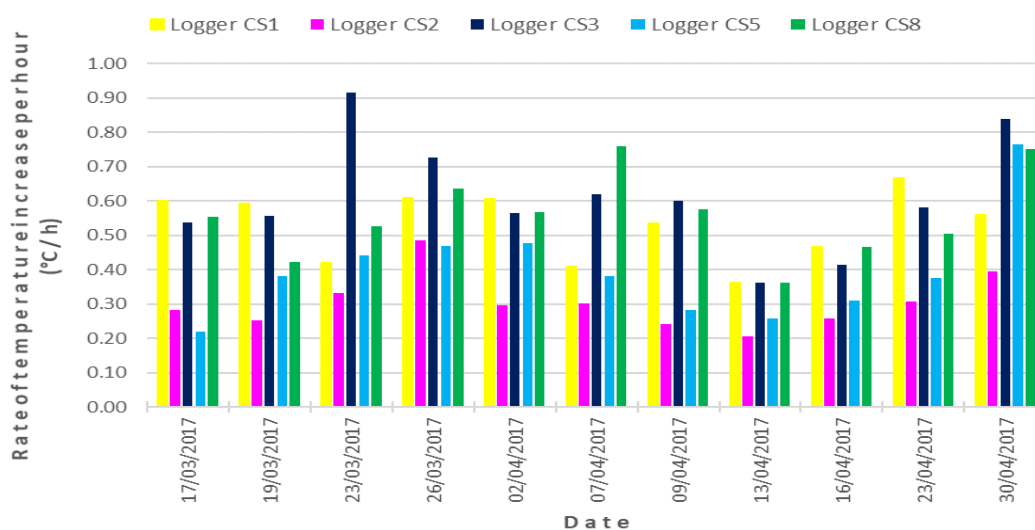
Figure 5.85 Killaloe cathedral rate per hour increase

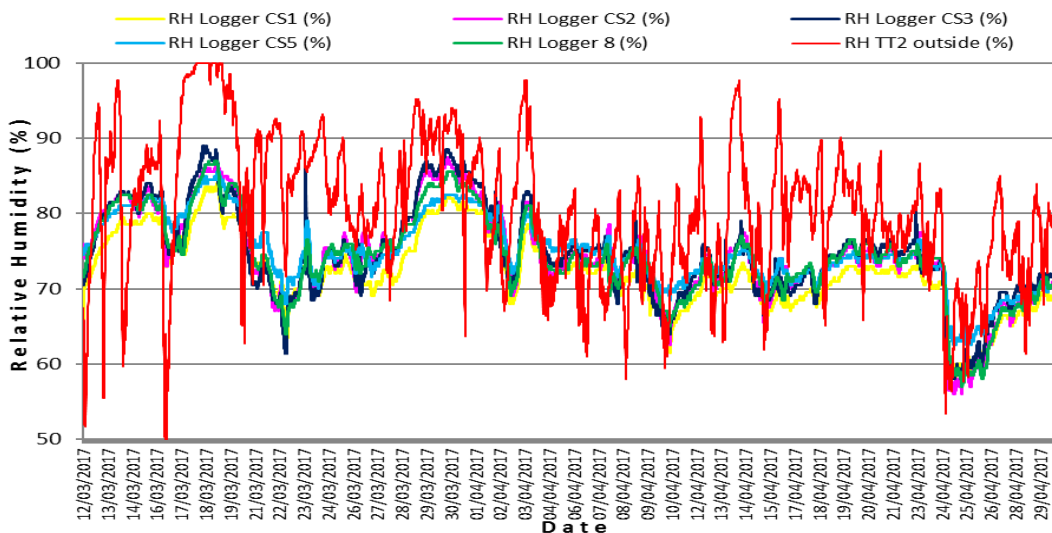
Figure 5.88 - Consolidated RH readings for Raphoe CI cathedral

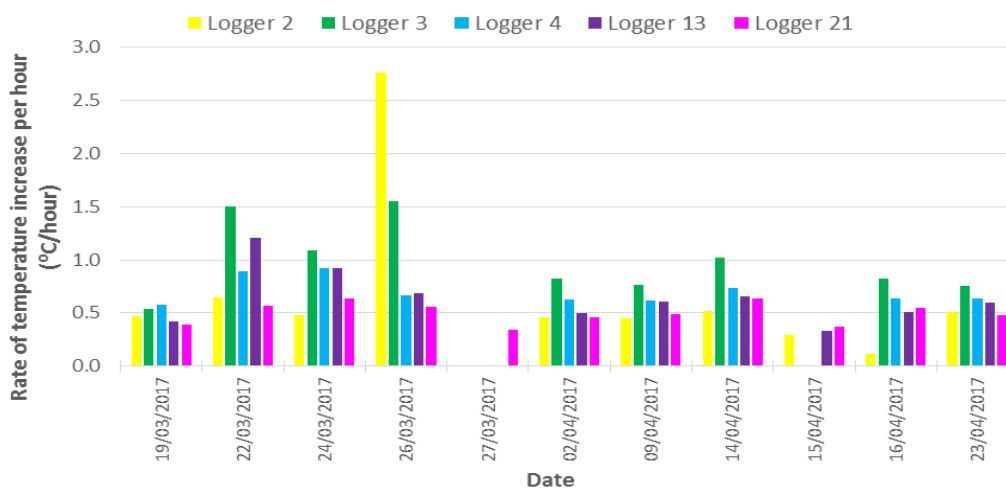
Figure 5.89 - Rate of temperature increase per hour in Raphoe's Cathedral

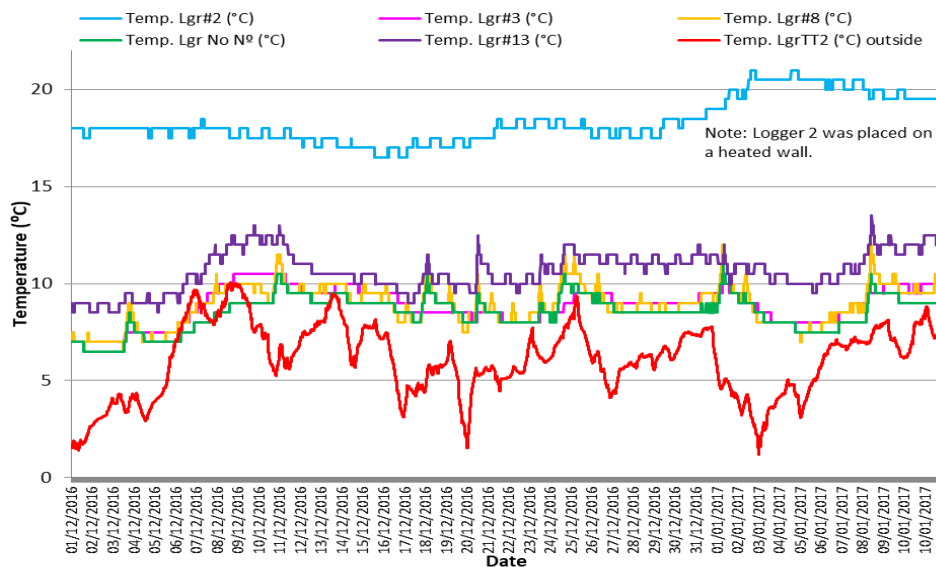
Figure 5.90 - Consolidated T readings from the loggers in Old Leighlin cathedral

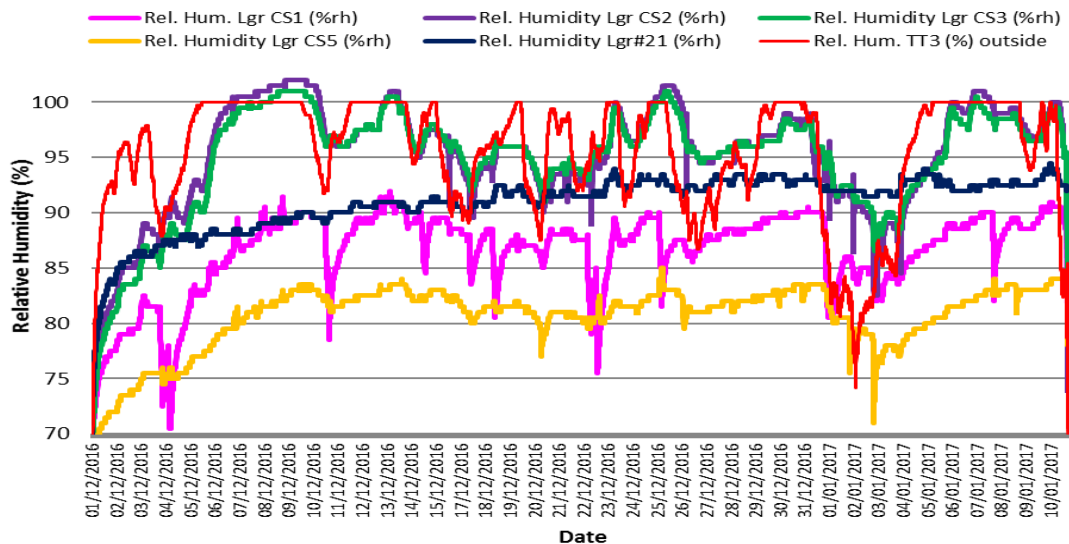
Figure 5.101 - Consolidated RH readings for St. Cathage's cathedral, Lismore

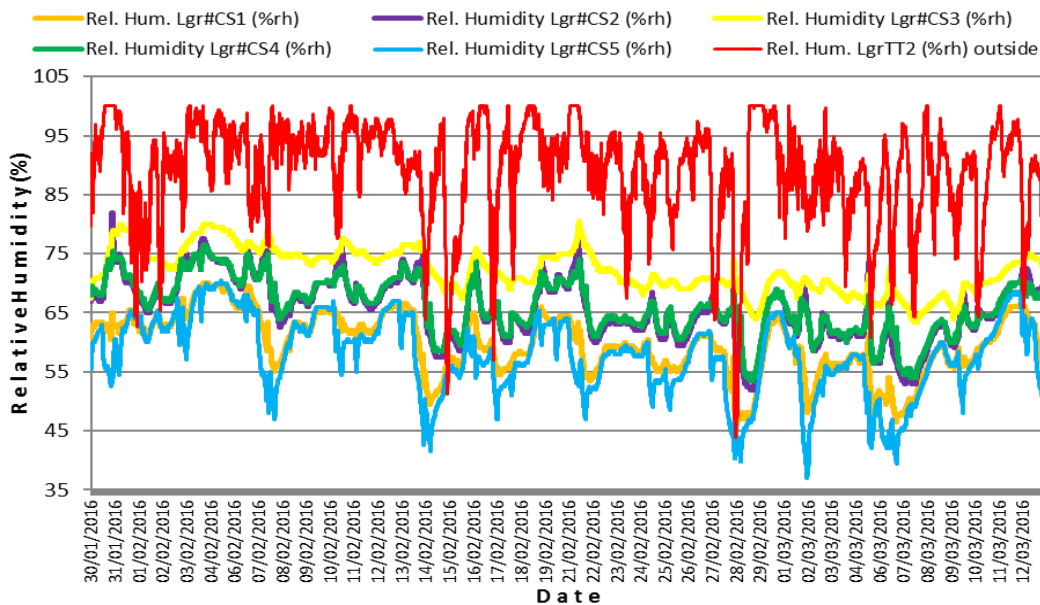
Figure 5.109 - Consolidated RH readings for St. Macartan's cathedral, Enniskillen

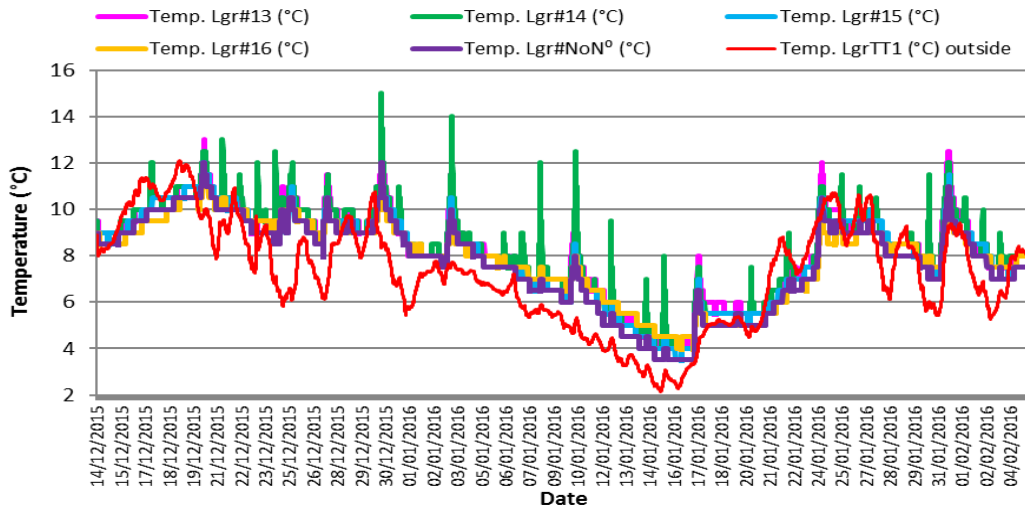
Figure 5.112 - St. Brigid's cathedral, Kildare, consolidated T readings from the loggers and TinyTag

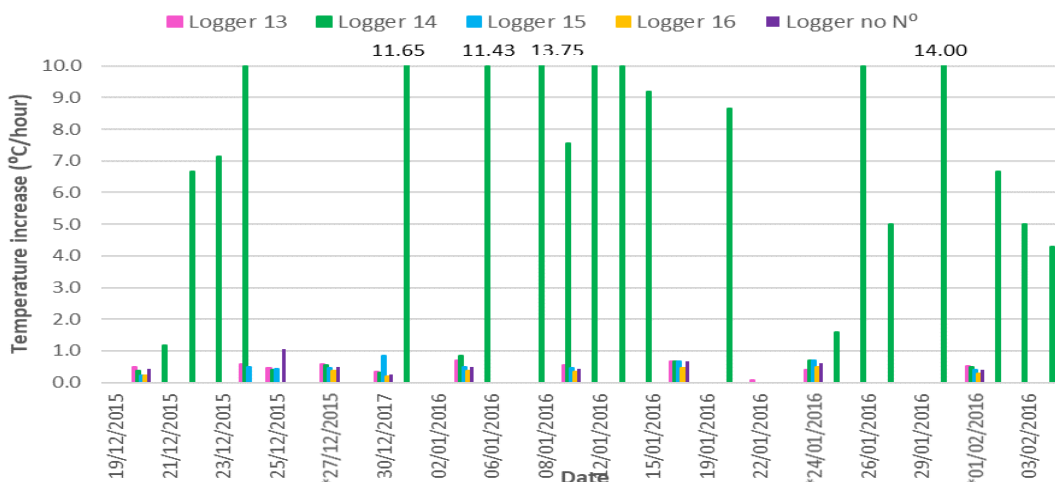
Figure 5.113 - Rate of temperature increase per hour for each logger in St. Brigid's cathedral, Kildare

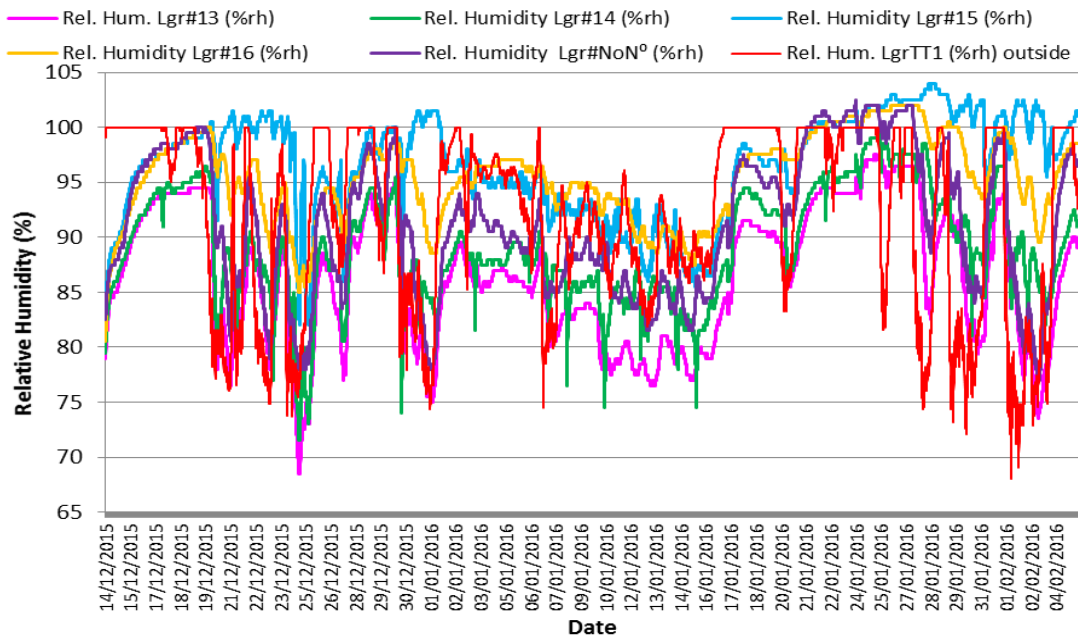
Figure 5.114 - Consolidated RH readings for St. Brigid's cathedral, Kildare

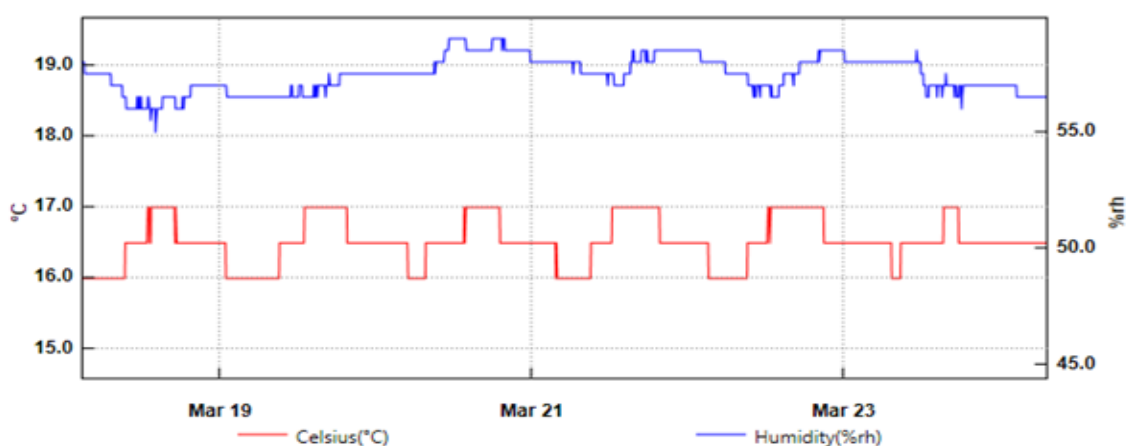
Figure 5.127 - St. Patrick's cathedral, Dublin, Logger 1, from March 18 to March 24, 2015
