**REPORT OF AN INVESTIGATION
INTO A MARINE CASUALTY
INVOLVING THE MERCHANT VESSEL
ARKLOW RAIDER
IN THE BRISTOL CHANNEL,
25 NOVEMBER 2022**

**REPORT NO. MCIB/324
(No.7 OF 2023)**

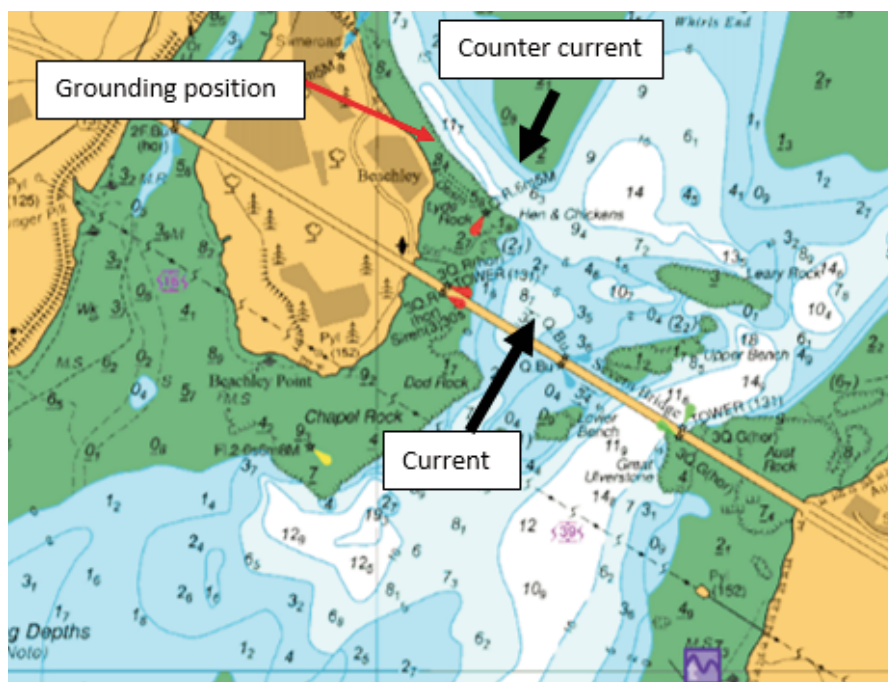
Annotated Extract from Admiralty Chart 1166: River Severn Avonmouth to Sharpness and Hook Cliff

- 1.1 On the evening of 25 November 2022, the general cargo vessel Arklow Raider, proceeded on a laden passage up the Bristol Channel towards her destination port of Sharpness, United Kingdom (UK). At around 19.19 hours (hrs) the vessel passed under the Severn Bridge and the Pilot commenced a planned turn to port to round Lyde Rock. Despite the Pilot applying starboard helm to counter the anticipated currents and counter currents, the vessel rapidly sheered to port, leaving the channel, before grounding heavily by the bow on a mud and rock bottom at approximately 19.21 hrs. After sounding all compartments and determining no apparent water ingress, the vessel was re-floated under its own power on the still rising tide. The passage was aborted and successfully completed on the following tide with the same Pilot. The vessel sustained damage to the shell plating and framing in the forepeak ballast tank, with water ingress subsequently detected in the forepeak. The vessel was dry-docked for repairs. No persons were injured and no pollution occurred.

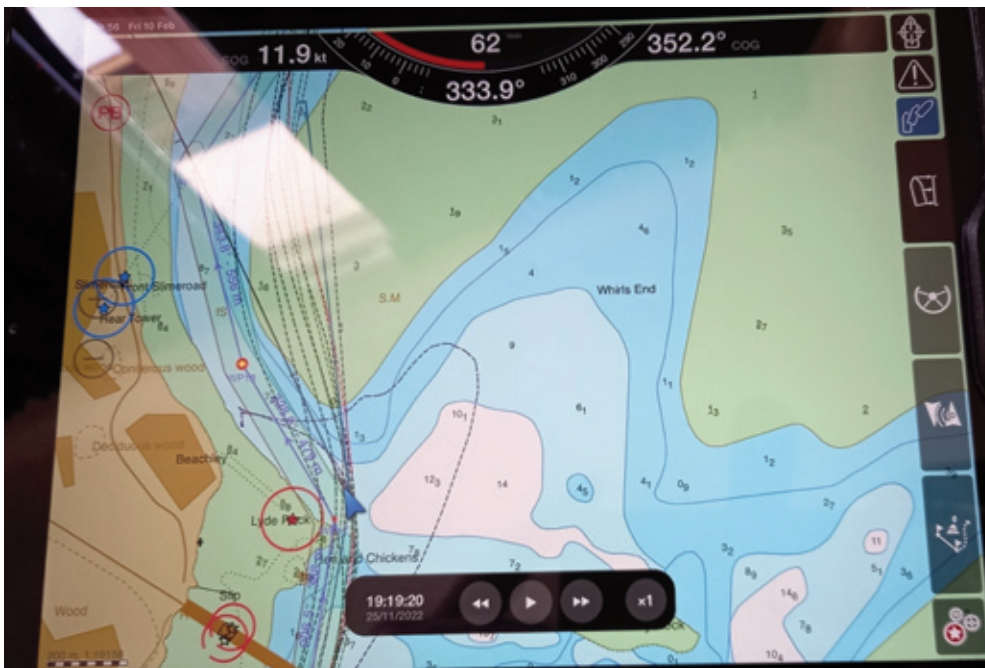
PPU – 19:19:20

- 3.14 Without warning the ROT to port rapidly increased. AIS data evidences the ROT increased from 2.2° at 19.18.57 hrs to 67.9° by 19.19.23 hrs i.e. an increase of 65.7° per minute in only 26 seconds. The Pilot described the effect as “*like putting tugs at the stern and bow of the vessel*”. During this period the Pilot applied full starboard helm of 45° rudder in an attempt to check the turn. Concerned that the rudder may have stalled, on two

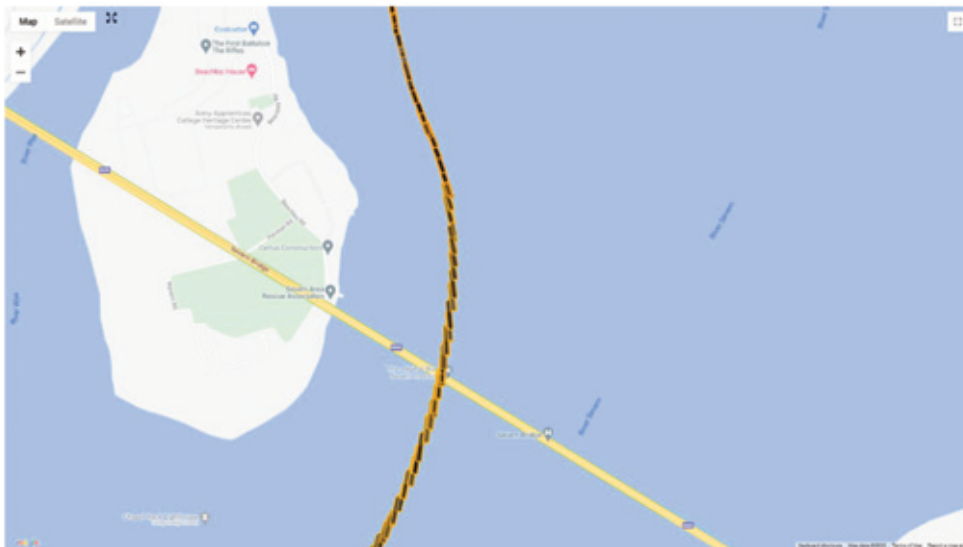
The vessel's heading throughout the turn is as expected initially and not out of the ordinary but can be seen heading too far to port once into the bend past the Lyde beacon, even with starboard rudder applied (see Fig.6 AIS track). The same vessel called in April 2022 (per Fig.3), and Fig.7 illustrates the inward track from AIS on that occasion, which is very similar on approach to the Lyde, but demonstrates continued successful passage past it and passing over the tail of Slimeroad Sands.

Fig.7: Screenshot of AIS track of Arklow Raider previous inward passage 29th April 2022.
