**REPORT OF AN INVESTIGATION INTO  
A MARINE CASUALTY  
INVOLVING THE VESSEL  
SIMMERDIM  
OFF ARDMORE PIER,  
CO. GALWAY  
8 NOVEMBER 2022**

**REPORT NO. MCIB/321  
(No.9 OF 2023)**

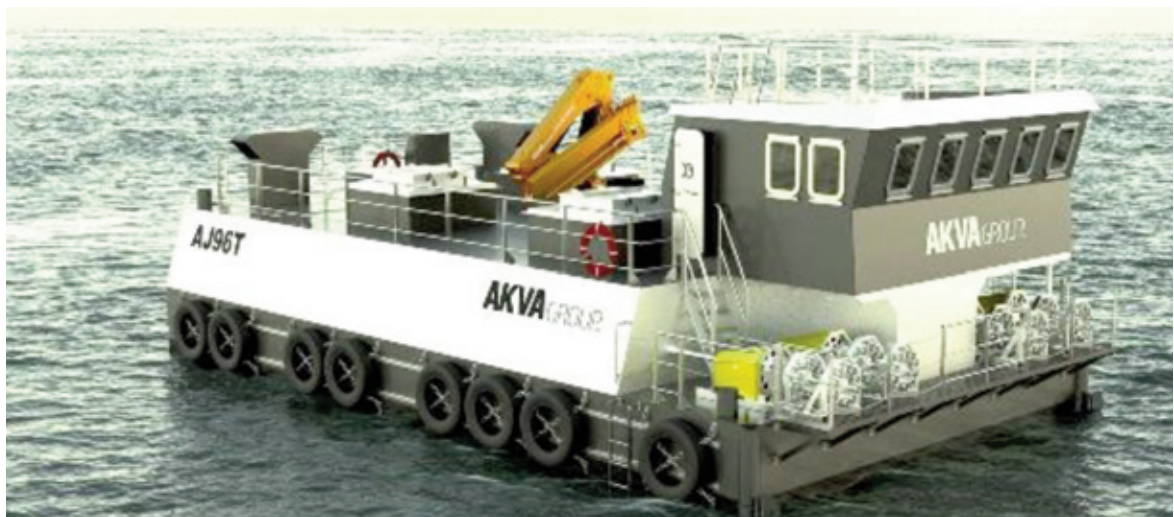
Computer Drawing of a Wavemaster Akva Junior 96T Barge

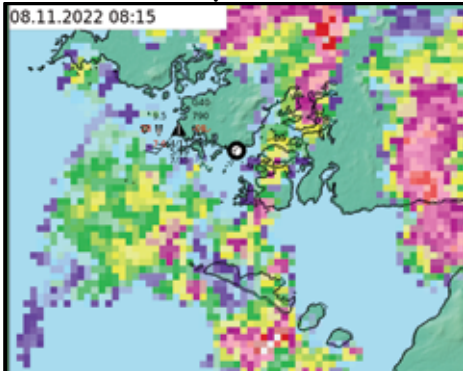
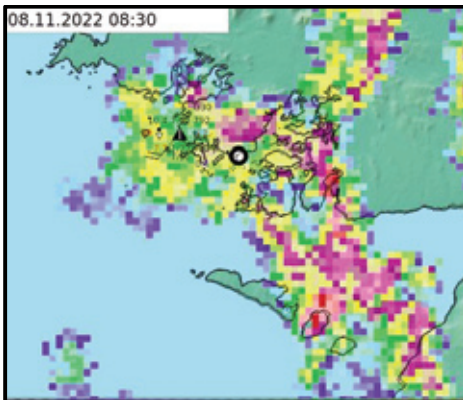
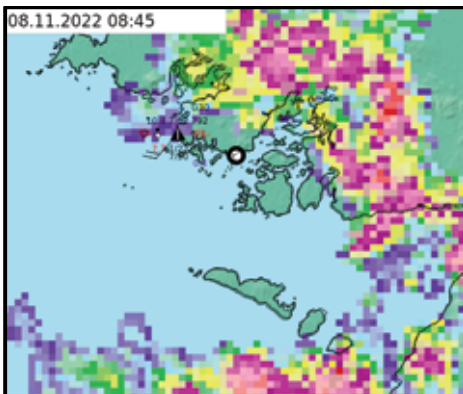
**Appendix 1d zoomed in Rainfall Radar Image with approximate location Kilkieran Bay marked with black/white circle. 8-November -2022 between 08:15 and 08:45 (note rainfall location approximate)**
